Faces of the Guard

A Portrait of the Willard Hirsch Panel Then and Now

Report prepared for
the South Carolina Army National Guard
Columbia, South Carolina

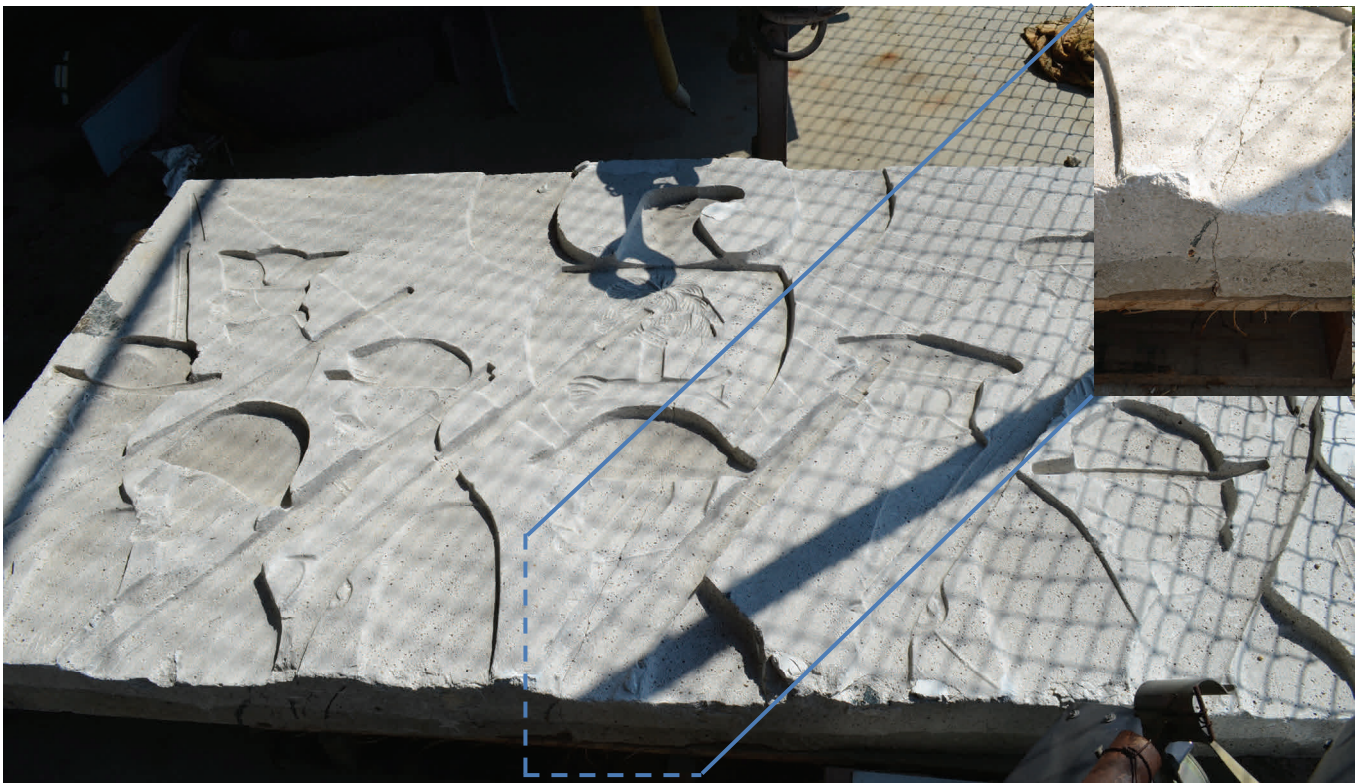
Figure 1. Hirsch panel mold at the South Carolina Military Museum. Inset image shows a major crack in mold.

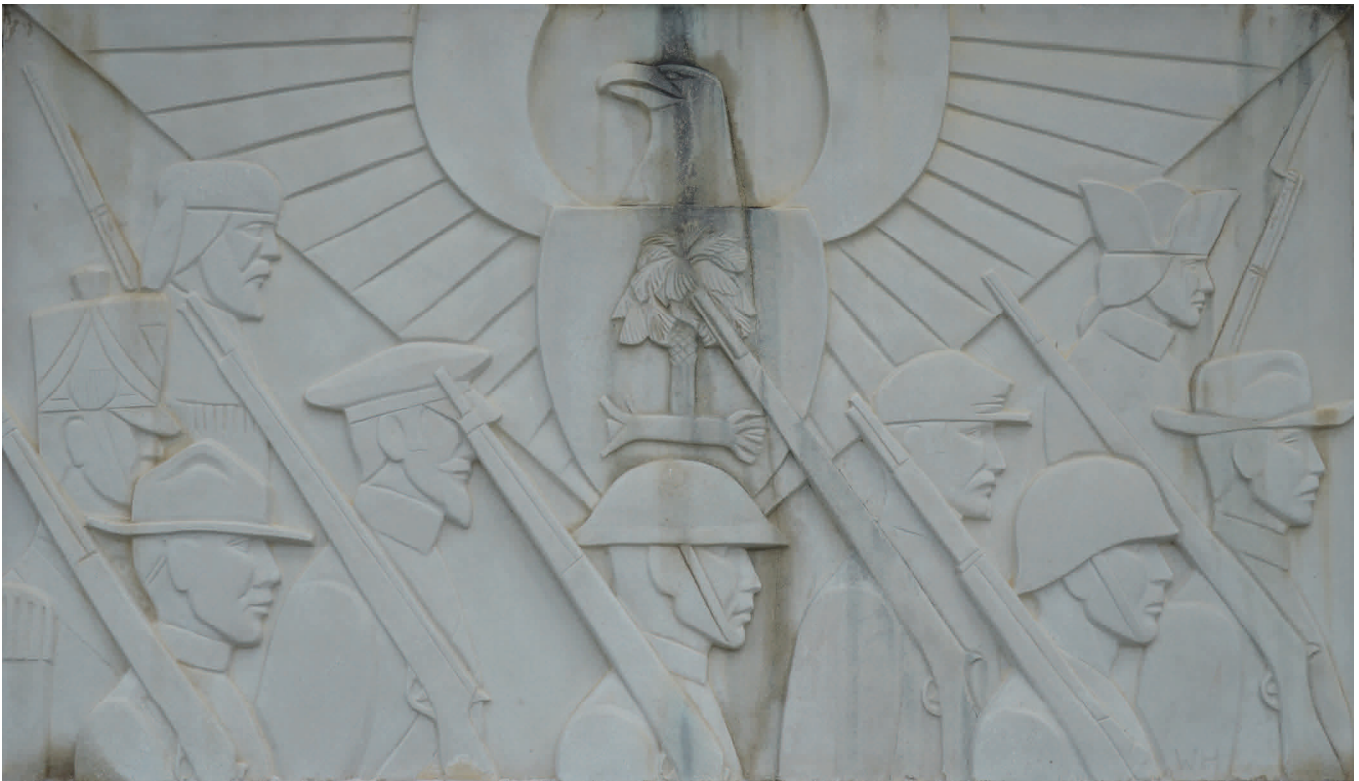
Figure 2. Hirsch panel at the Barnwell Armory as it appears today.

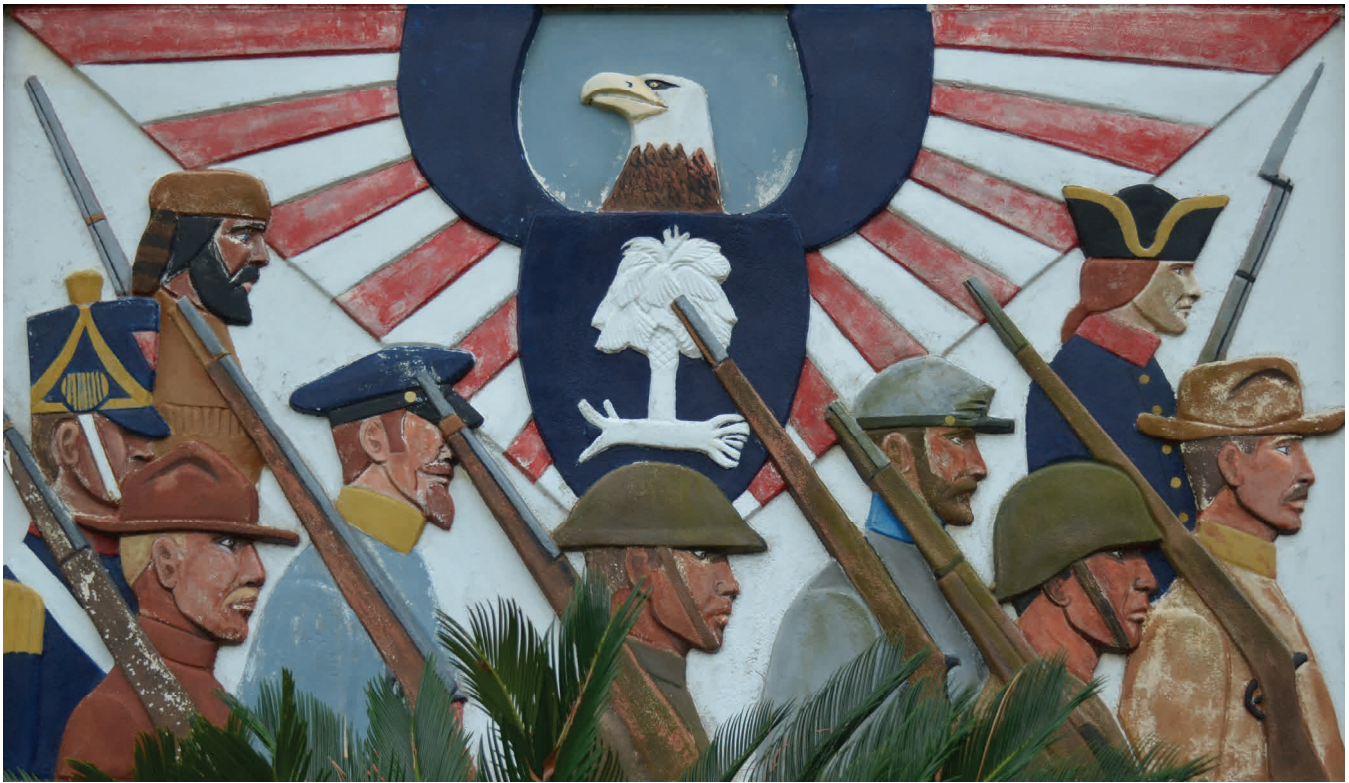
Figure 3. Hirsch panel at the Myrtle Beach Armory as it appears today.

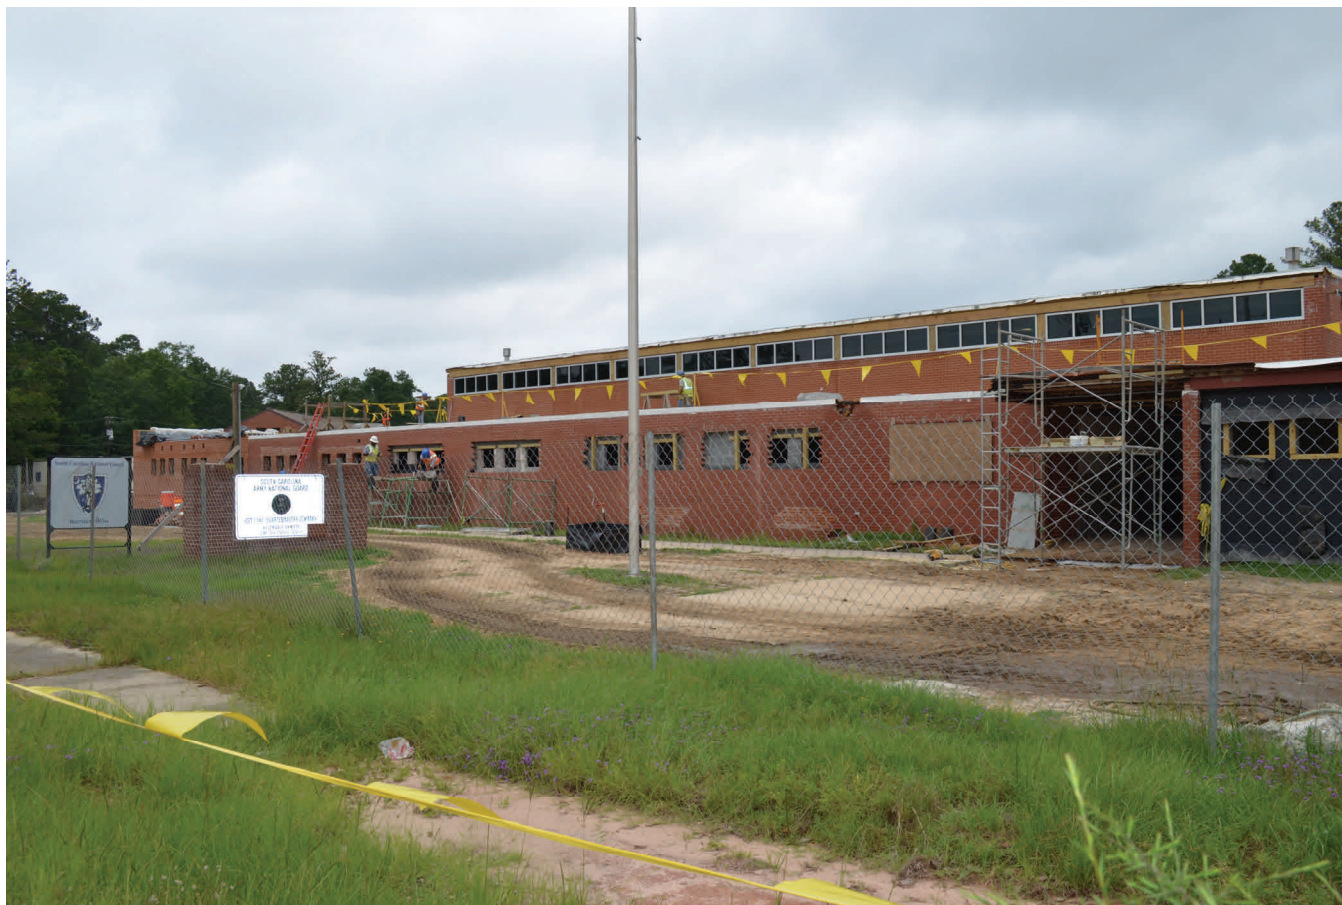
ALLENDALE ARMORY

As seen in the picture above, the Hirsch panel was covered in plywood at the time of the visit because the Allendale Armory was being remodeled. The condition of the panel could not be documented as a result. The Allendale Armory is one of the original fifteen **NRHP-eligible** complexes.

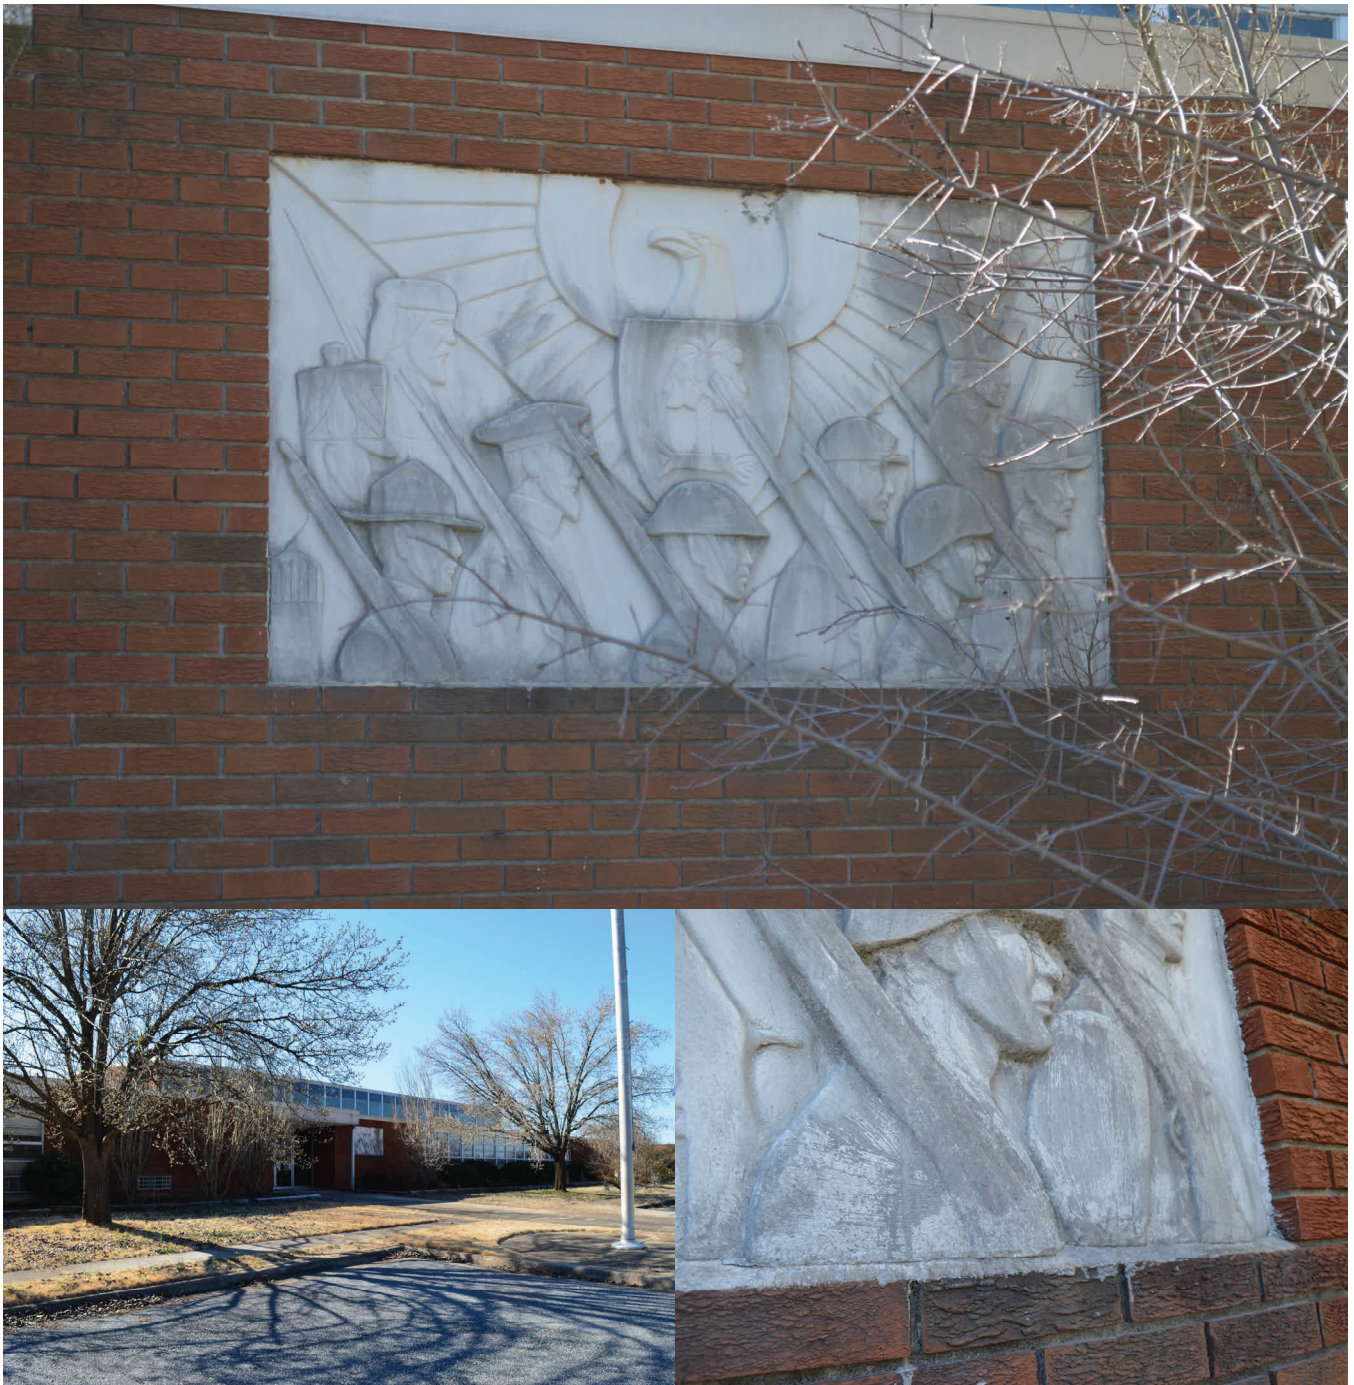
ANDERSON ARMORY

The vacant Anderson Armory, located on Martin L. King, Jr. Blvd., has a Hirsch panel that has been treated with a thin coat of white paint which is peeling or fading, particularly in areas of high relief. Some cracks and staining are also present on the panel.

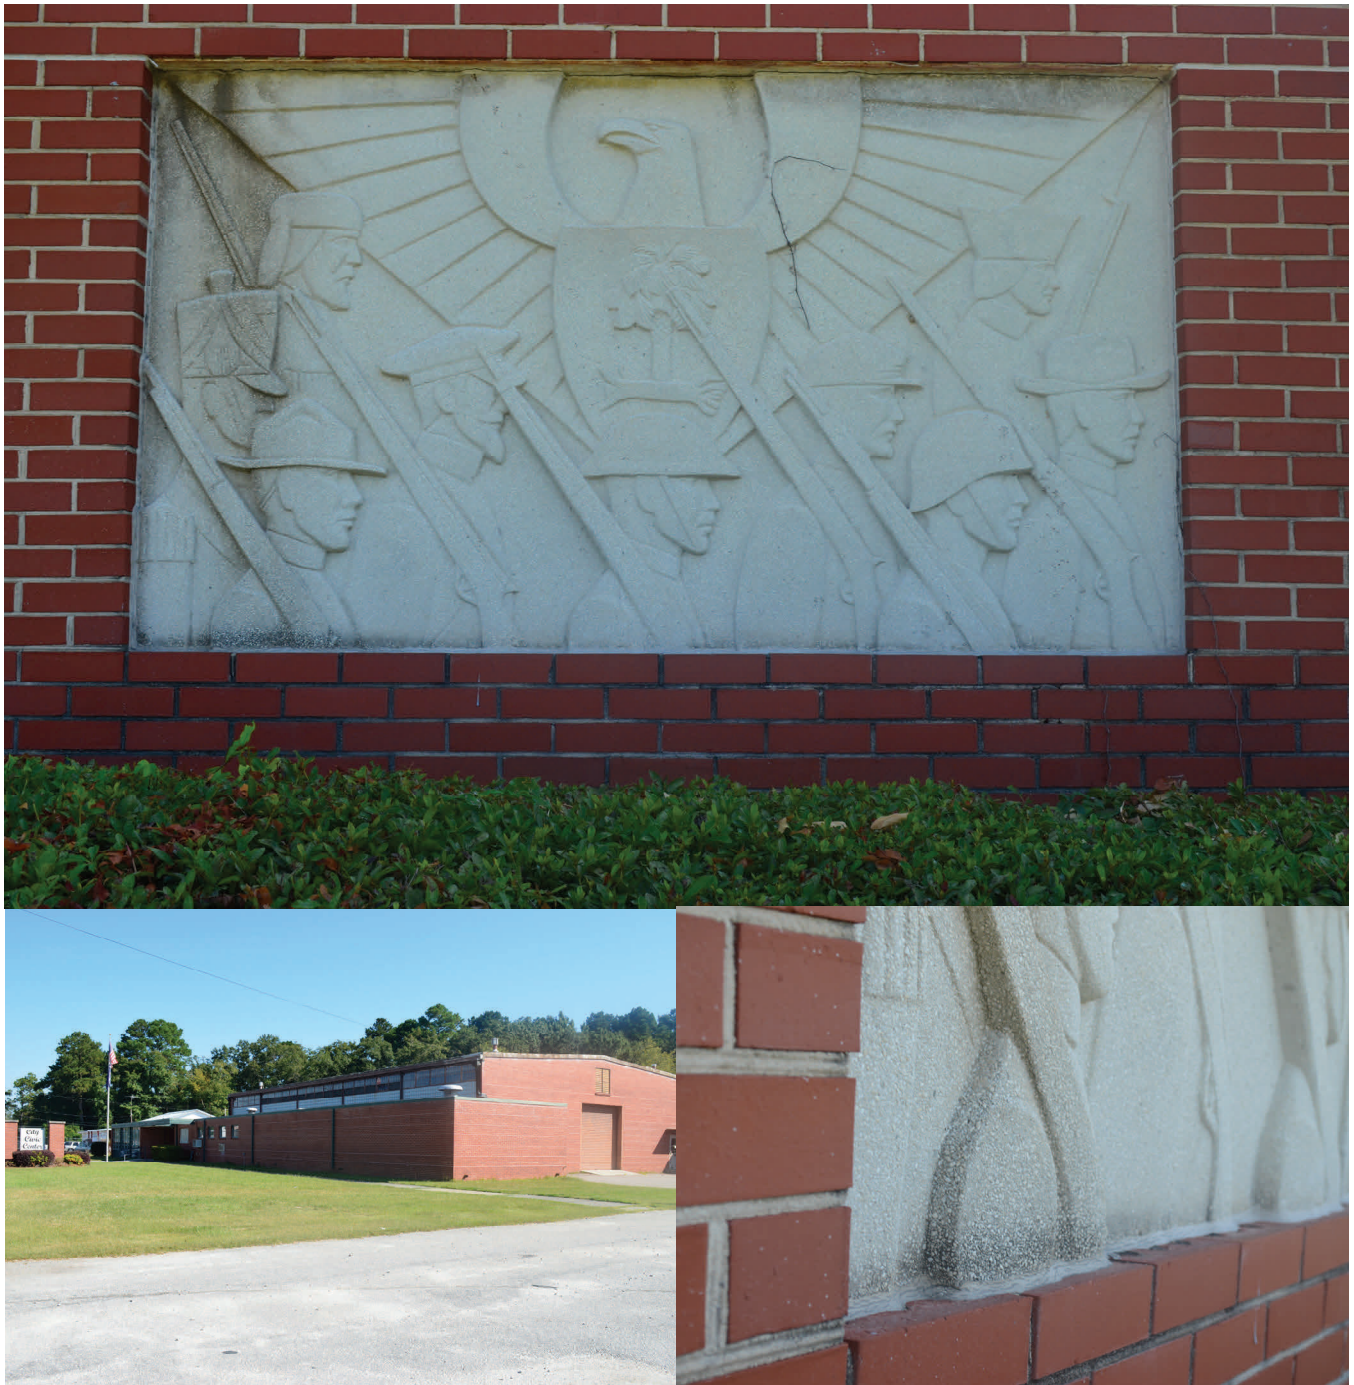
BAMBERG ARMORY

The Bamberg Armory is owned by the City of Bamberg, according to signage, and the Cold War-era structure functions as a civic center. A Hirsch panel is present to the right of the entryway, if facing the building from the street, and is in good, probably original, condition. Some staining from normal weathering is present, particularly on the far left eighth of the panel.

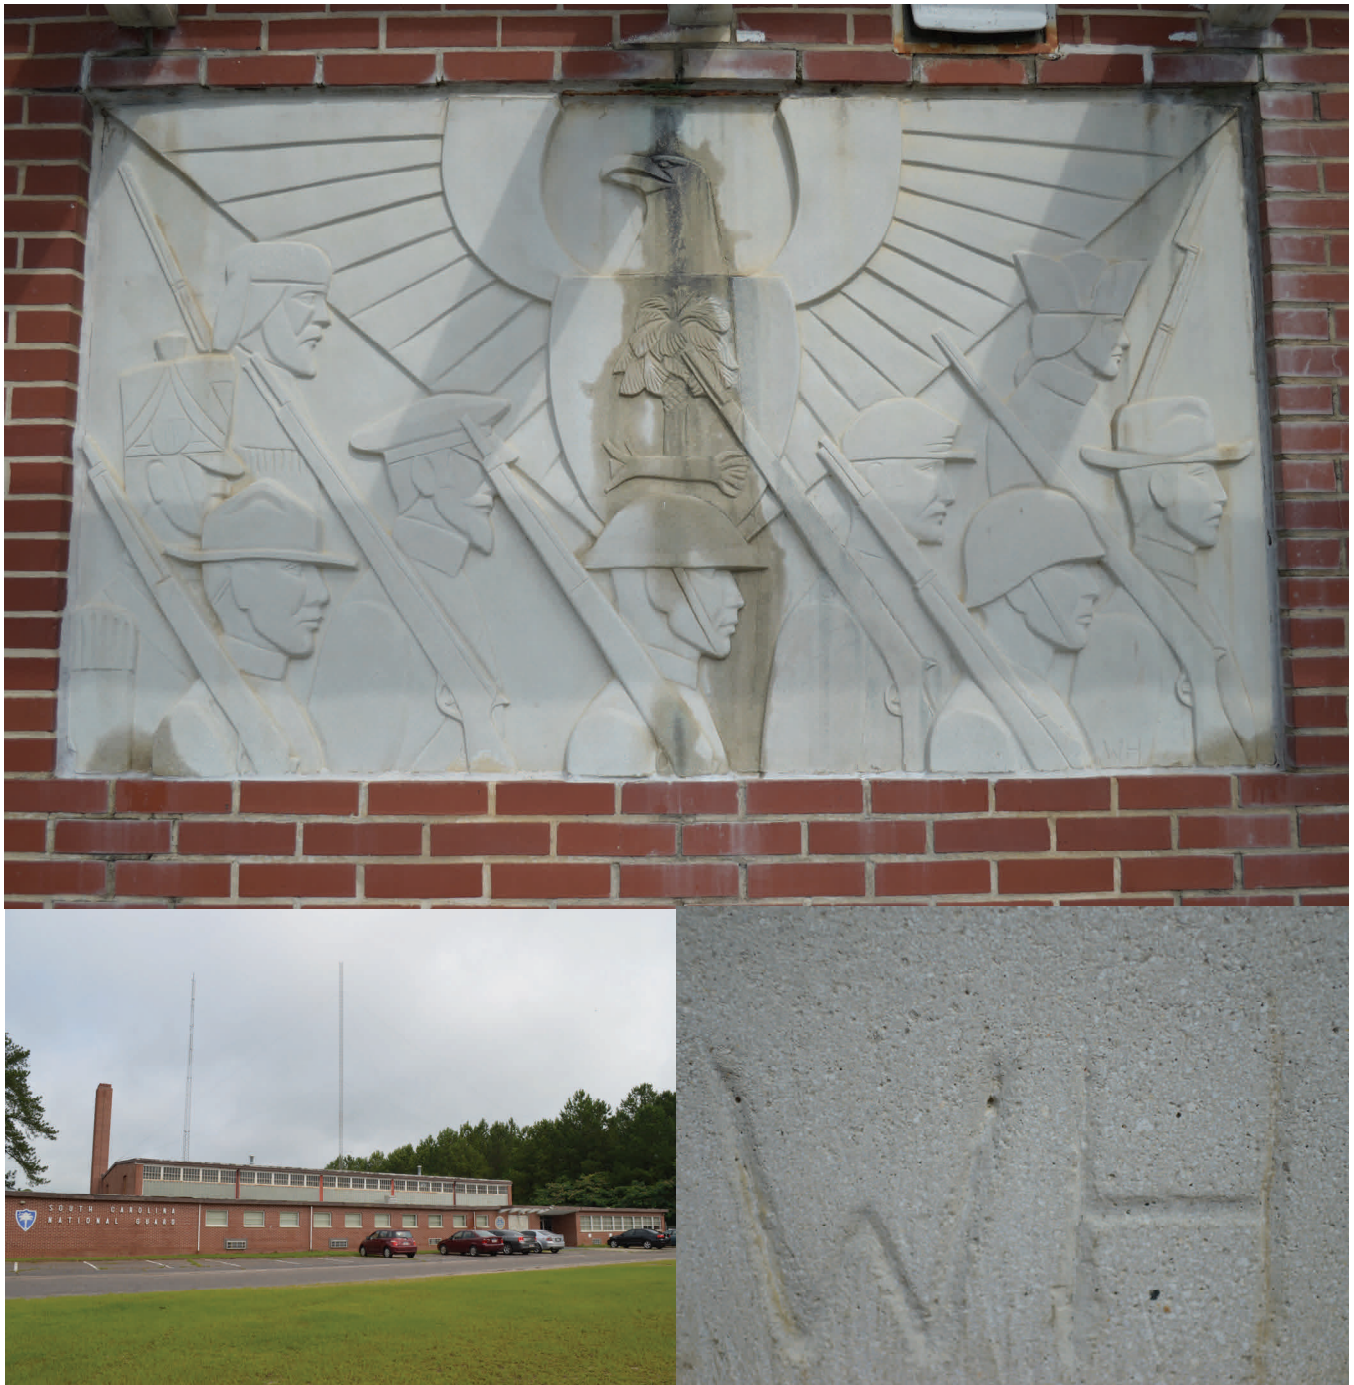
BARNWELL ARMORY

The Barnwell panel is one of the few panels documented during the project that is in original and good condition. Light cleaning of the composite stone would reduce the staining attributed to normal weathering and would probably be all that is required to restore it fully. Because of its good condition, Willard Hirsch's initials are clearly visible in the lower right corner. The Barnwell Armory is one of the original fifteen **NRHP-eligible** complexes.

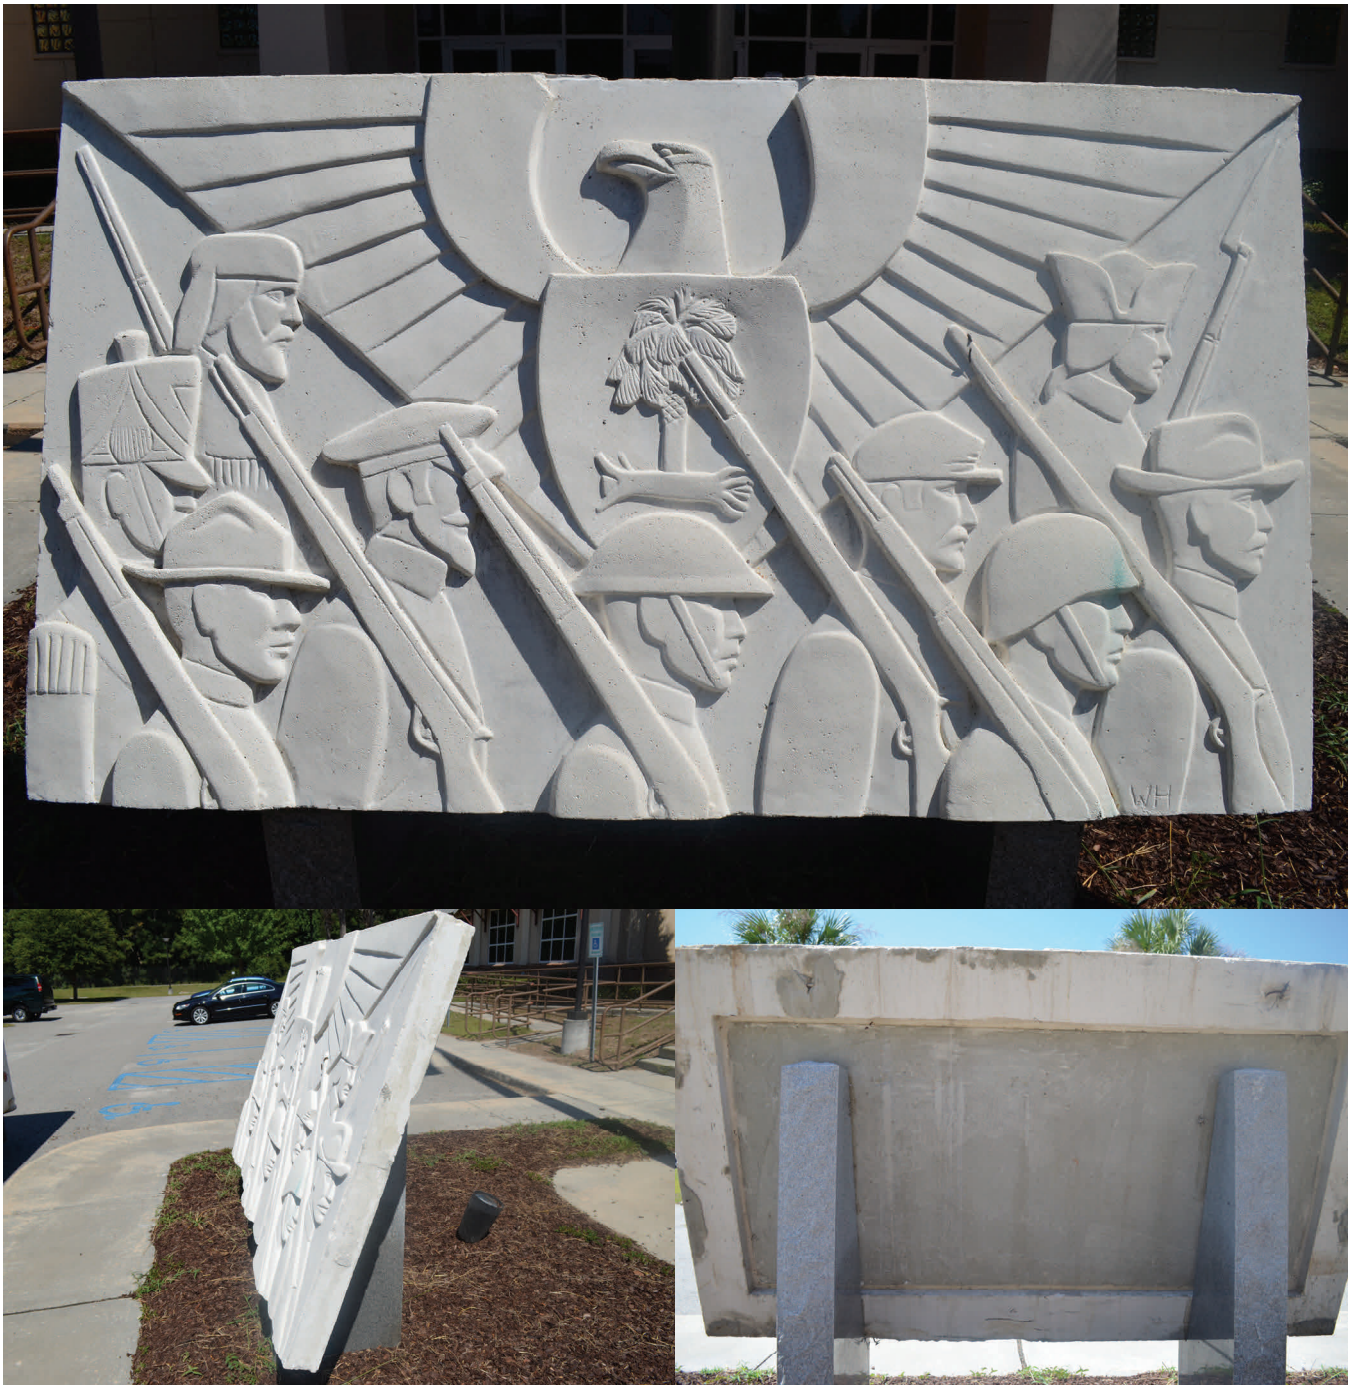
BEAUFORT ARMORY

After several years in storage, the Hirsch panel in Beaufort is now artfully displayed in front of the new Beaufort Readiness Center, built in 2002 on the Marine Corps Air Station (Kitchens et al. 2005:18). It is the only panel documented that can be viewed in the round. Visible on the upper back are two metal hooks presumably used to mount the panel on Type B armory exteriors. The panel itself is in good condition. No paint but some pitting is present.

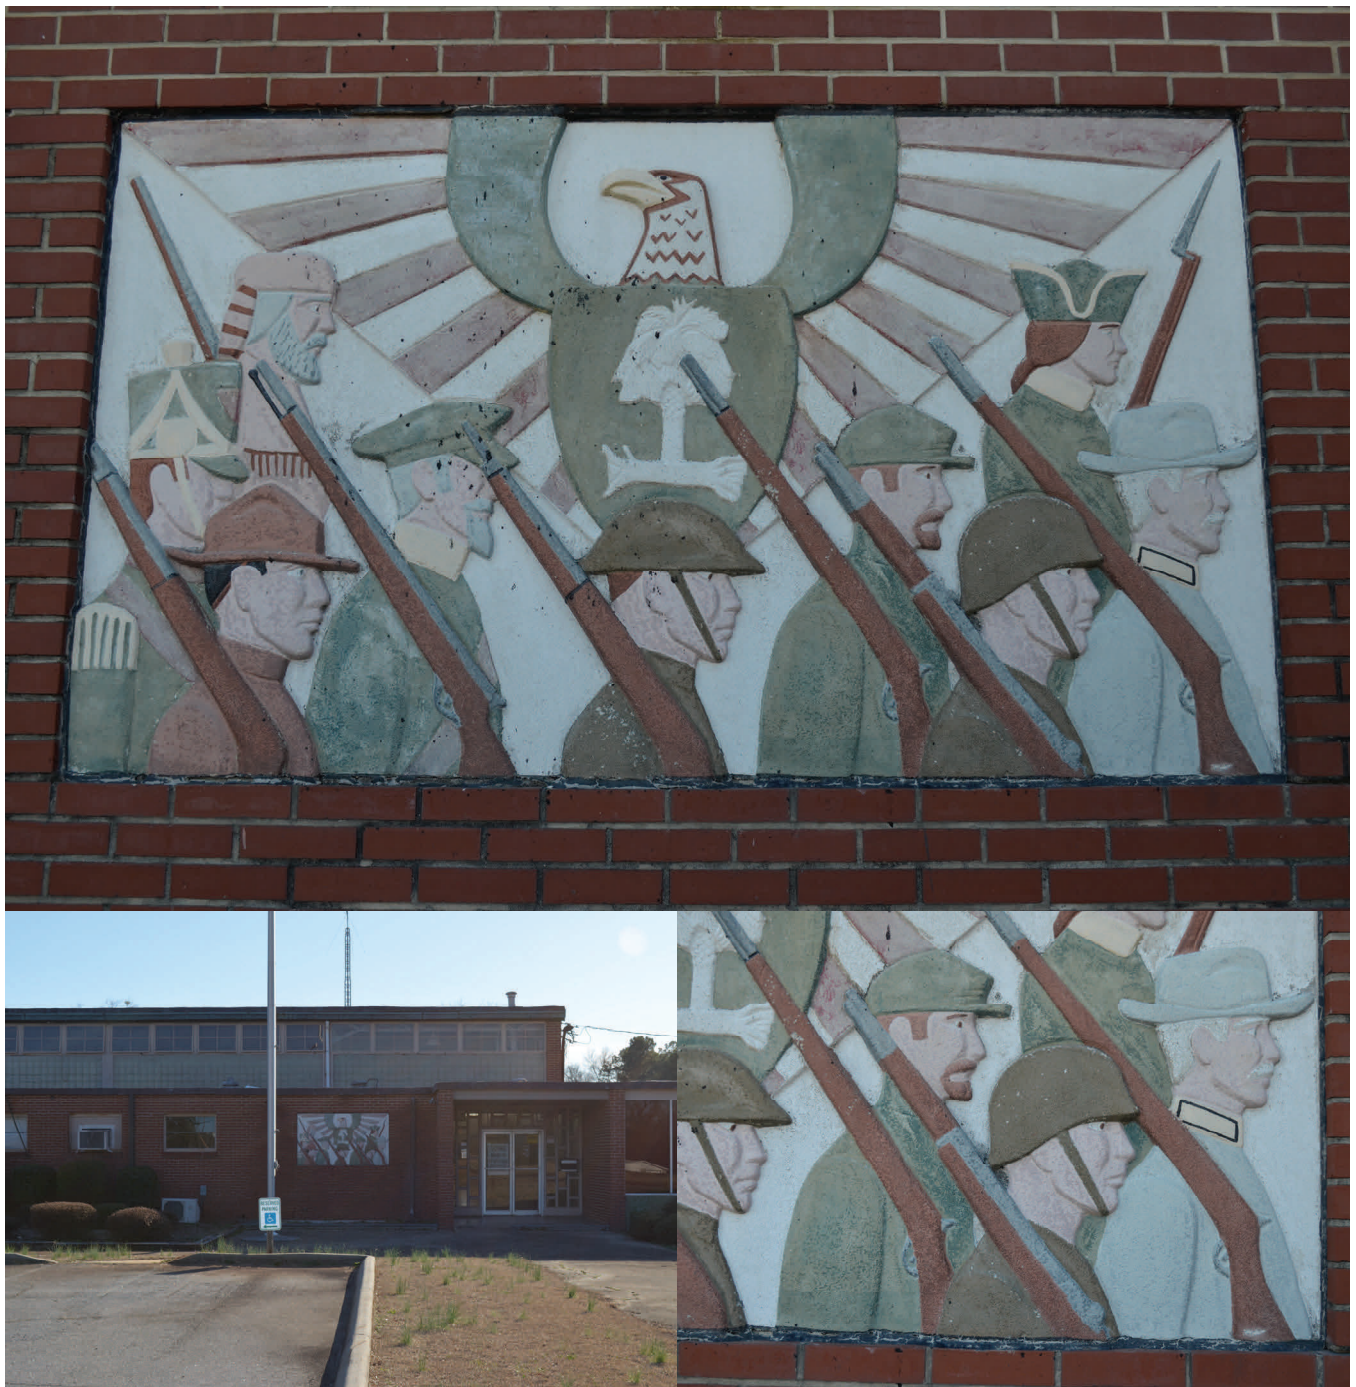
BELTON ARMORY

The Belton Armory, located at the corner of Murdock Rd. and Blue Ridge Ave. in Belton, has a polychrome painted Hirsch panel in a unique, earthy color palette that emphasizes olive green instead of dark blue (see Ware Shoals Armory for comparison). At the time of the visit, the building appeared vacant, though the unit sign was still posted. The Belton Armory is one of the original fifteen **NRHP-eligible** complexes.

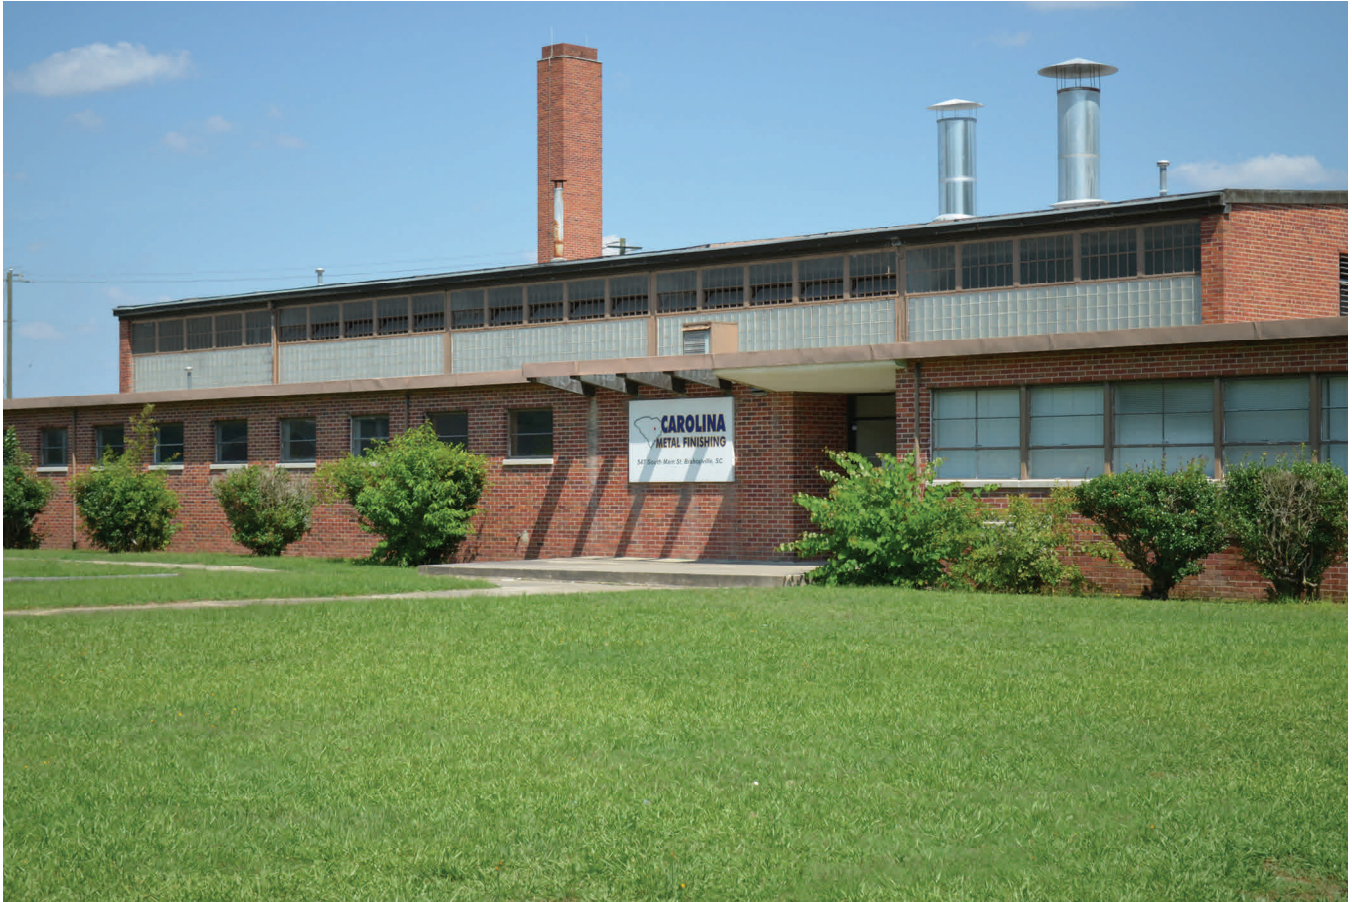
BISHOPVILLE ARMORY

The Bishopville Armory is privately owned, according to signage. The Hirsch panel is no longer visible on the exterior of the Type B building. At the time of the visit, it was unclear whether the panel was covered by current signage or removed altogether. In a subsequent unrelated trip to Bishopville, colleague Keith Stephenson spotted the Hirsch panel, in original condition, set in a building front next to the South Carolina Cotton Museum on W Cedar Lane.

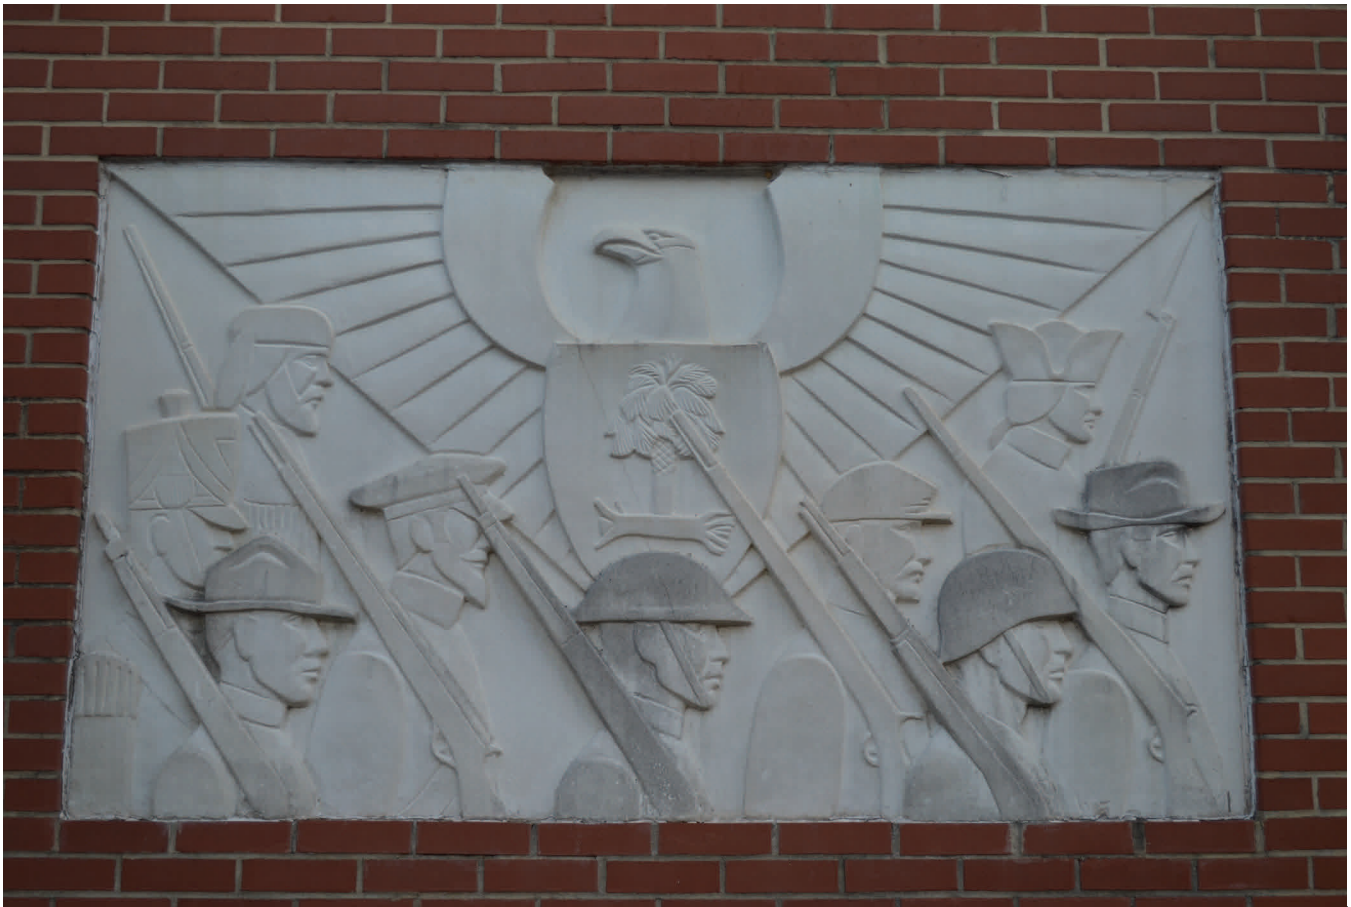
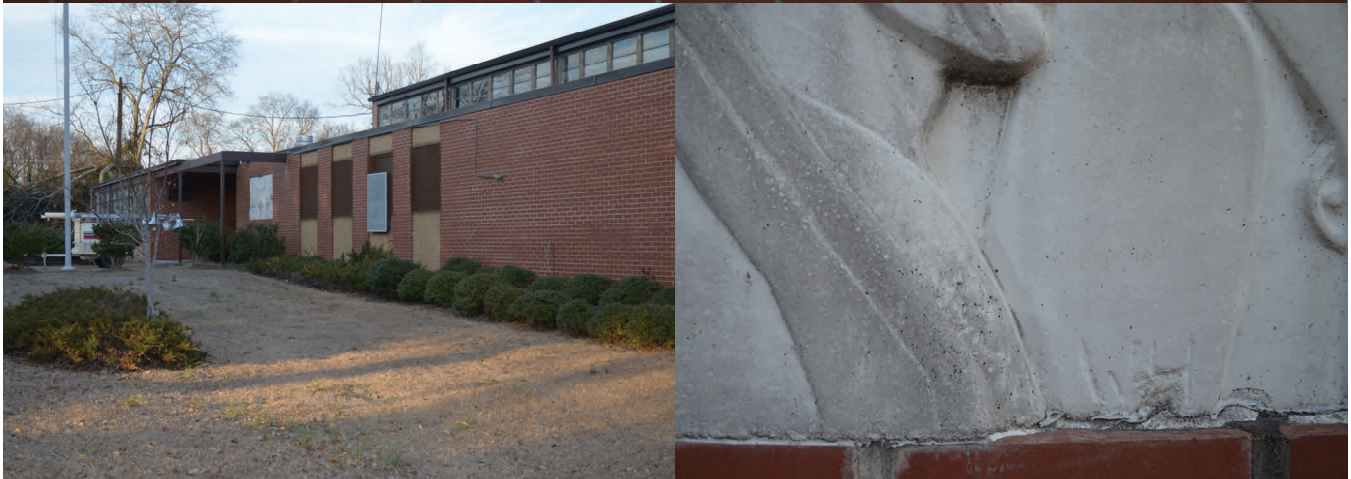
CHESTERFIELD ARMORY

The Chesterfield Armory, located on Watson St., is owned or leased by the Sherriff's Department, based on the signage. A Hirsch panel is present and is moderate condition. The panel has a crack running across the center. Also visible on the surface is a thin light-colored coat (paint?) that is wearing off on the higher relief surfaces. Paint may not be the right word, as the surface coat looks natural compared to other paint surfaces documented on these panels.

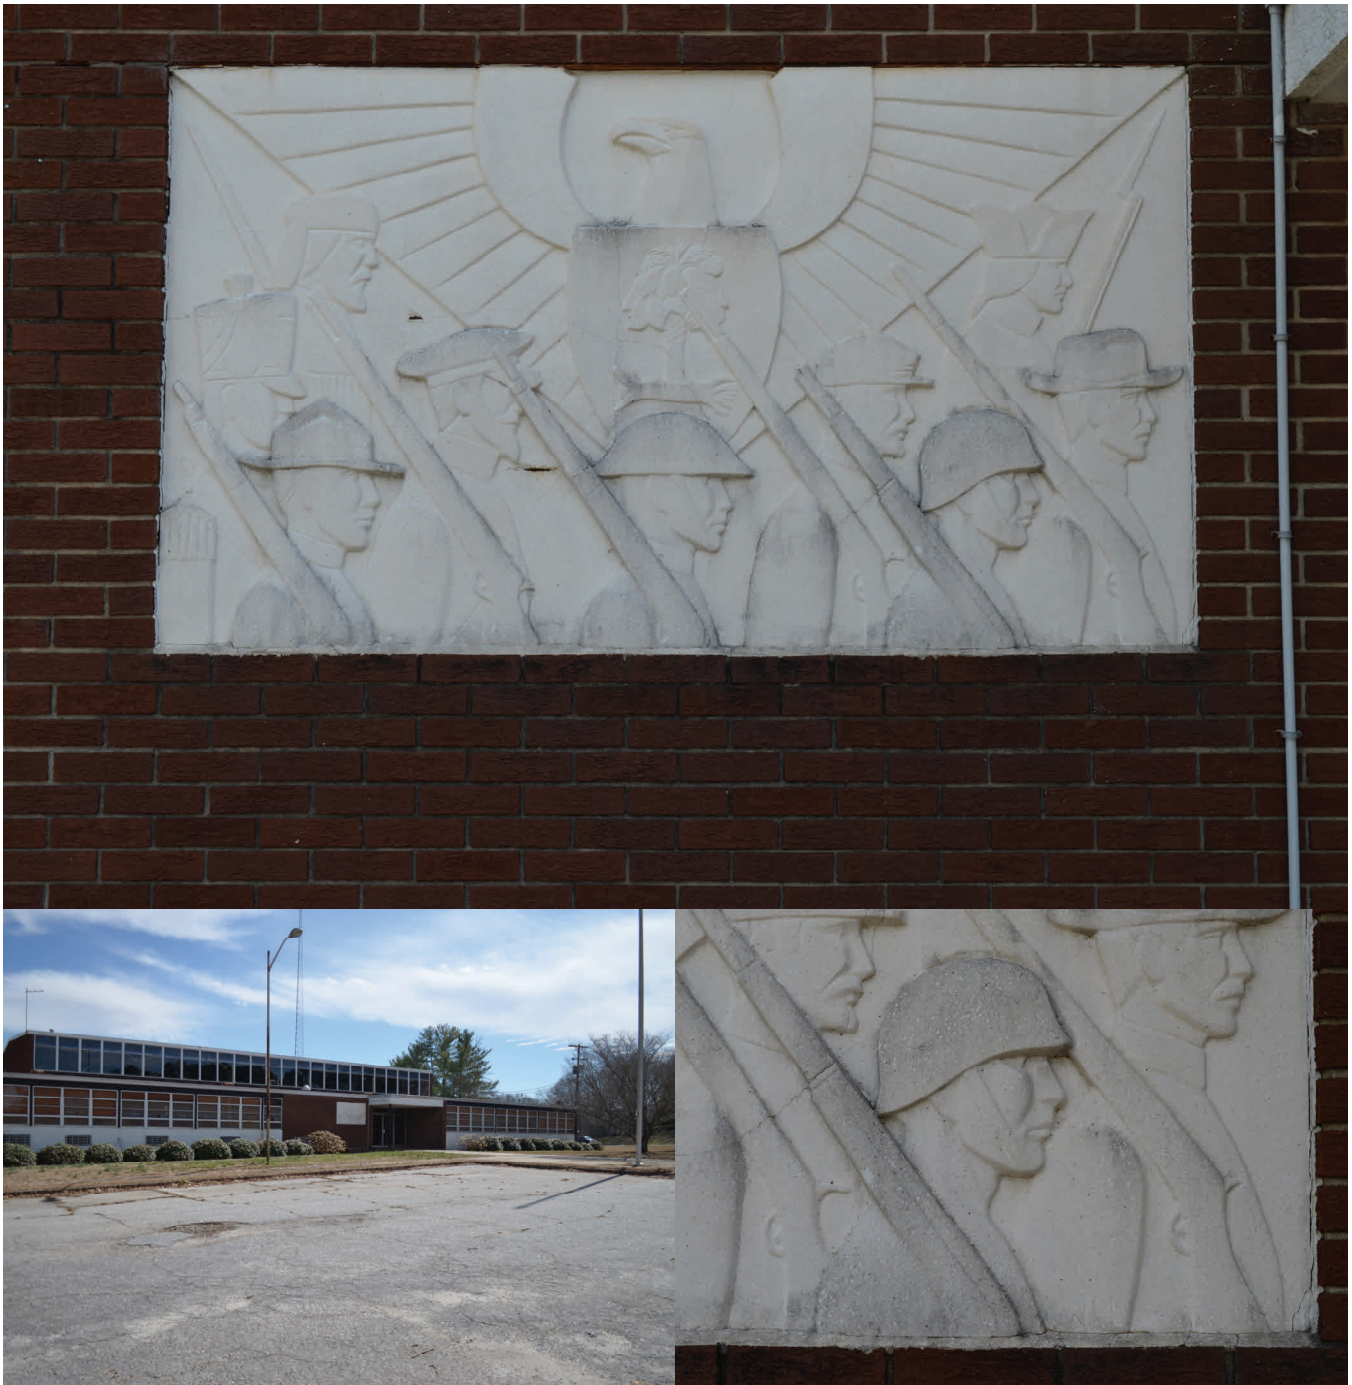
CLEMSON ARMORY

The Cold War-era Clemson Armory is located within sight of a newer facility. This Hirsch panel has not been painted and the original composite stone described by Hirsch is clearly visible. However, there is prominent staining present and, more significantly, several cracks running throughout the panel which would no doubt prohibit its intact removal from the brickwork. The Clemson Armory is one of the original fifteen **NRHP-eligible** complexes.

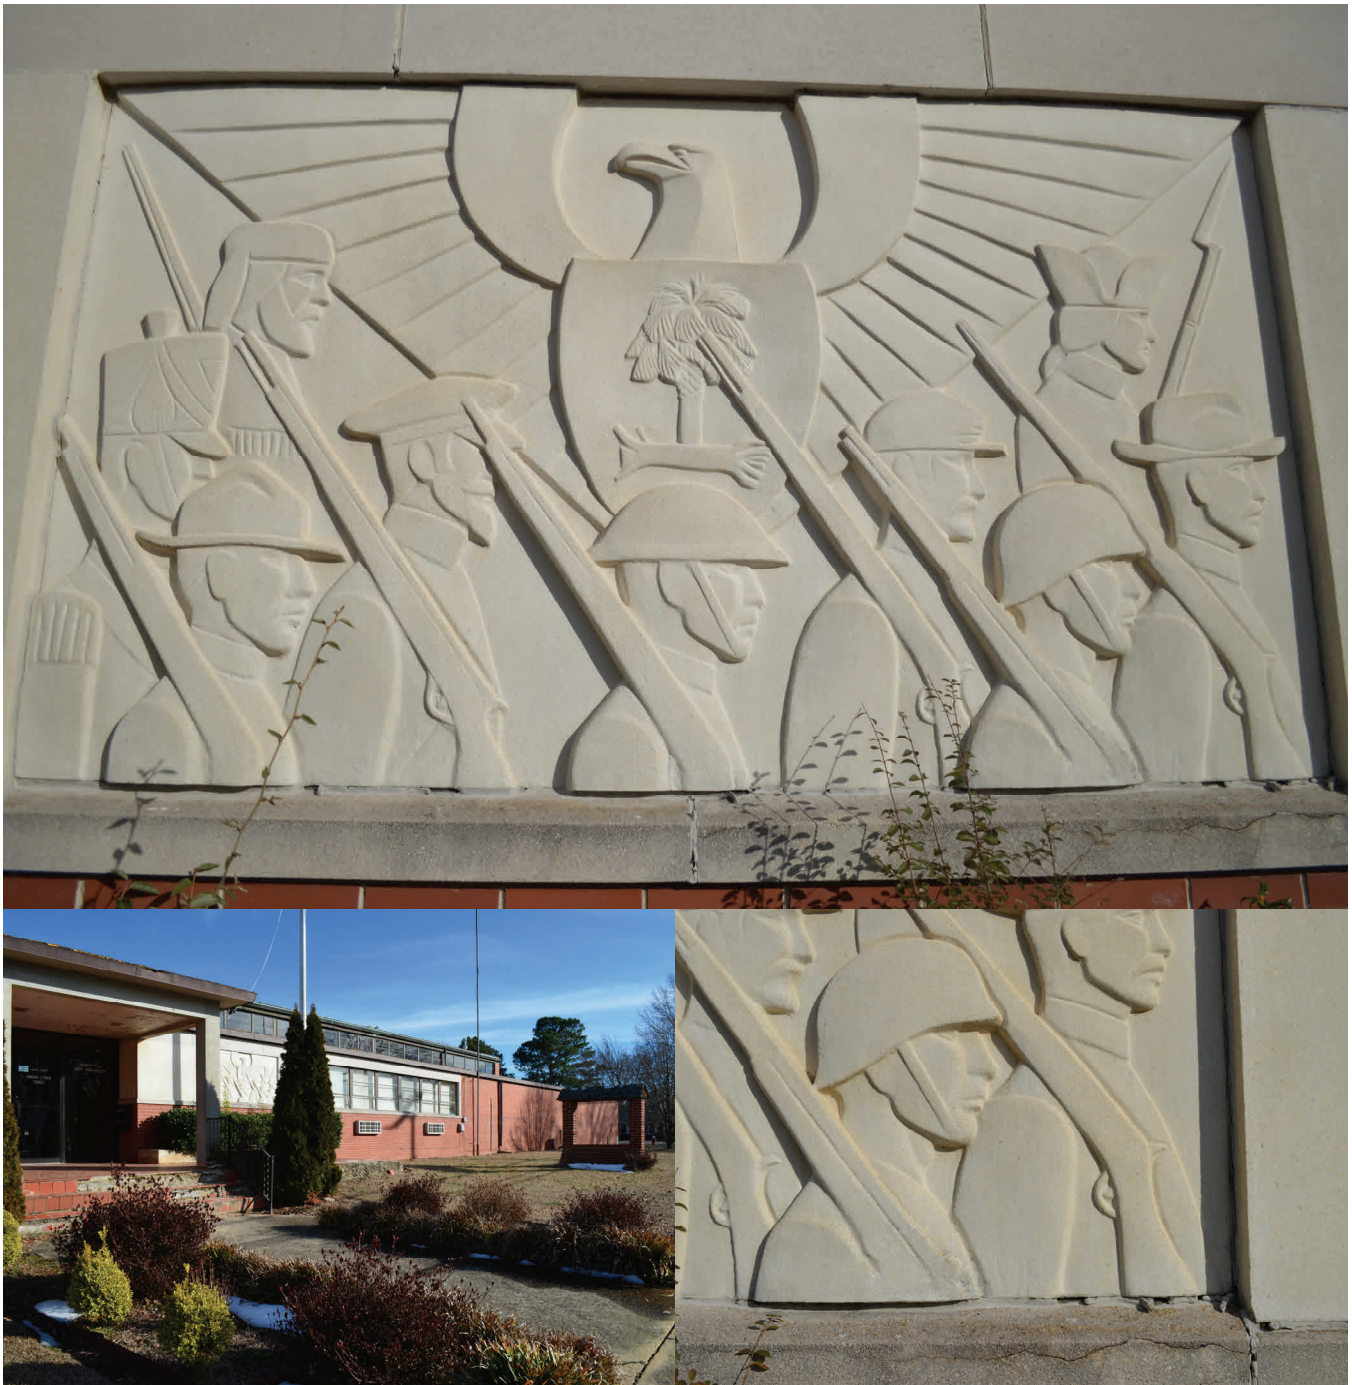
CLOVER ARMORY

The Clover Armory on Memorial Dr. has a Hirsch panel to the right of the front entrance. The panel is in excellent condition. However, uniquely, the panel's composite stone continues both to the right and left, outside the panel itself. In no other instance, was this extended framing observed. The material does differ slightly from the sill (below the panel). The Clover Armory is one of the original fifteen **NRHP-eligible** complexes.
