Faces of the Guard

A Portrait of the Willard Hirsch Panel Then and Now

Report prepared for
the South Carolina Army National Guard
Columbia, South Carolina

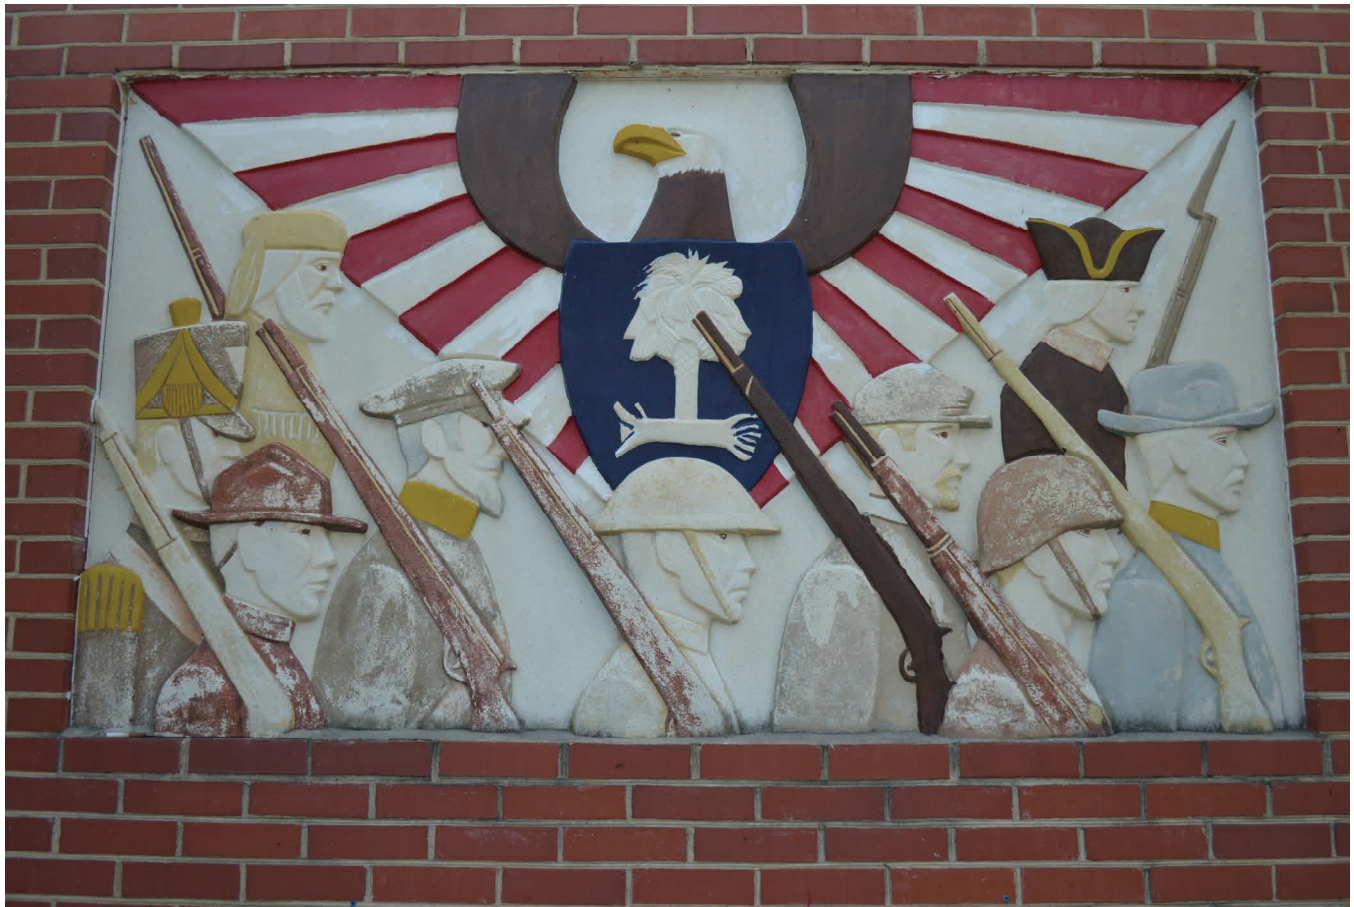
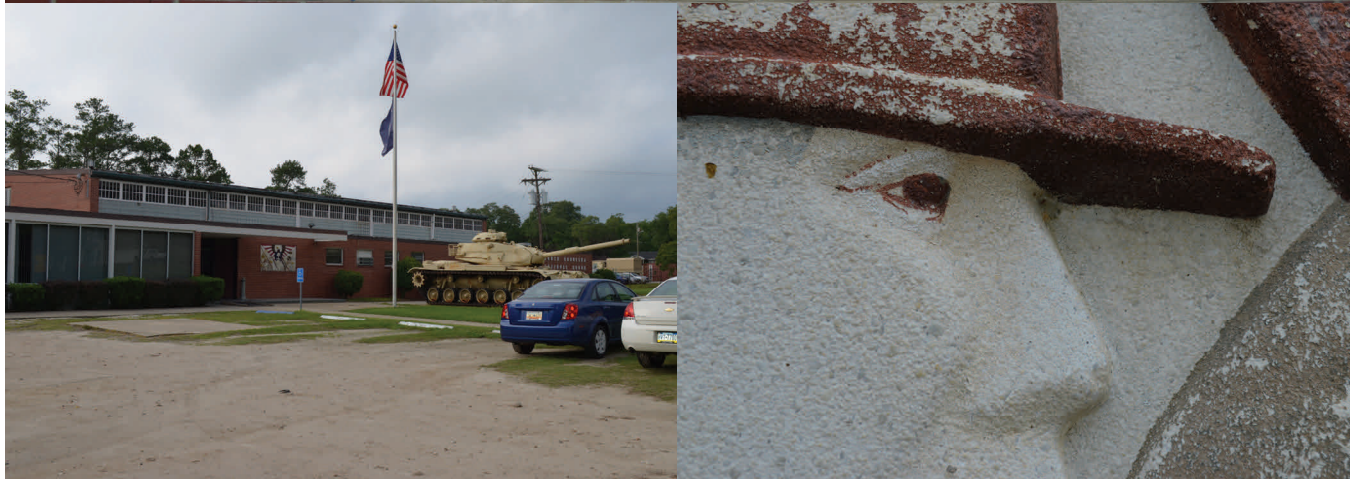
CONWAY ARMORY

The Conway Armory on 16th Ave. has a Hirsch panel to the right of the entryway. The Hirsch panel is painted in polychrome but is otherwise in good condition. In fact, in several areas on the panel the original composite stone shows through as clearly as if it had never been painted—the white paint has been completely worn away. The Conway Armory is one of the original fifteen **NRHP-eligible** complexes.

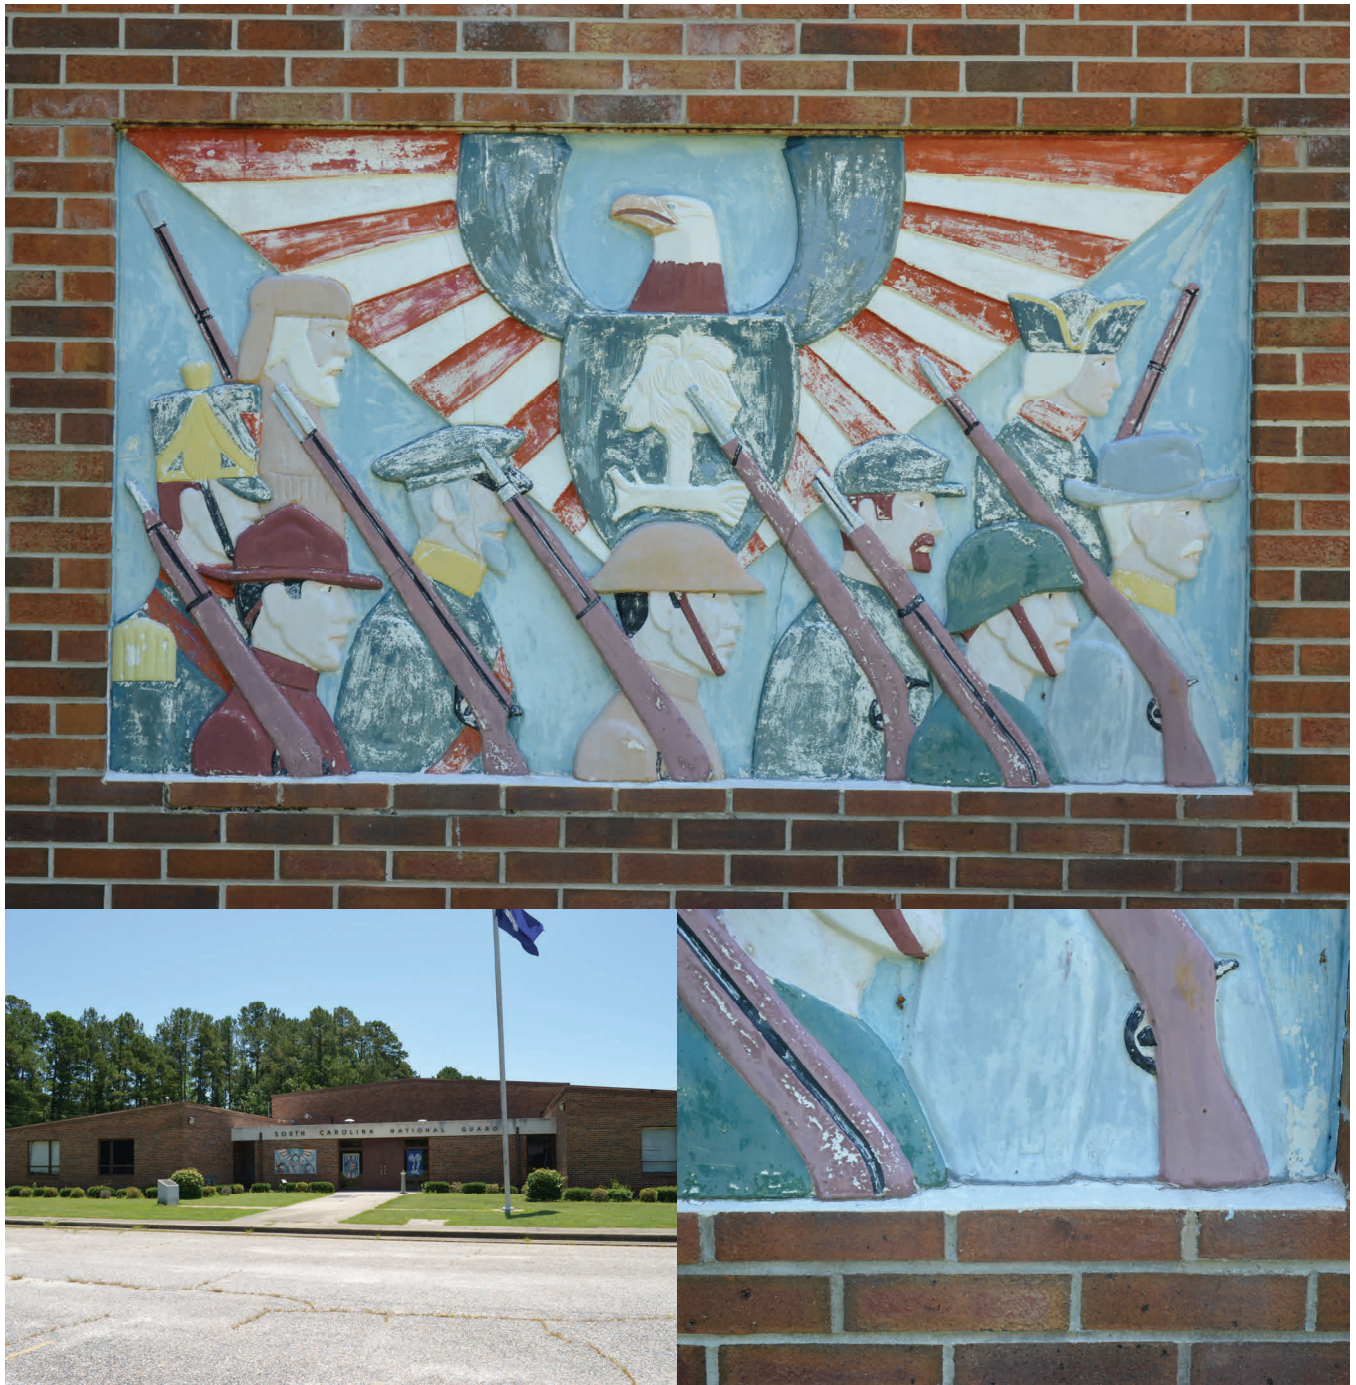
DILLON ARMORY

The Dillon Armory located on Hwy 34 West appears to be a later construction; however, a Hirsch panel is present to the left of the entryway. The panel is painted but is otherwise in good condition.

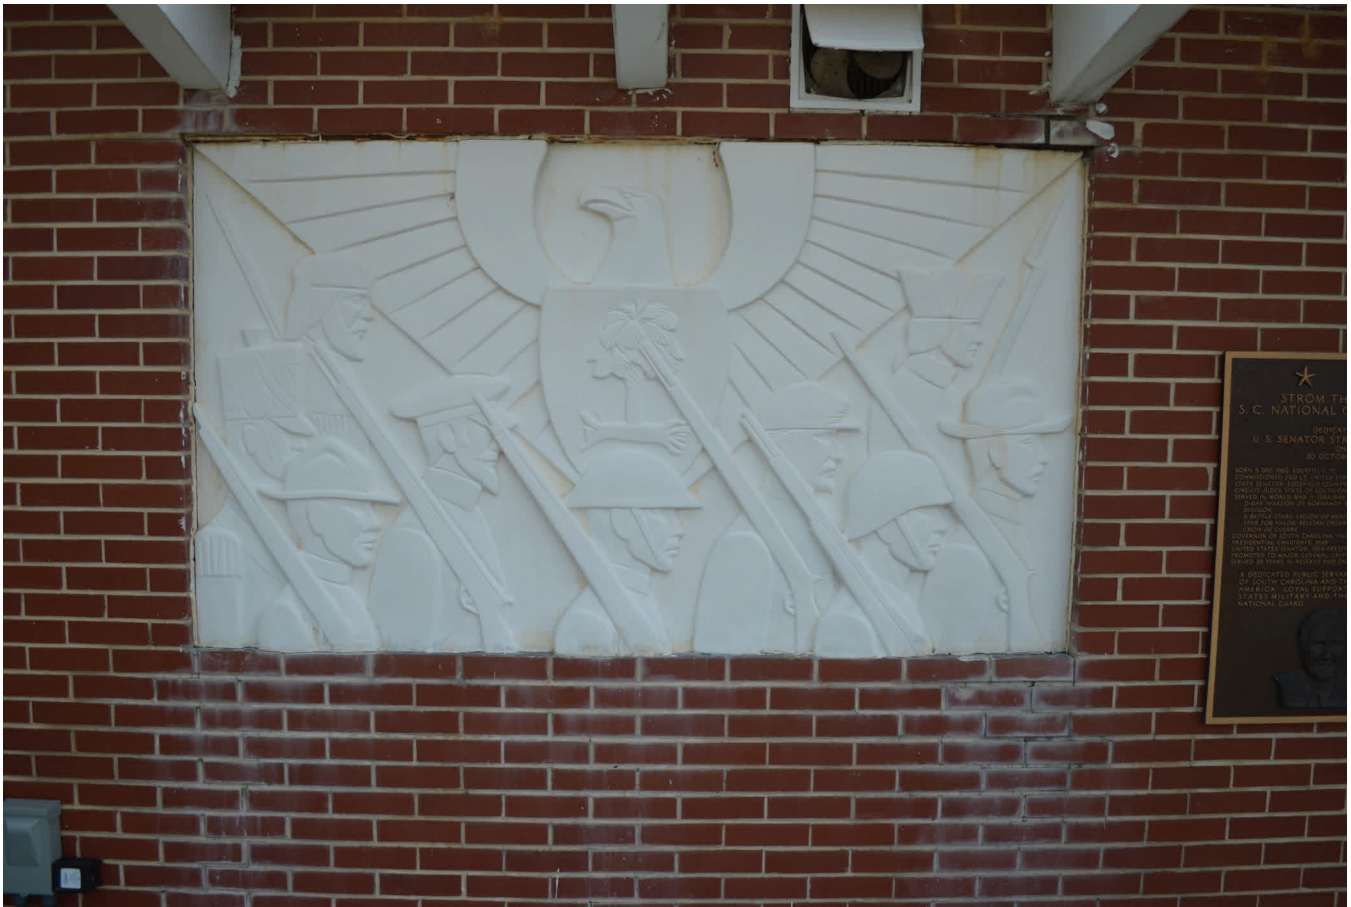
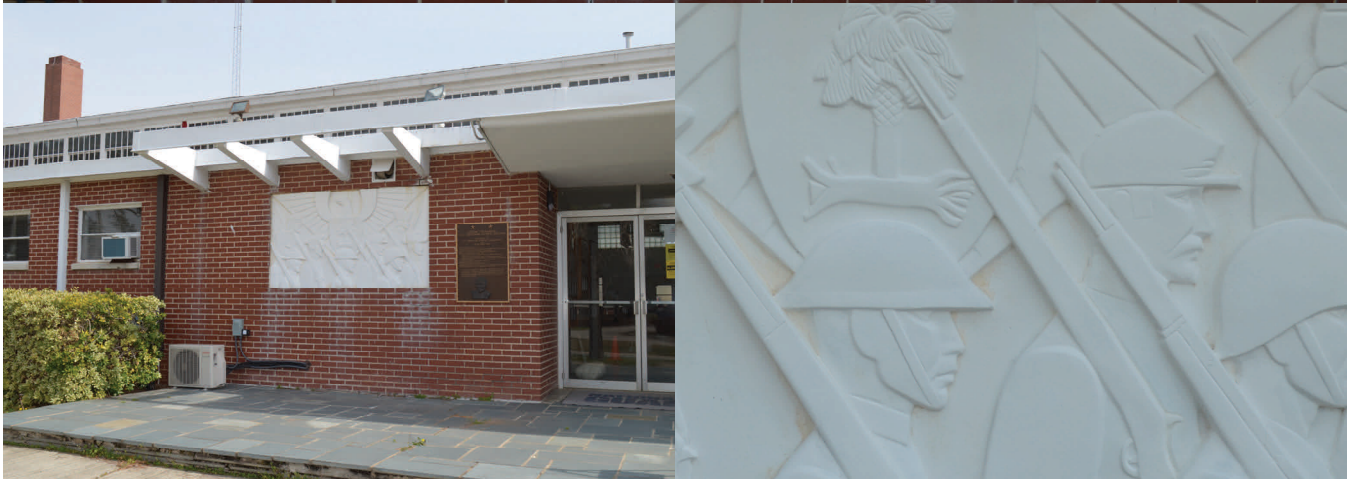
EDGEFIELD ARMORY

The Edgefield Armory, on Augusta Rd. in Edgefield, has a Hirsch panel painted in white. The white paint has weathered, staining the brick framing below but, aside from the paint, the panel's condition is good.

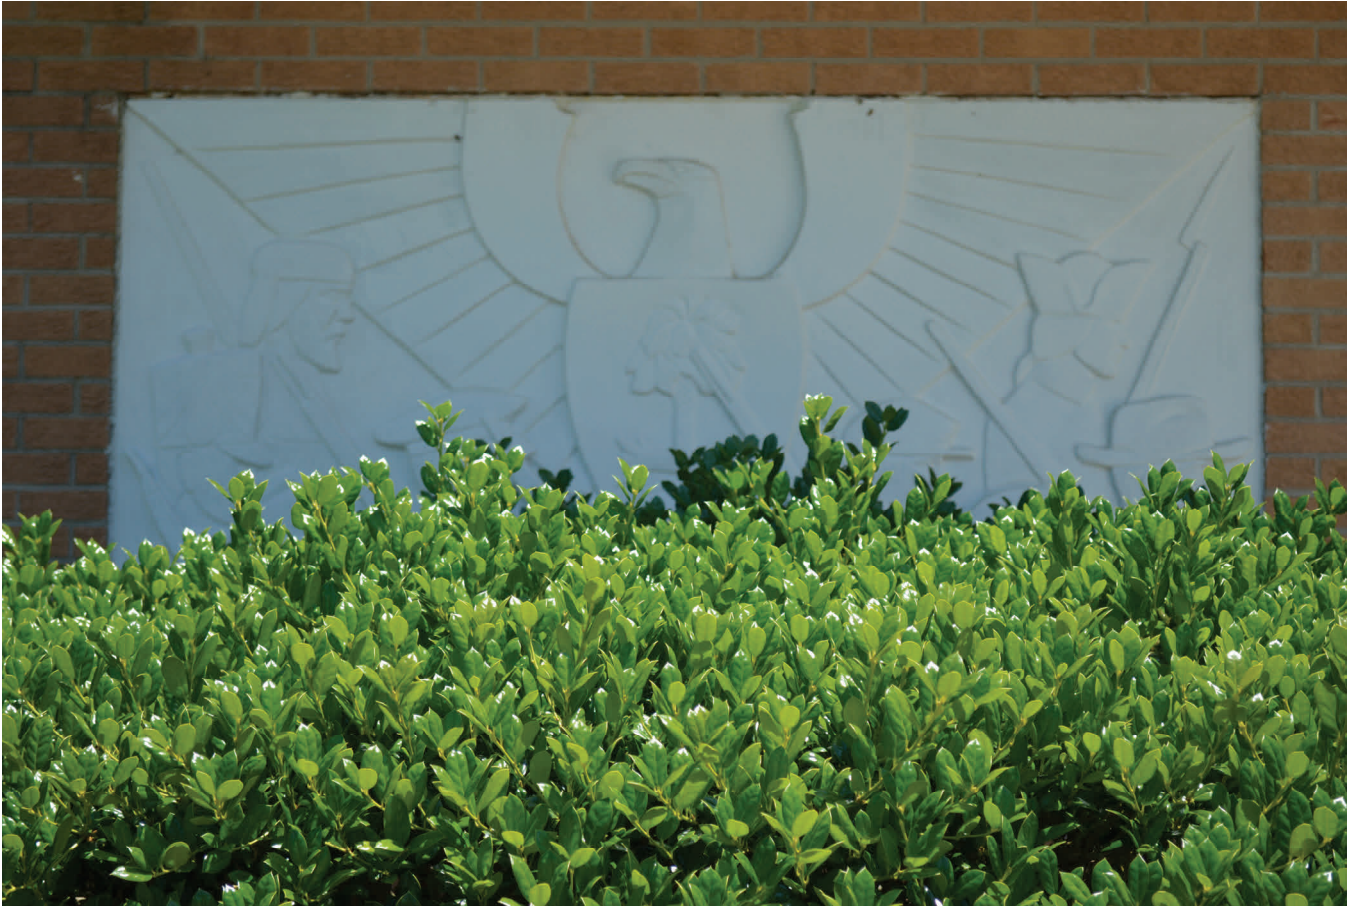
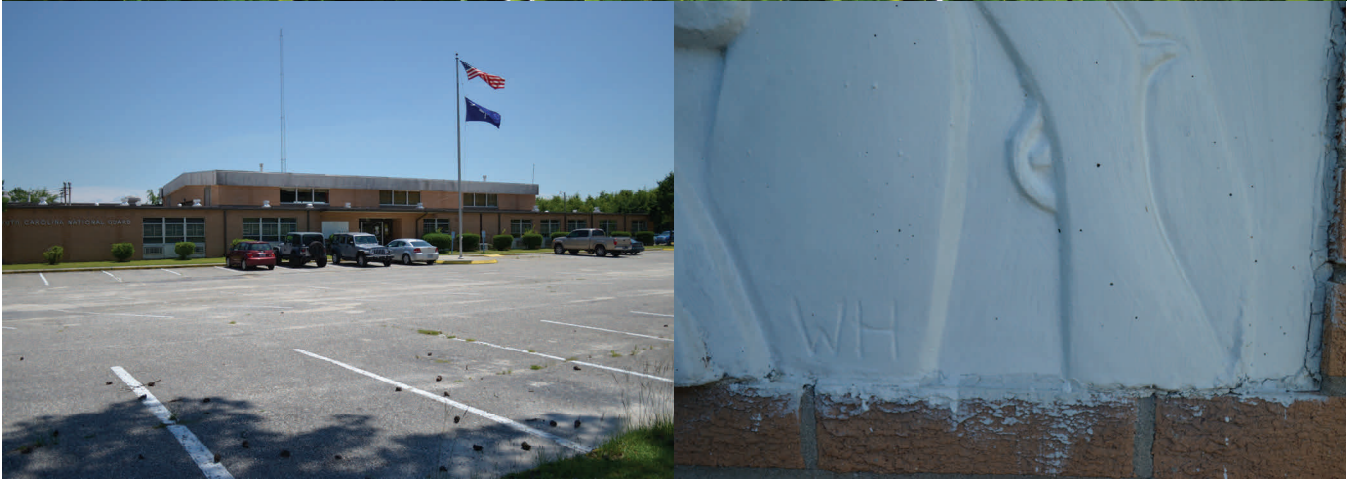
FLORENCE ARMORY

The Florence Armory, on S. Greer Rd., has a Hirsch panel on the left side of the main front entryway. The panel has been painted or washed in white, and some pitting is present which may indicate it has been sandblasted. The initials “WH” are clearly visible in the lower right corner of the panel.

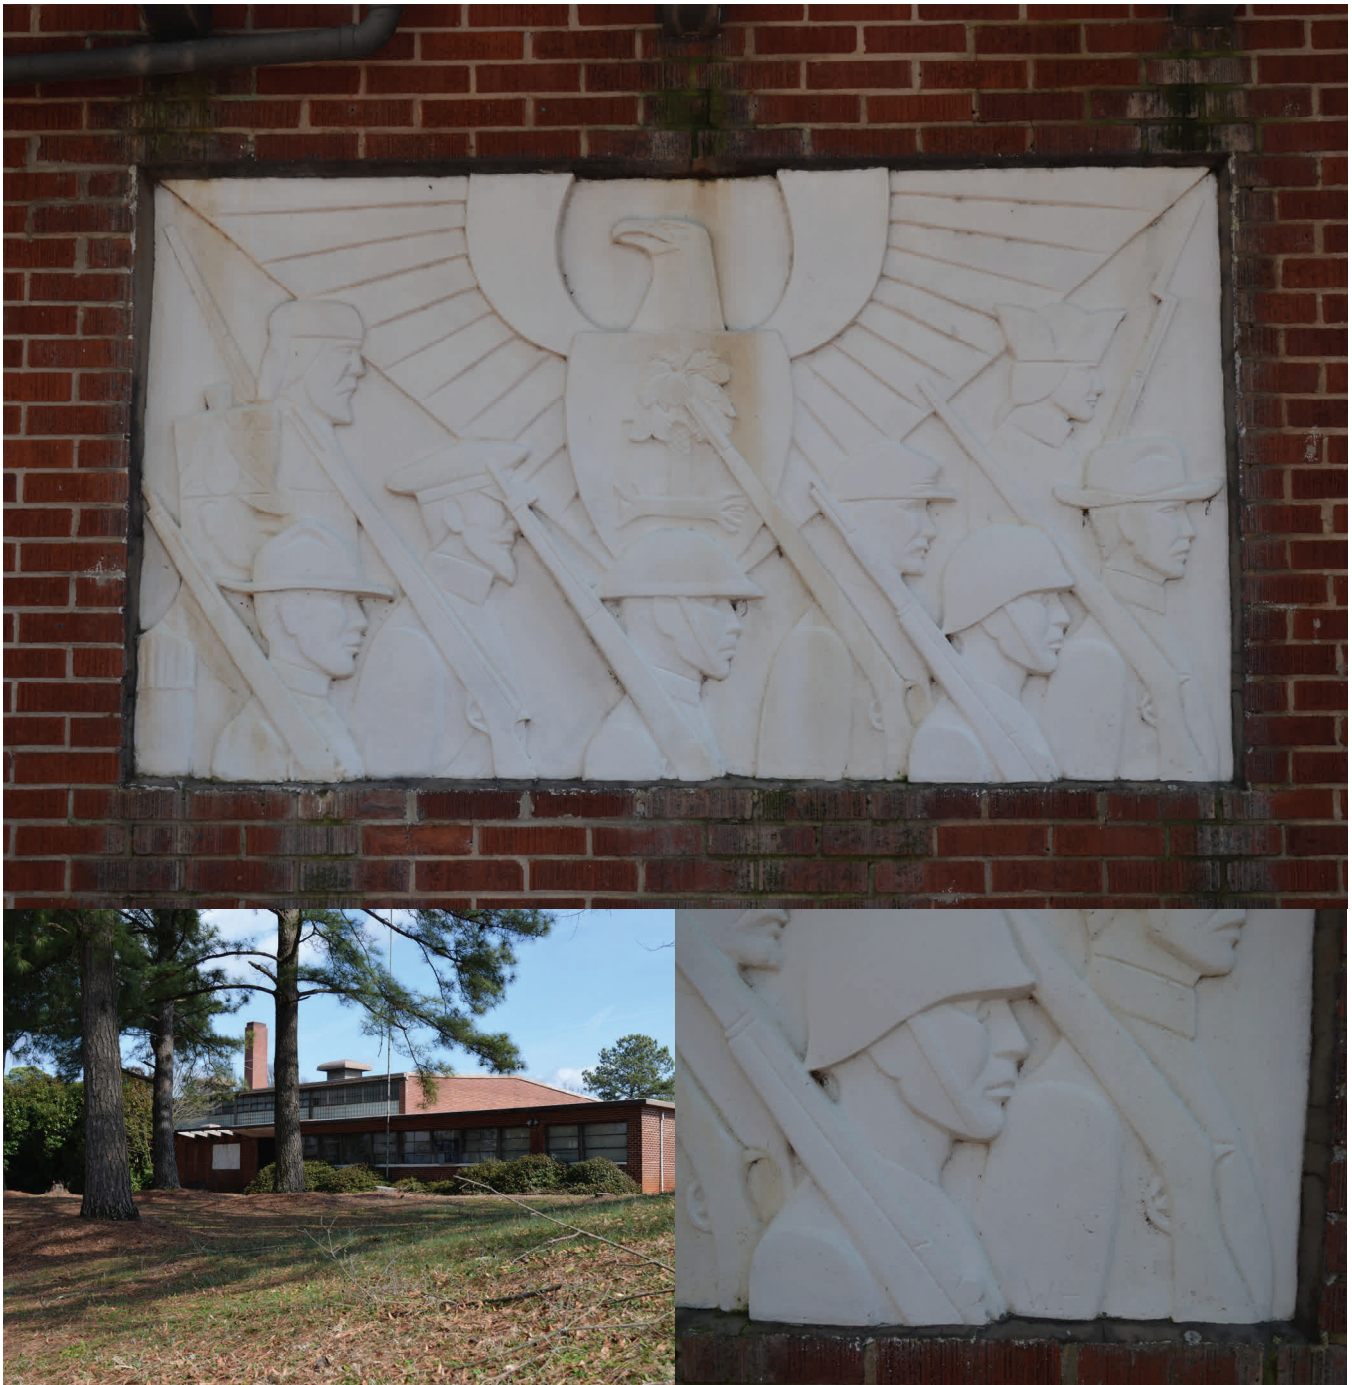
GAFFNEY ARMORY

These guard facilities were replaced by a modern complex in 1996 (Kitchens et al. 2005:43). The Hirsch panel is present to the left of the main entrance. The panel has been painted in white and some staining is present.

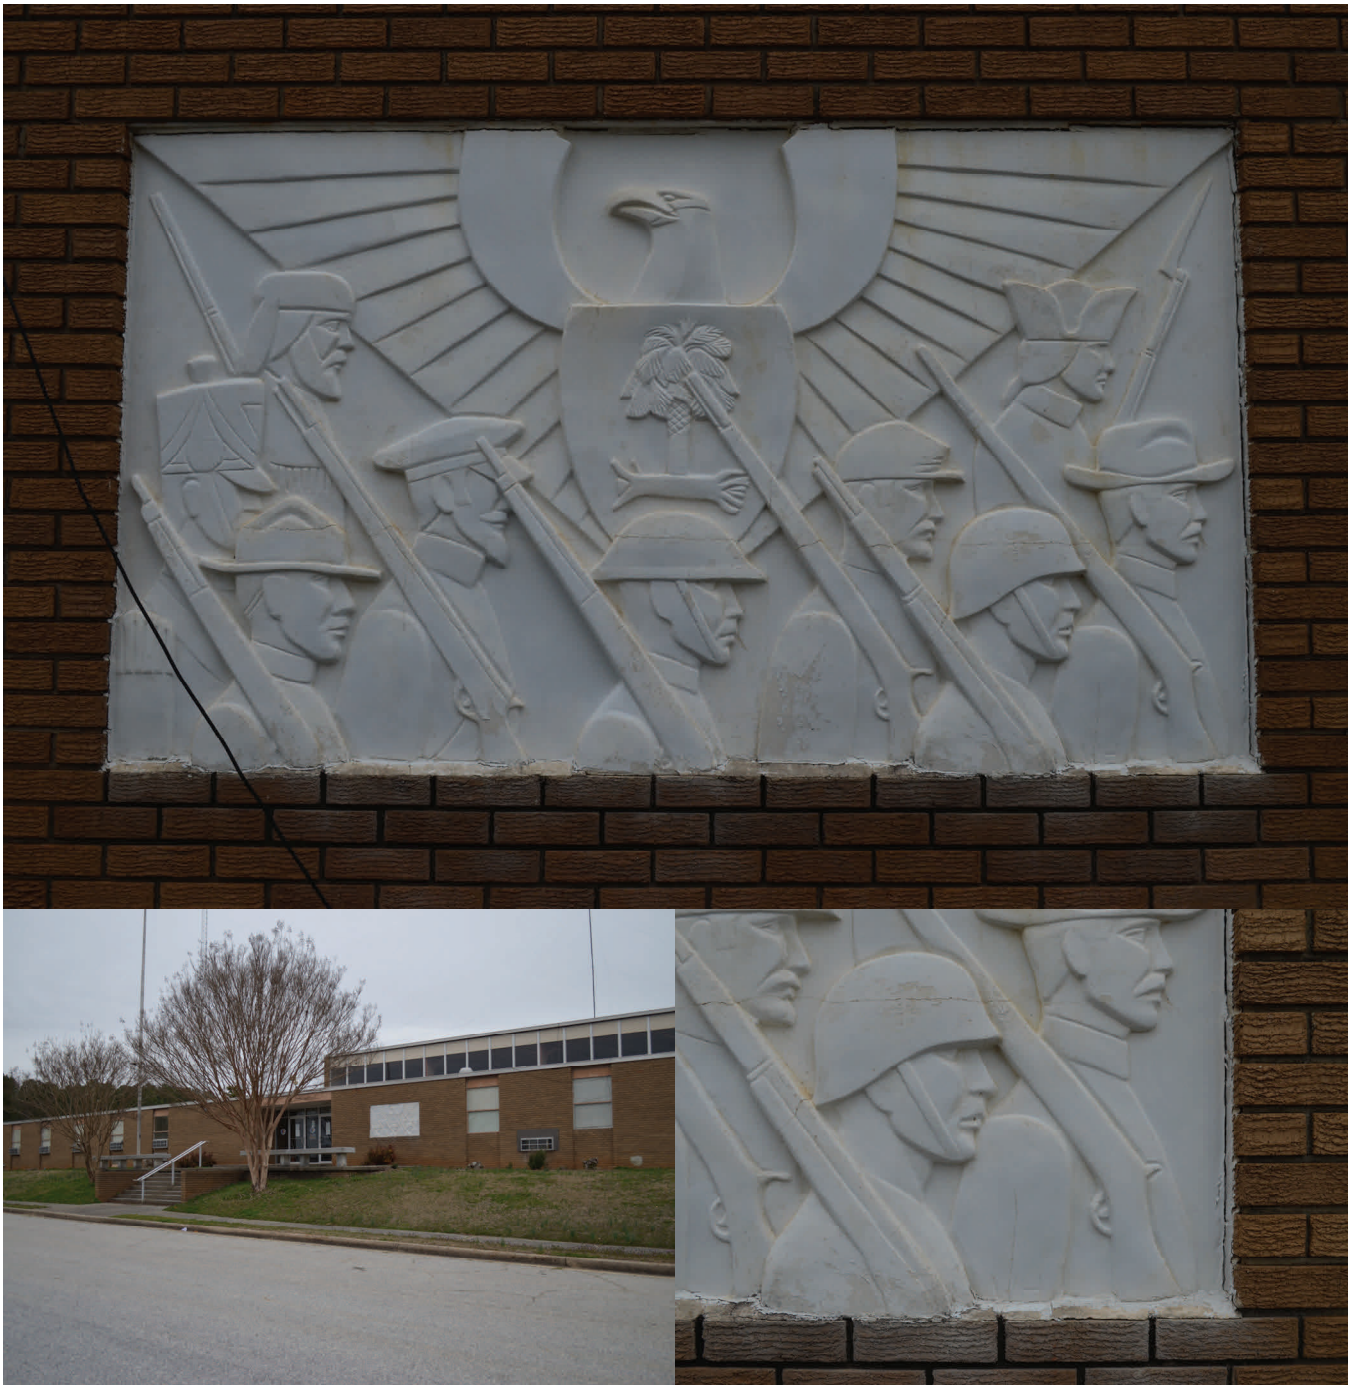
GREENWOOD ARMORY

The Hirsch panel at the Greenwood Armory, like so many others, has been painted white. In addition, there are cracks present in the panel itself and the paint is peeling in various places (seen as slightly darker areas in the panel photos). The Greenwood Armory is one of the original fifteen **NRHP-eligible** complexes.

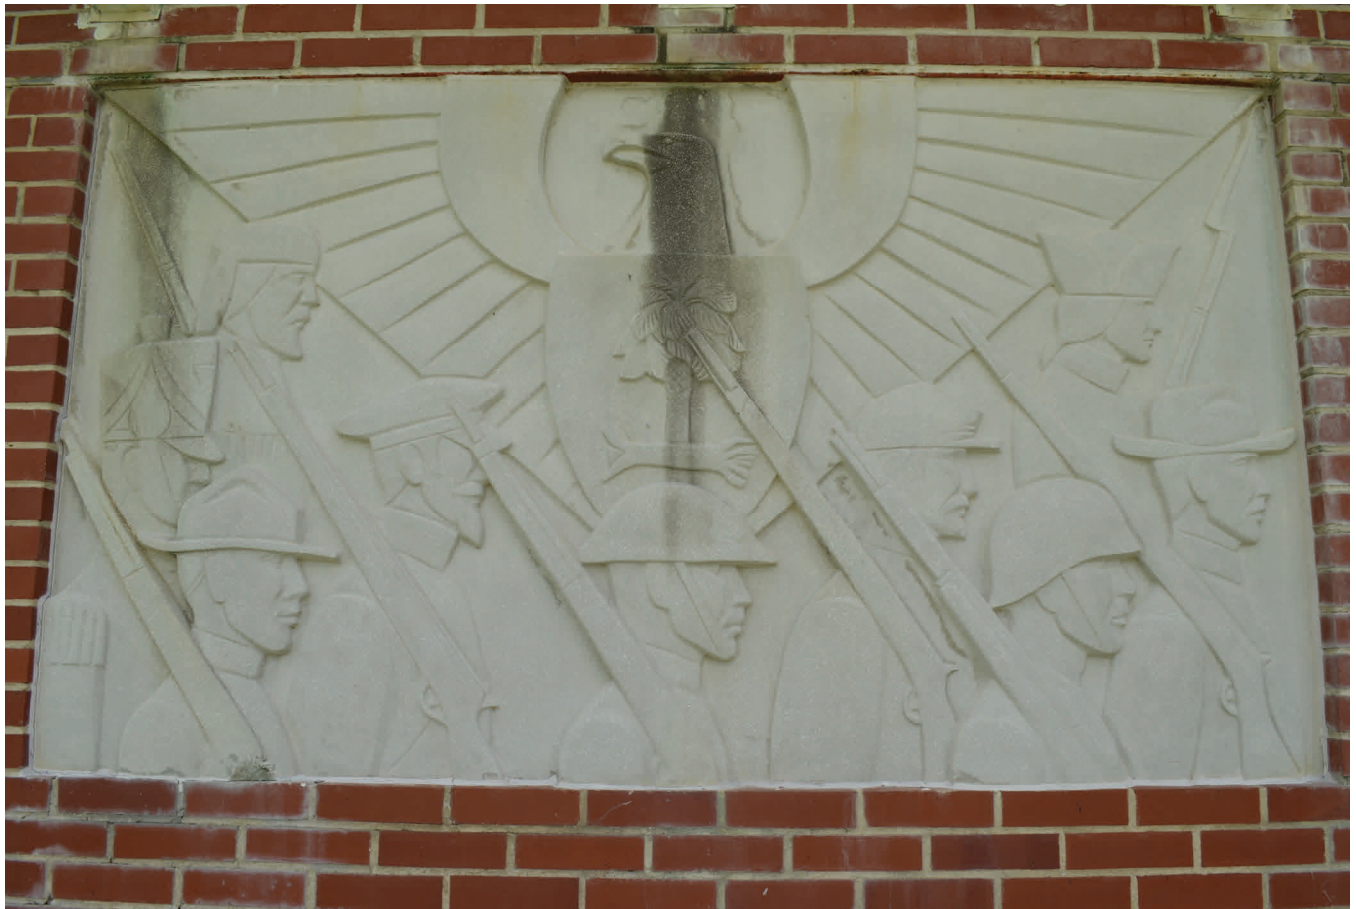
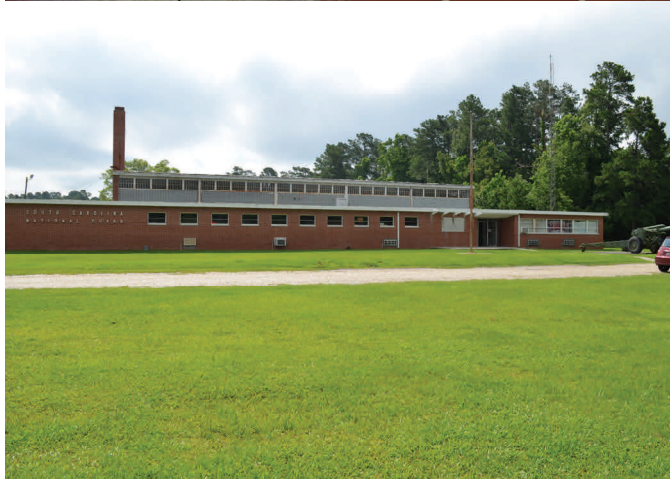
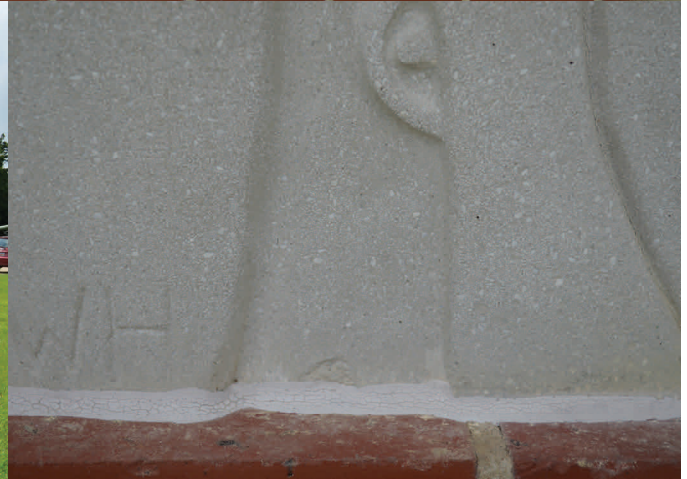
HEMINGWAY ARMORY

The Hirsch panel at the Hemingway Armory is in good and original condition, with some staining present particularly across the center and left eighth of the panel. Willard Hirsch's initials are plainly visible on the lower right. The panel itself is displayed on the left-hand side of the front entrance to the Type B building. The Hemingway Armory is one of the original fifteen **NRHP-eligible** complexes.

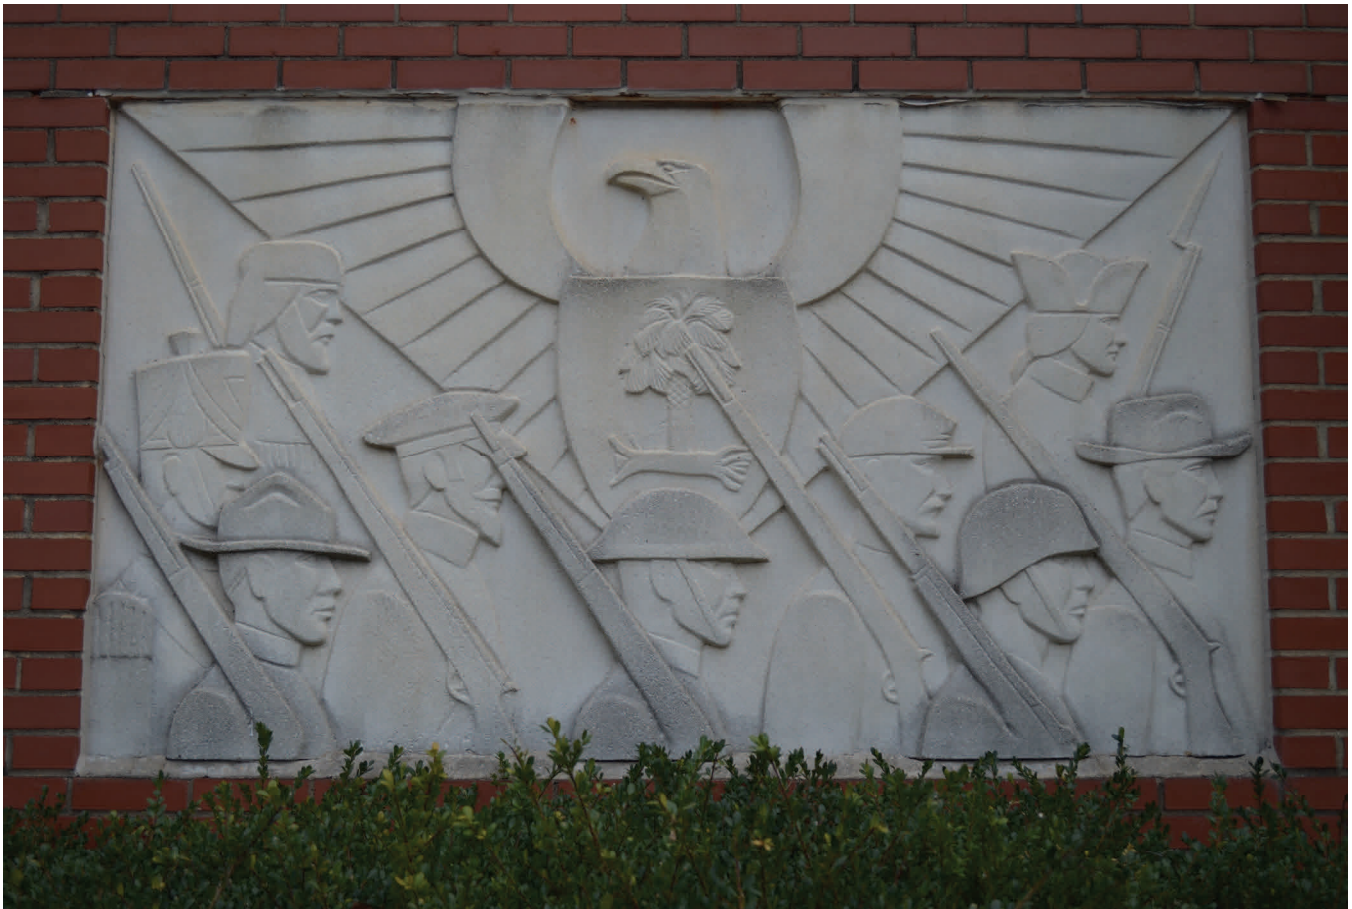
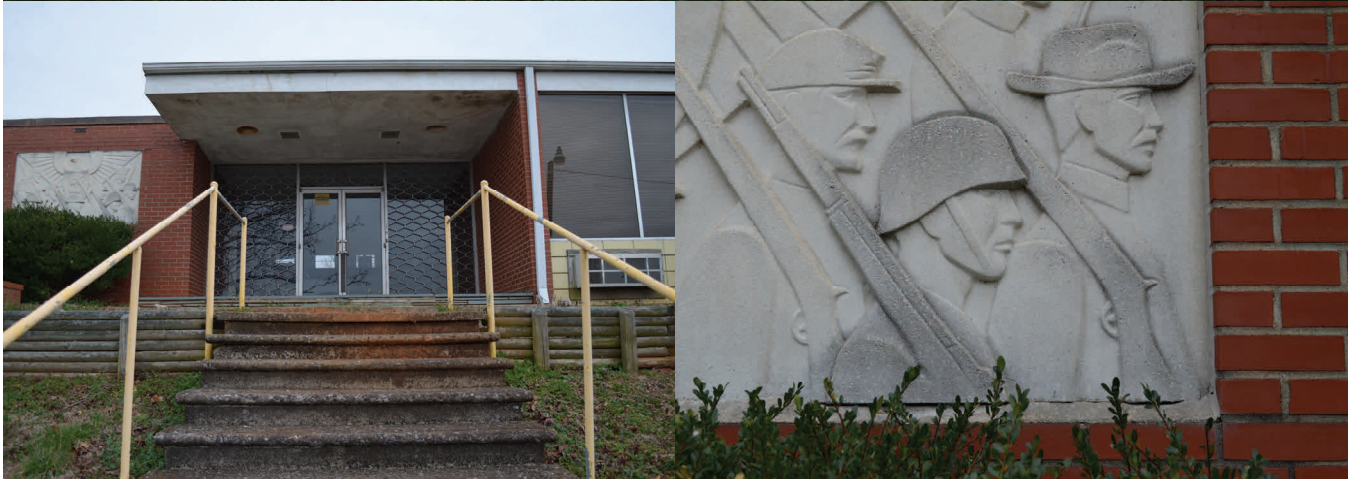
INMAN ARMORY

The Cold War-era armory building at Inman is no longer owned by the SCARNG. A Hirsch panel is present and in good condition. Some staining and weathering was observed but there are no indications that the panel has ever been painted or sandblasted (to remove paint).

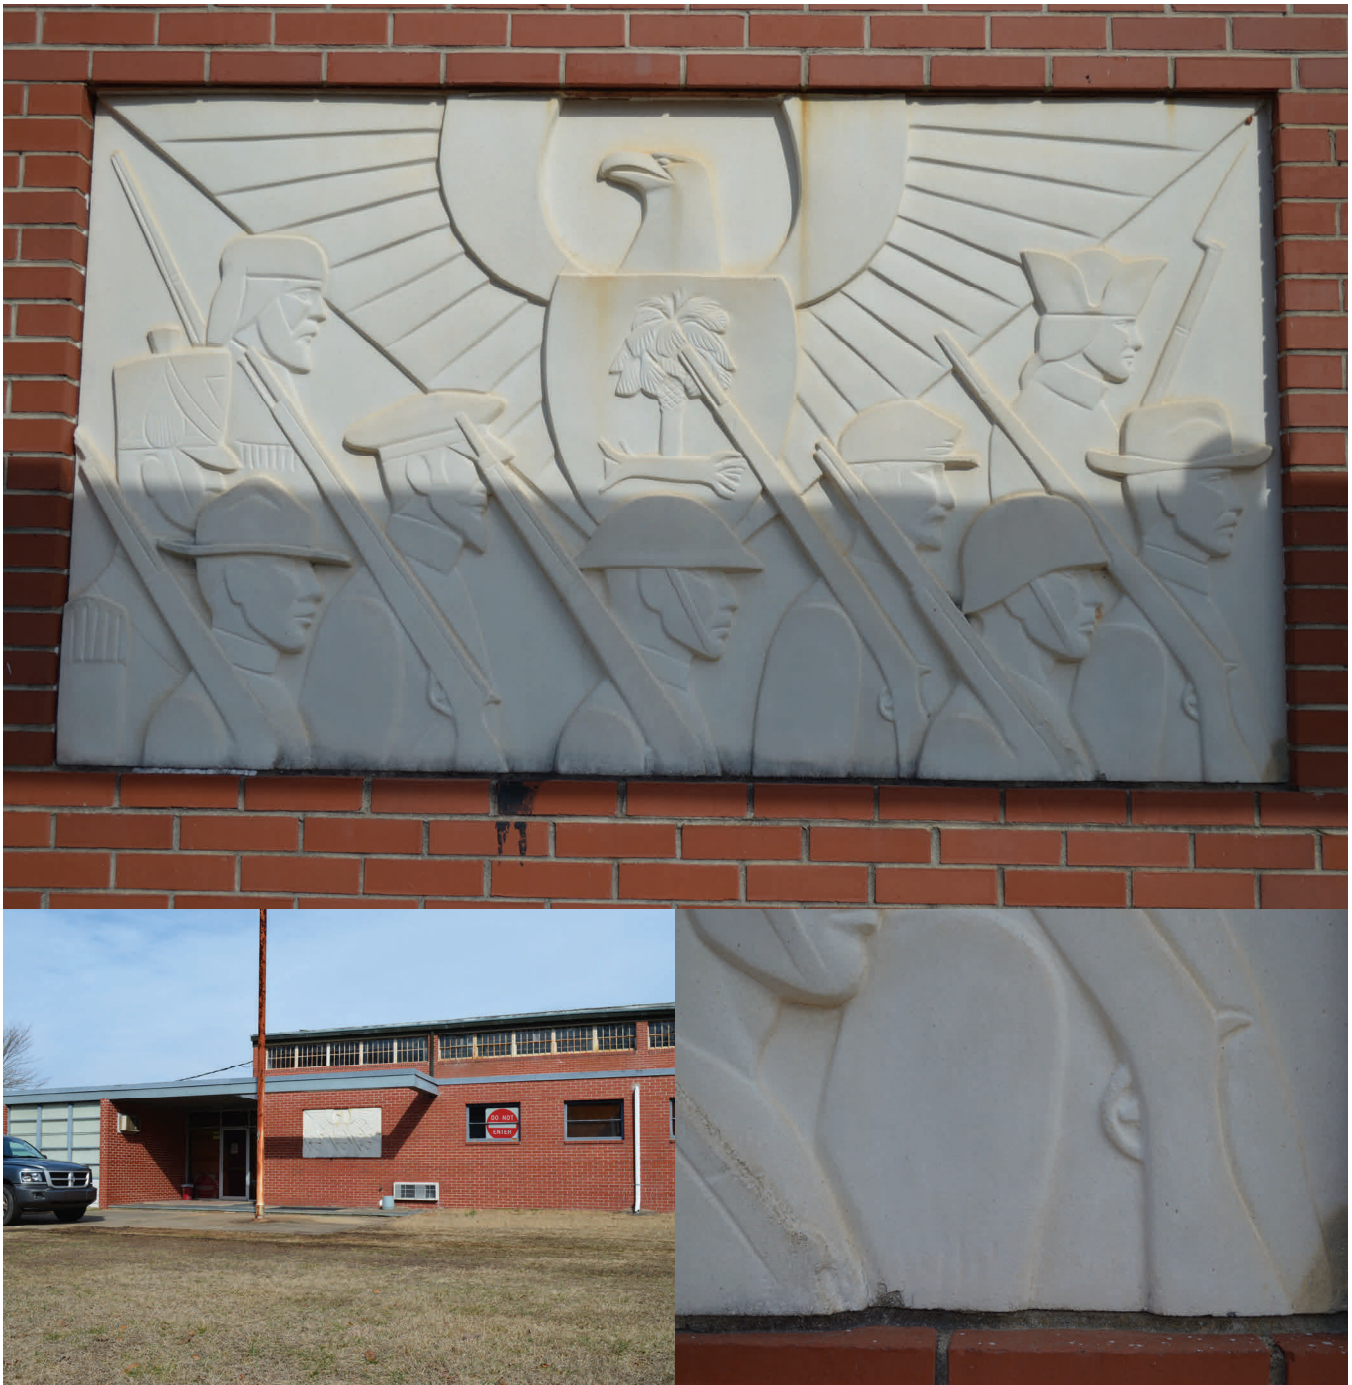
JONESVILLE ARMORY

The Jonesville Armory on Gilead St. has a Hirsch panel which is in good original condition. No indications of painting or sandblasting were observed. The building itself appeared at the time of the visit to be in private hands.

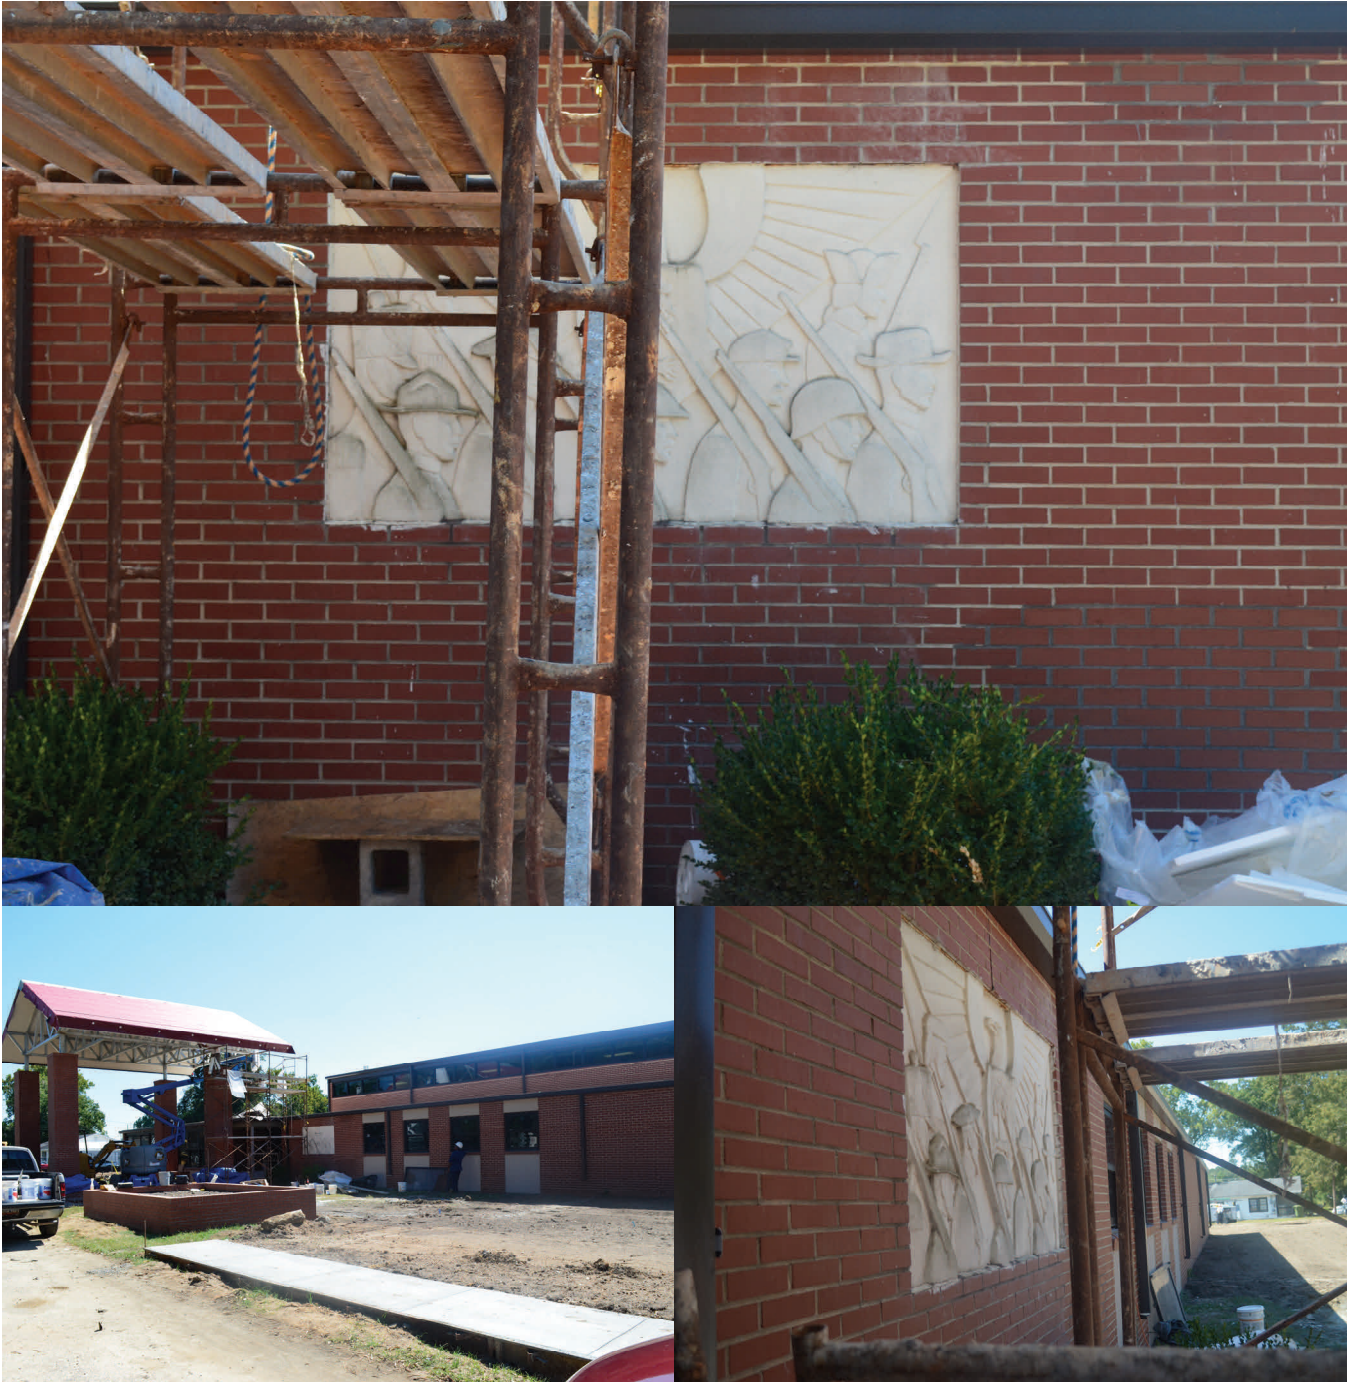
LAKE CITY ARMORY

The Lake City Armory on Calhoun St. is being remodeled for use by the Boys and Girls Club of Lake City, according to on-site construction workers. The Hirsch panel is in good condition with no evidence that it has ever been painted. Some mold or staining is present, particularly on the left quarter. The long-term outcome of the panel is not known, though there were no indications during the visit that the panel was going to be removed.

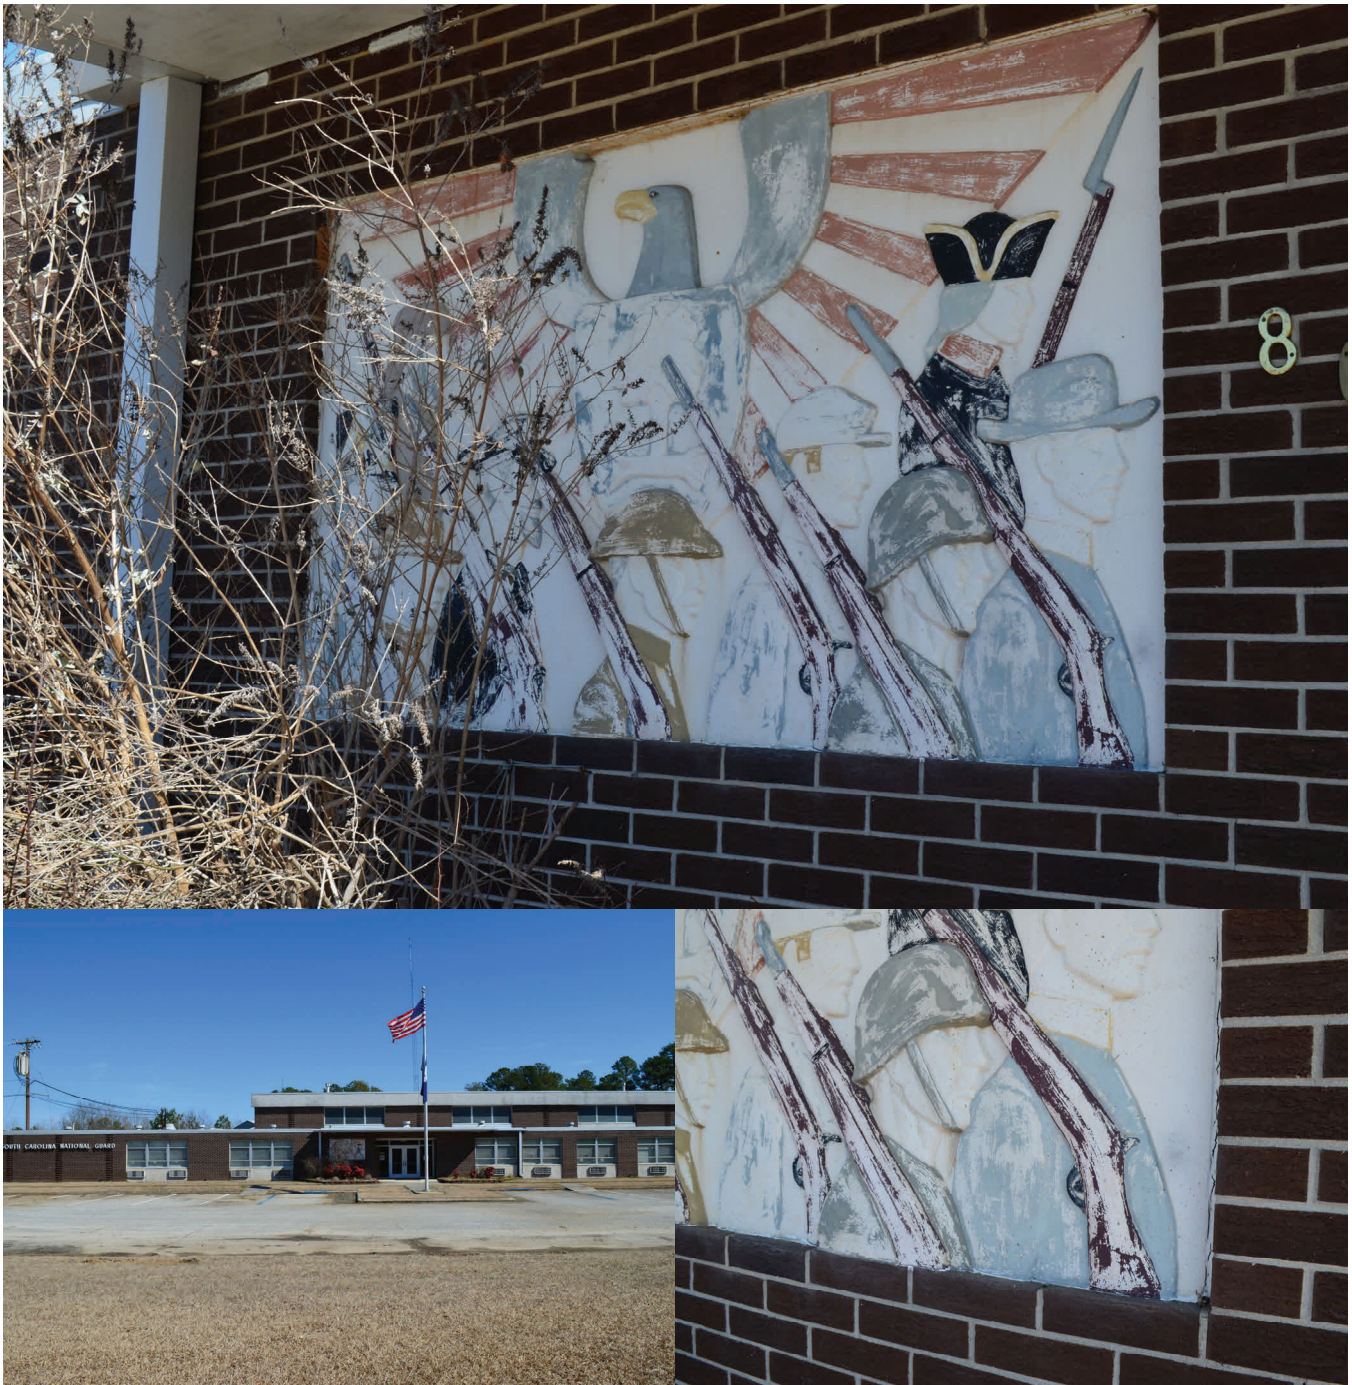
LANCASTER ARMORY

The Lancaster Armory on Nichols Road, still owned and managed by the SCARNG, has a Hirsch panel which has been painted in polychrome. Tall brush blocked the view of the panel from the front. Unlike some of the armories that date to the Cold War-era, this building did not have composite stone window sills.
