Faces of the Guard

A Portrait of the Willard Hirsch Panel Then and Now

Report prepared for
the South Carolina Army National Guard
Columbia, South Carolina

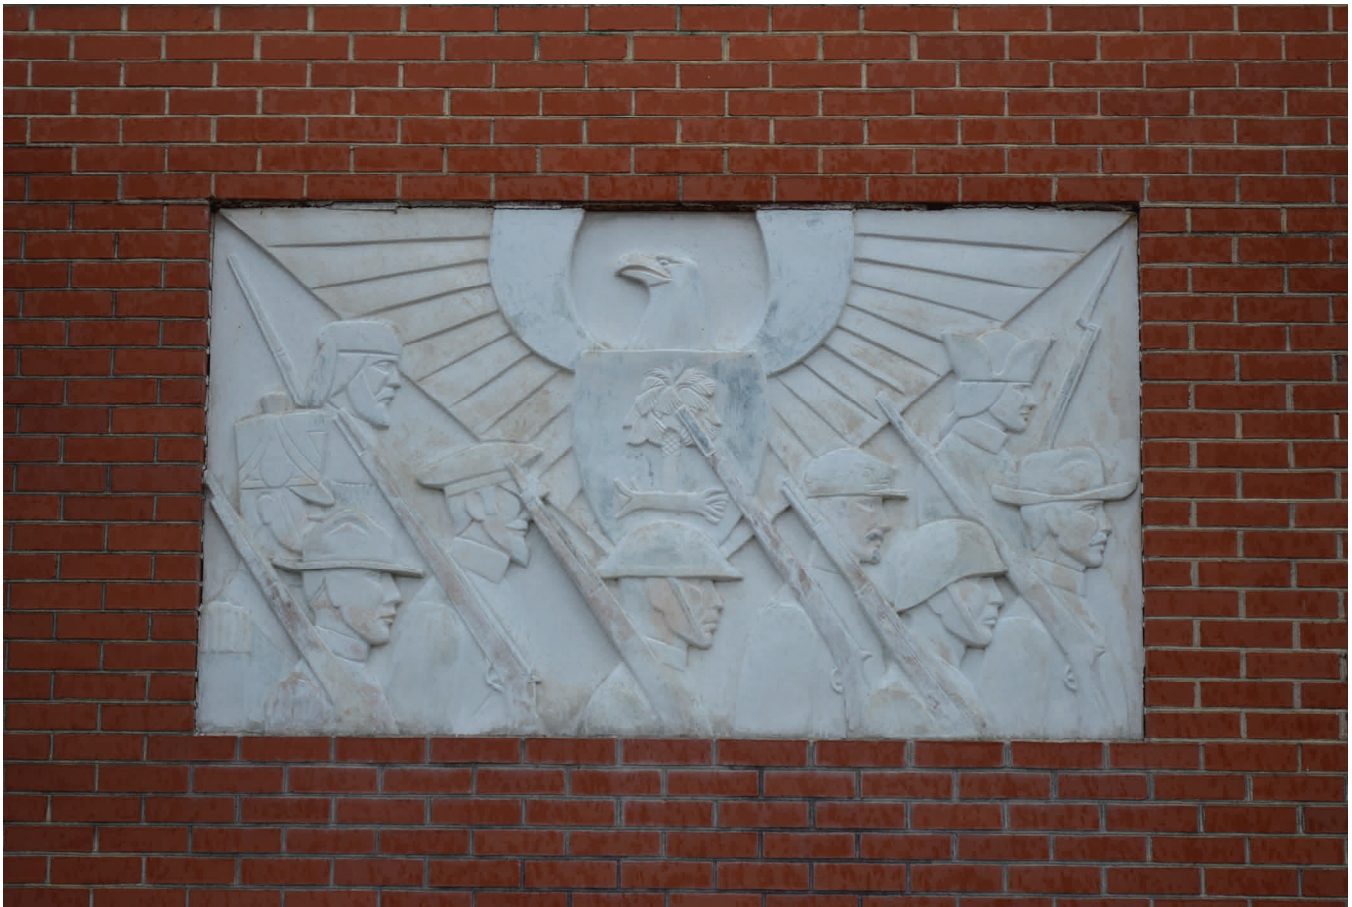
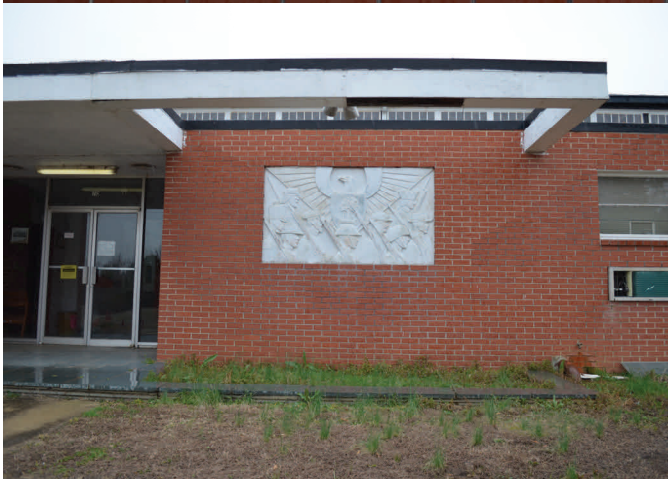
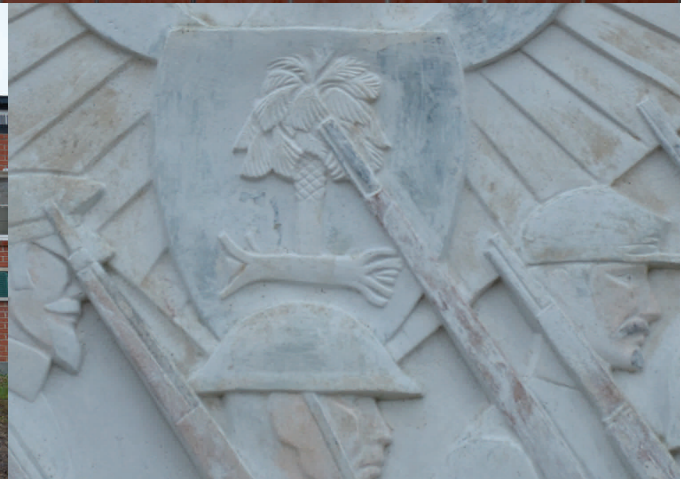
McCORMICK ARMORY

The McCormick Armory, located on Bradley St., has a Hirsch panel that is painted in polychrome. However, the colors have faded so significantly with time that at a distance the panel appears white. The McCormick Armory is one of the original fifteen **NRHP-eligible** complexes.

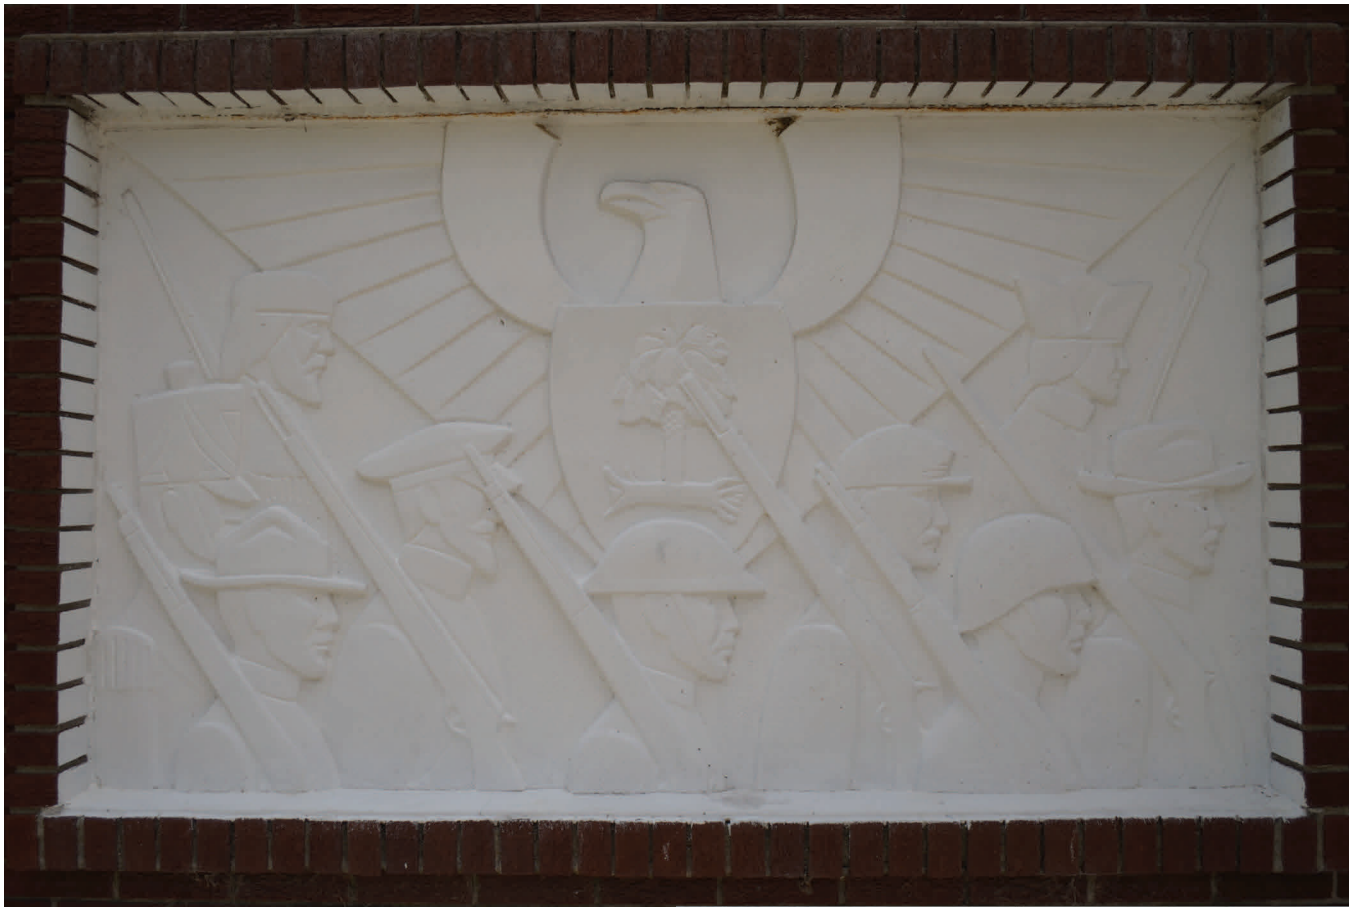
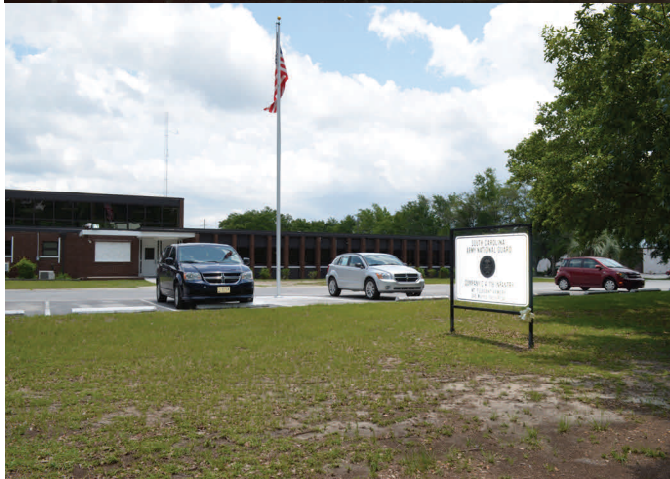
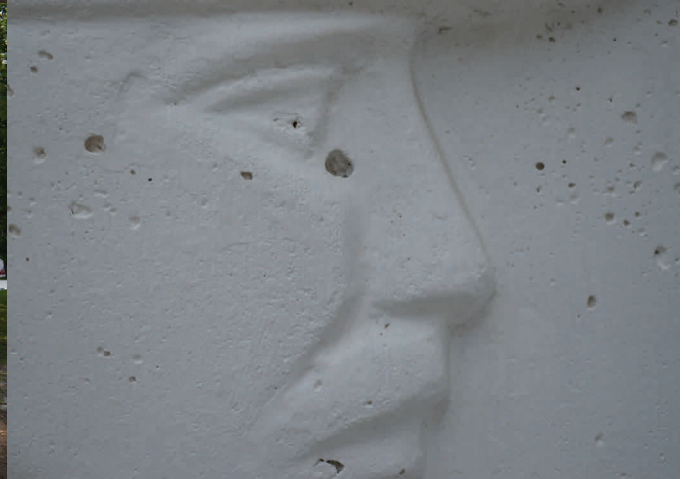
MOUNT PLEASANT ARMORY

The Mount Pleasant Armory's Hirsch panel has been painted white. The paint, for the most part, is intact, and covers a heavily pitted surface that appears to be the result of sandblasting (image, lower right). The Mount Pleasant panel is inset more than some of the others recorded during the survey. The reasons for this are unclear but may relate to the age of the building. The Mount Pleasant Armory is one of the original fifteen **NRHP-eligible** complexes.

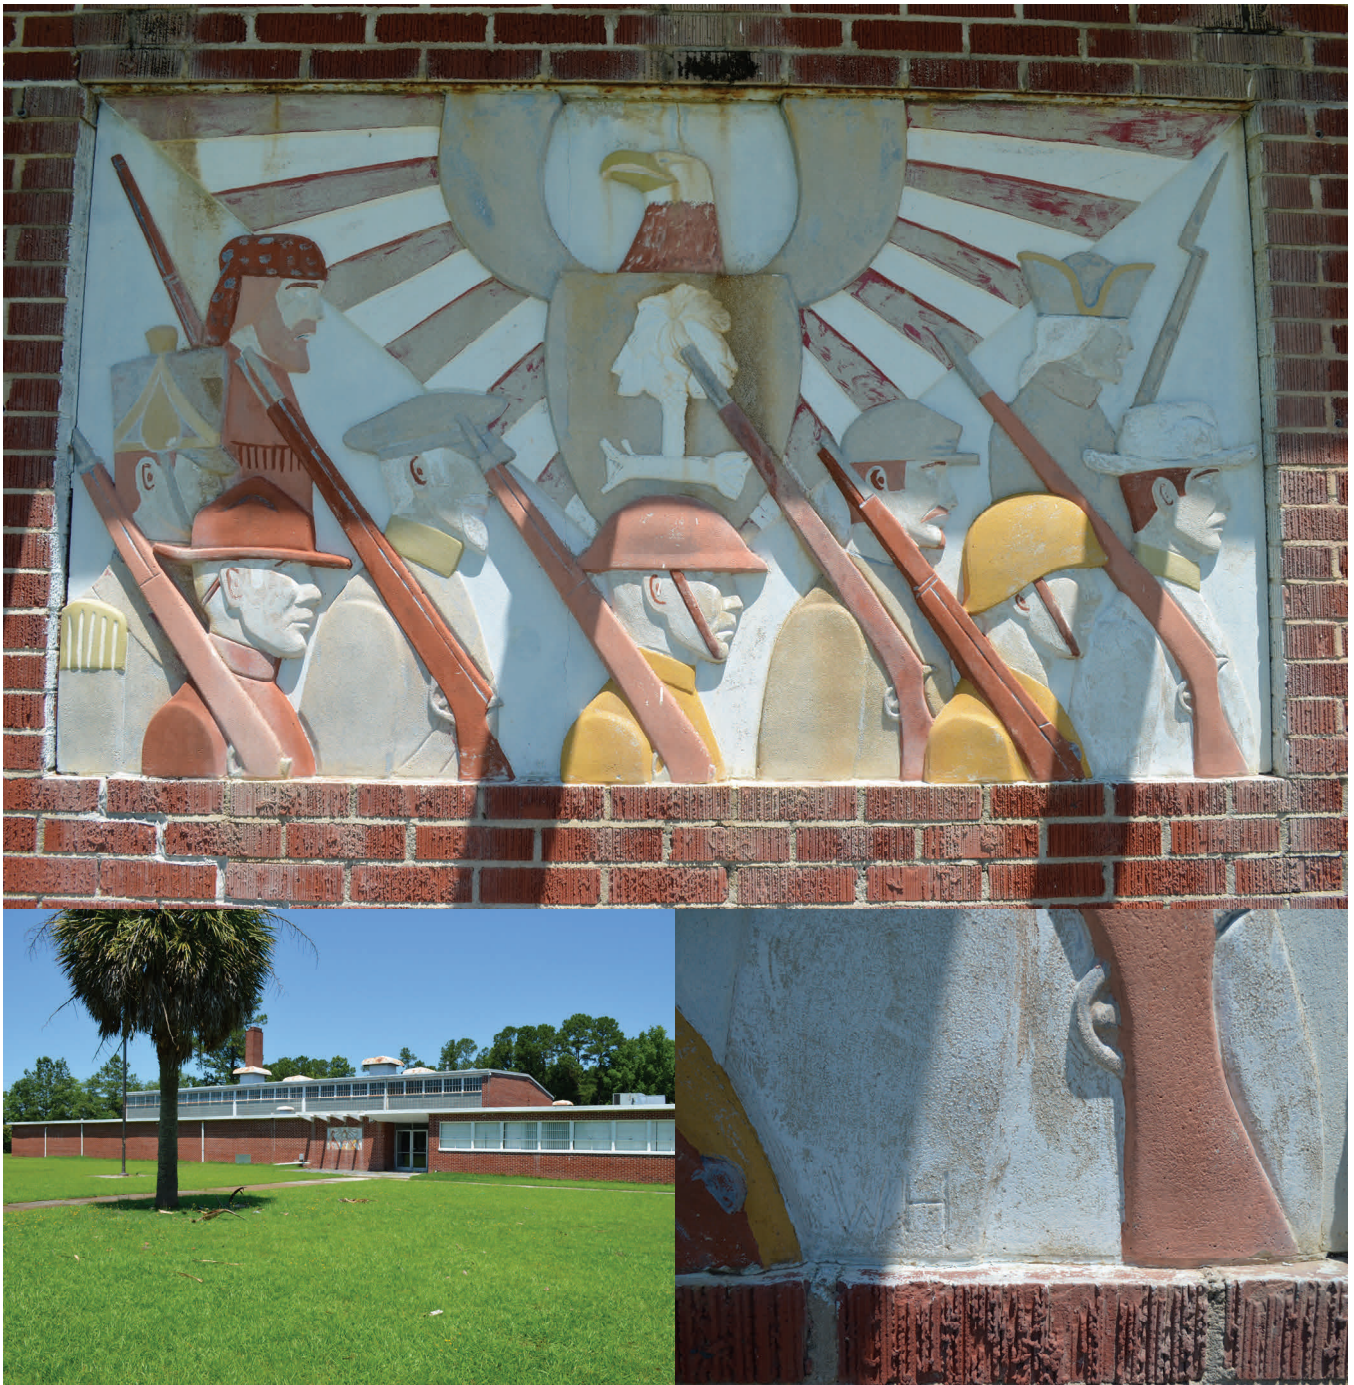
MULLINS ARMORY

The Mullins Armory, on W Marion St., is now owned by the City of Mullins but sits unused from all appearances. The Hirsch panel, located to the left of the main entrance, is painted in polychrome. The color palette is olive green to brown. Willard Hirsch's initials are visible in the lower right corner.

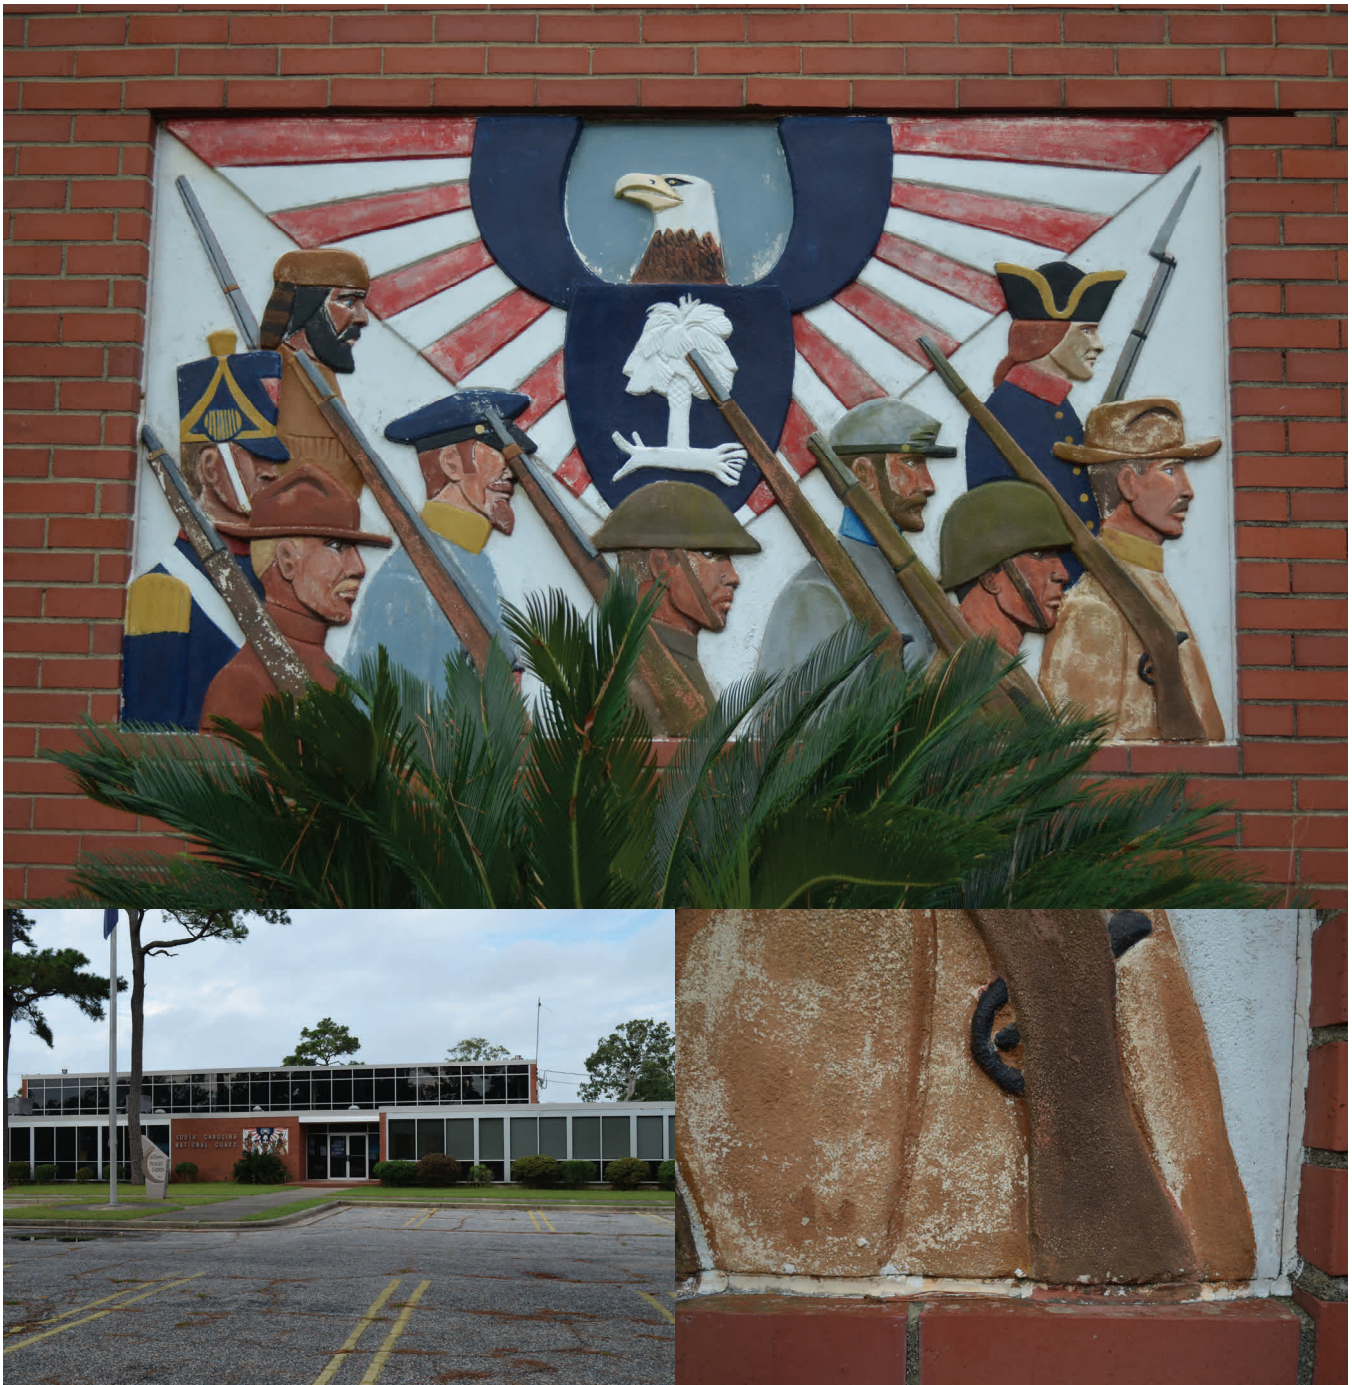
MYRTLE BEACH ARMORY

The Myrtle Armory is one of the original fifteen **NRHP-eligible** complexes. A Hirsch panel is present, located to the left of the main entrance. Like many panels documented during the project, this panel is painted in polychrome. The initials "WH" are present but are difficult to read and may be obscured by subsequent etching (image, lower right).

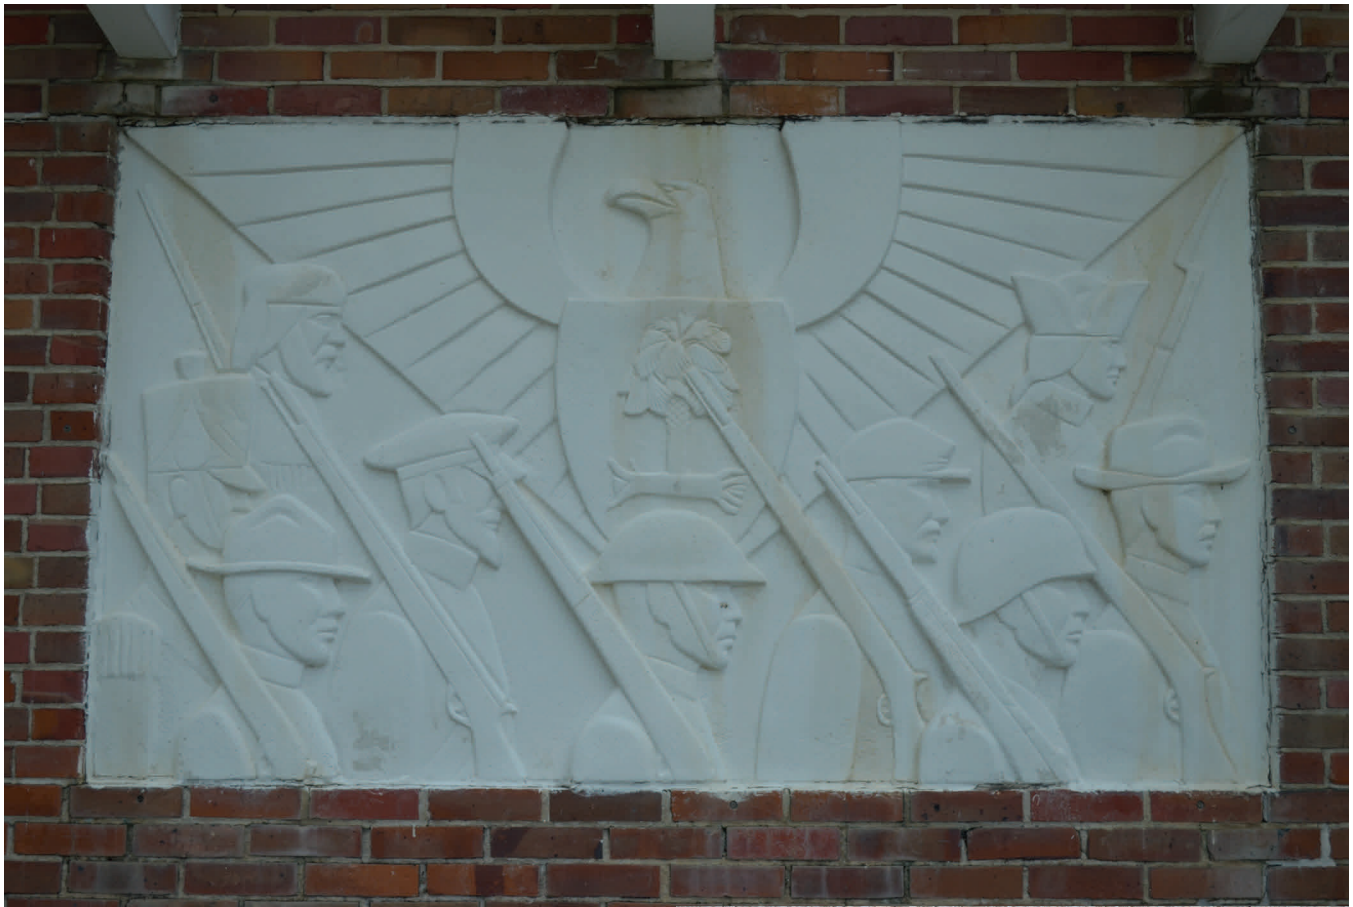
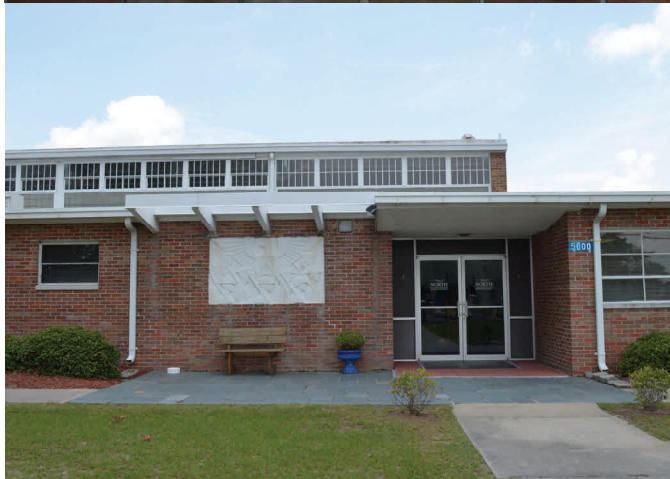
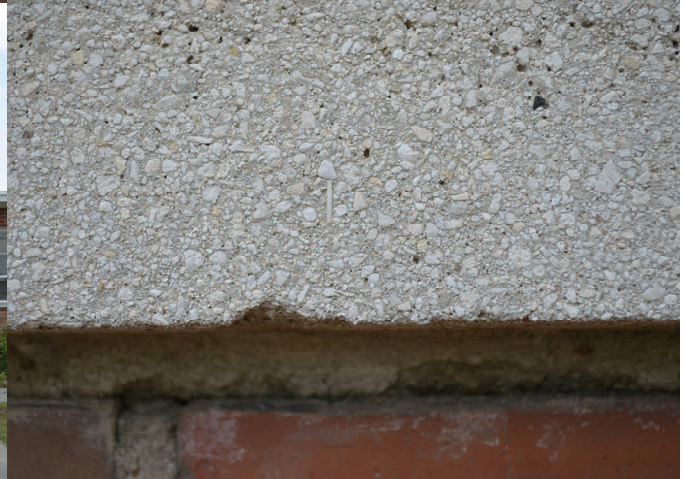
NORTH CHARLESTON ARMORY

The North Charleston Armory on Lakawanna Blvd., now owned by the City's Recreation Department, has an intact Hirsch panel that has been painted white. The paint, for the most part, is intact, and covers a pitted surface that appears to have been sandblasted. Original composite stone in excellent condition can be seen in the structure's window sills (image, lower right).

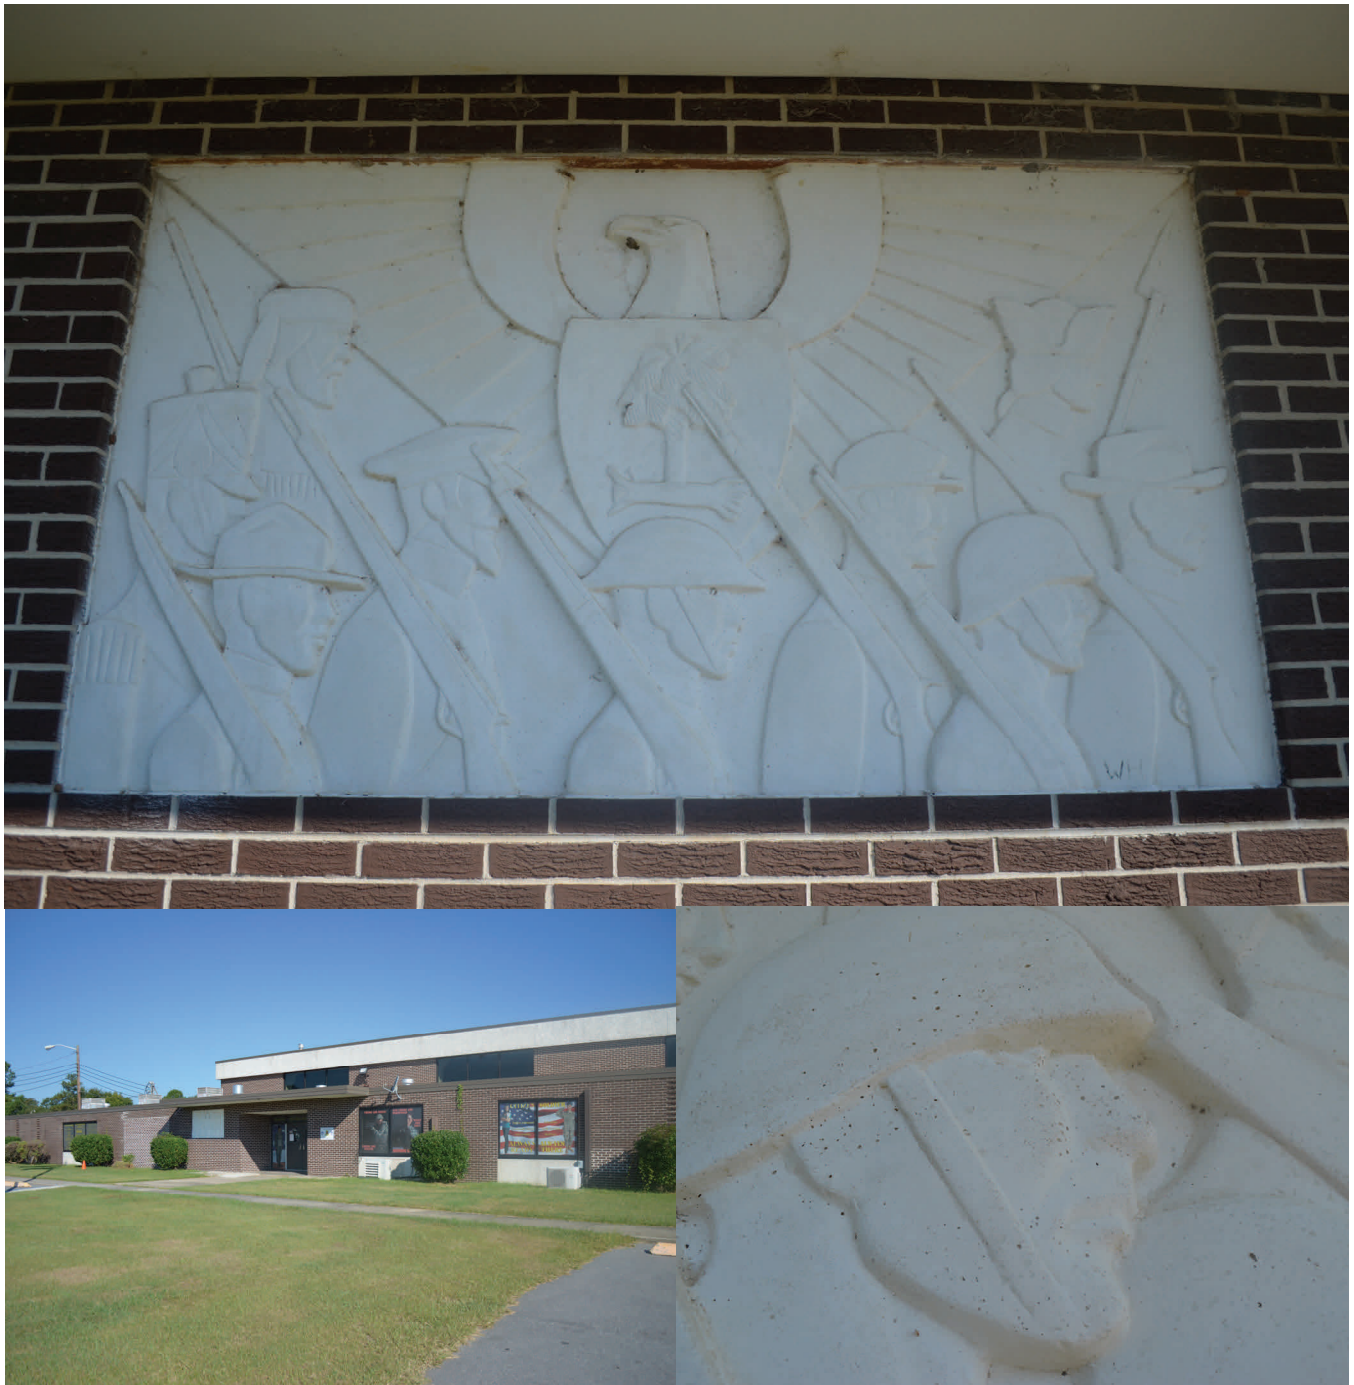
ORANGEBURG ARMORY

The Orangeburg Armory, on Stonewall Jackson Blvd., has a Hirsch panel on the left side of the main entrance. Like many Hirsch panels, this one has been covered in a white paint or wash. Pock or pitted marks, likely from a previous sandblasting episode, are clearly visible across the panel's surface (image, lower right).

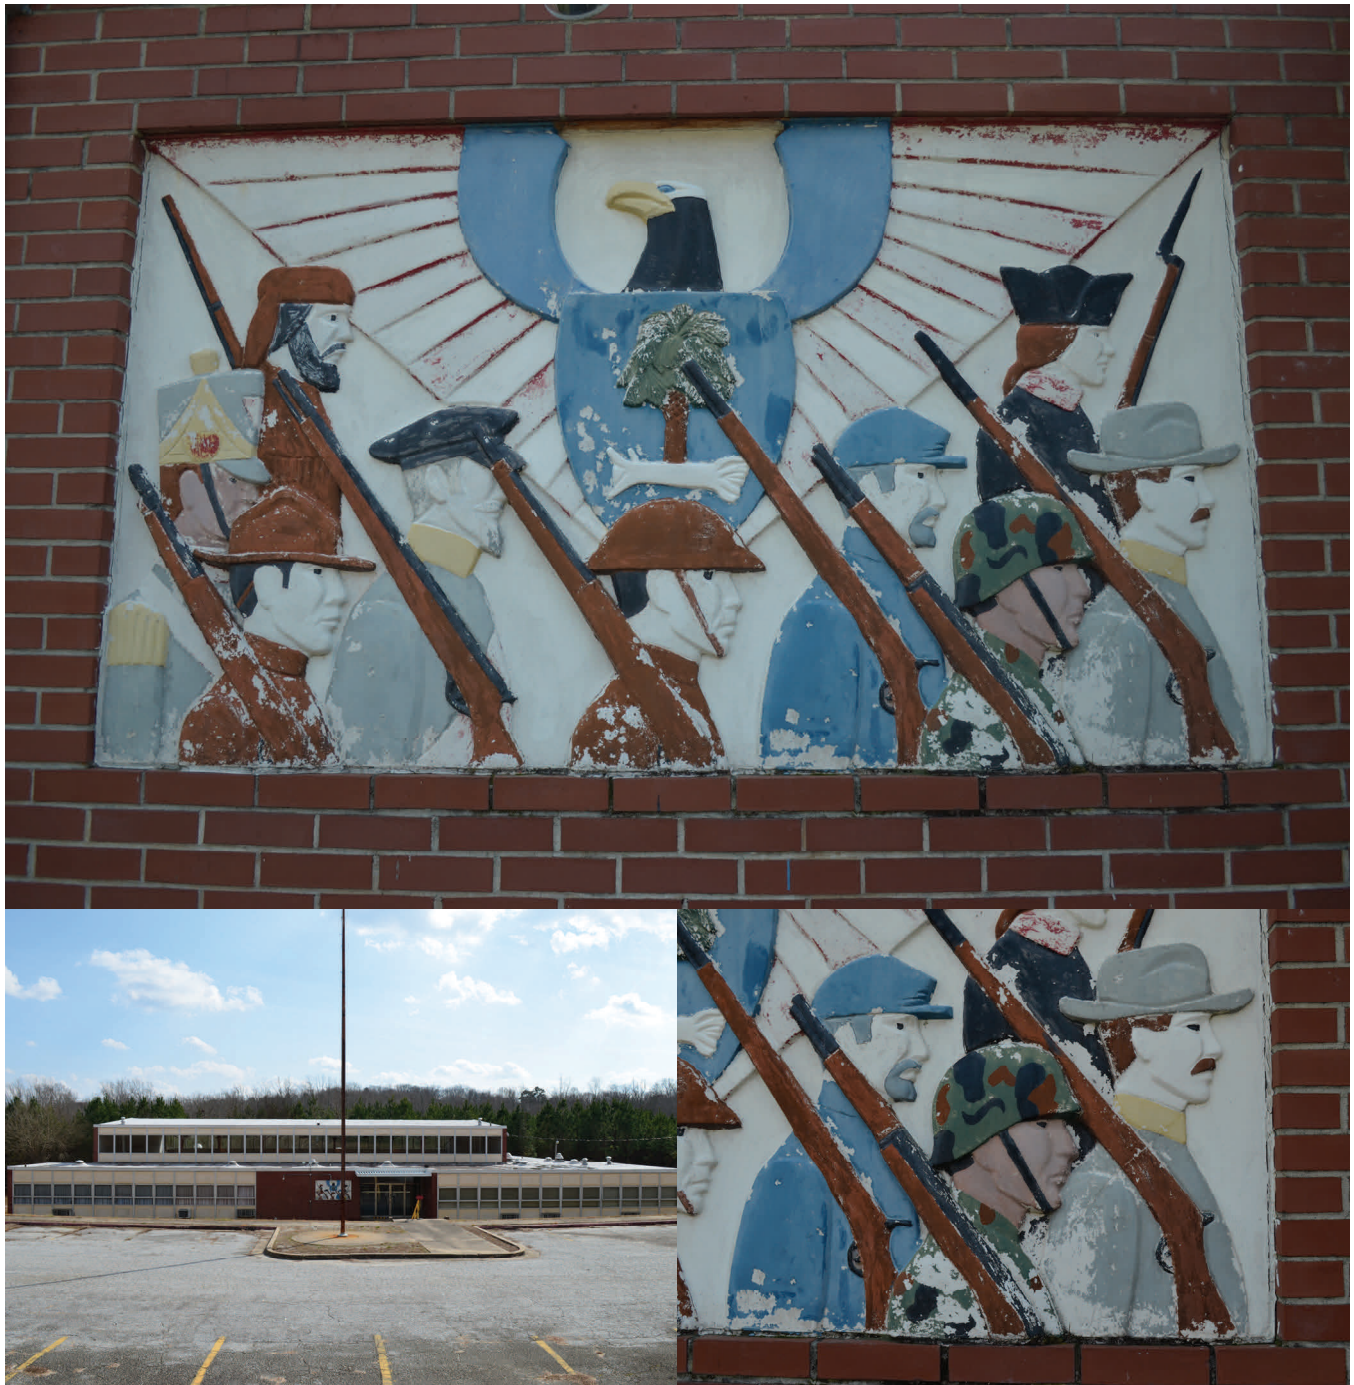
PACOLET ARMORY

The Pacolet Armory is in significant disrepair and no signage is present which would indicate current use or ownership. A Hirsch panel is present and is painted in polychrome. The paint is peeling in areas of panel, particularly the higher relief portions.

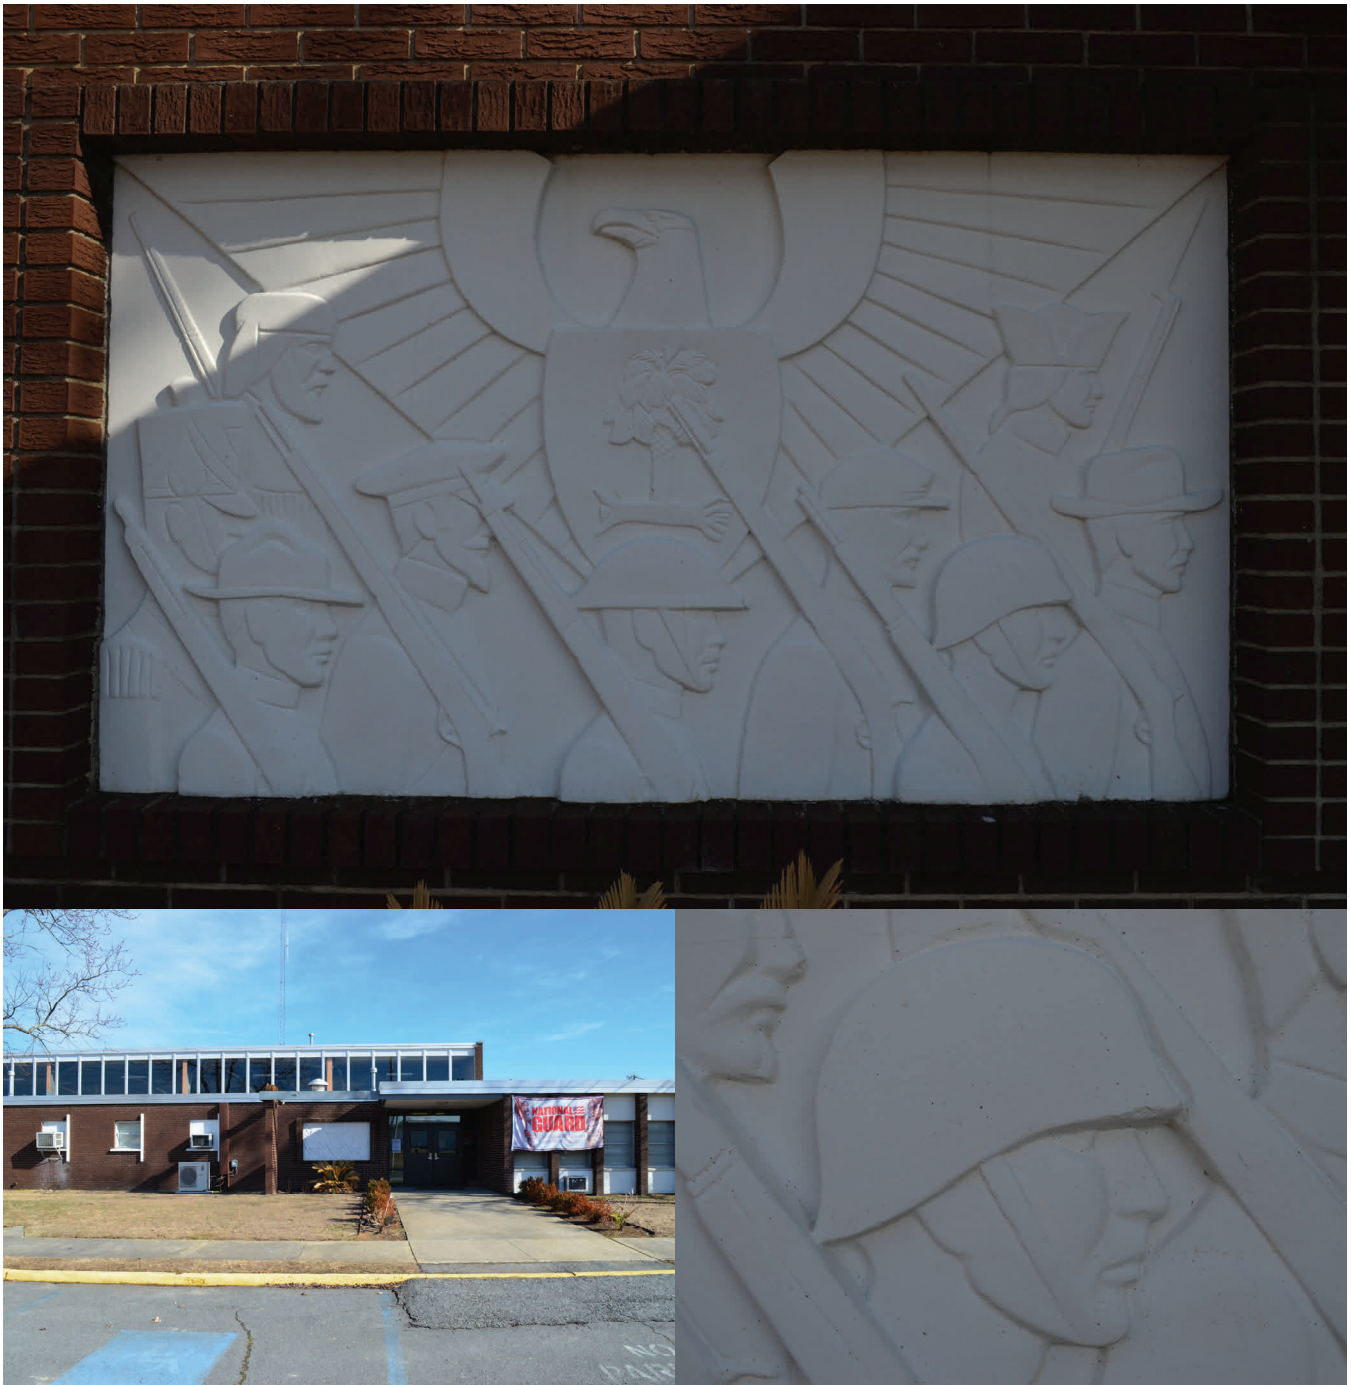
ROCK HILL ARMORY

The Rock Hill Armory on Airport Road is owned by the SCARNG and is one of the fifteen original Cold War-era **NRHP-eligible** armories discussed in Plaag (2012). The Hirsch panel is present at Rock Hill. The panel has been painted white and may have been sandblasted at one point.

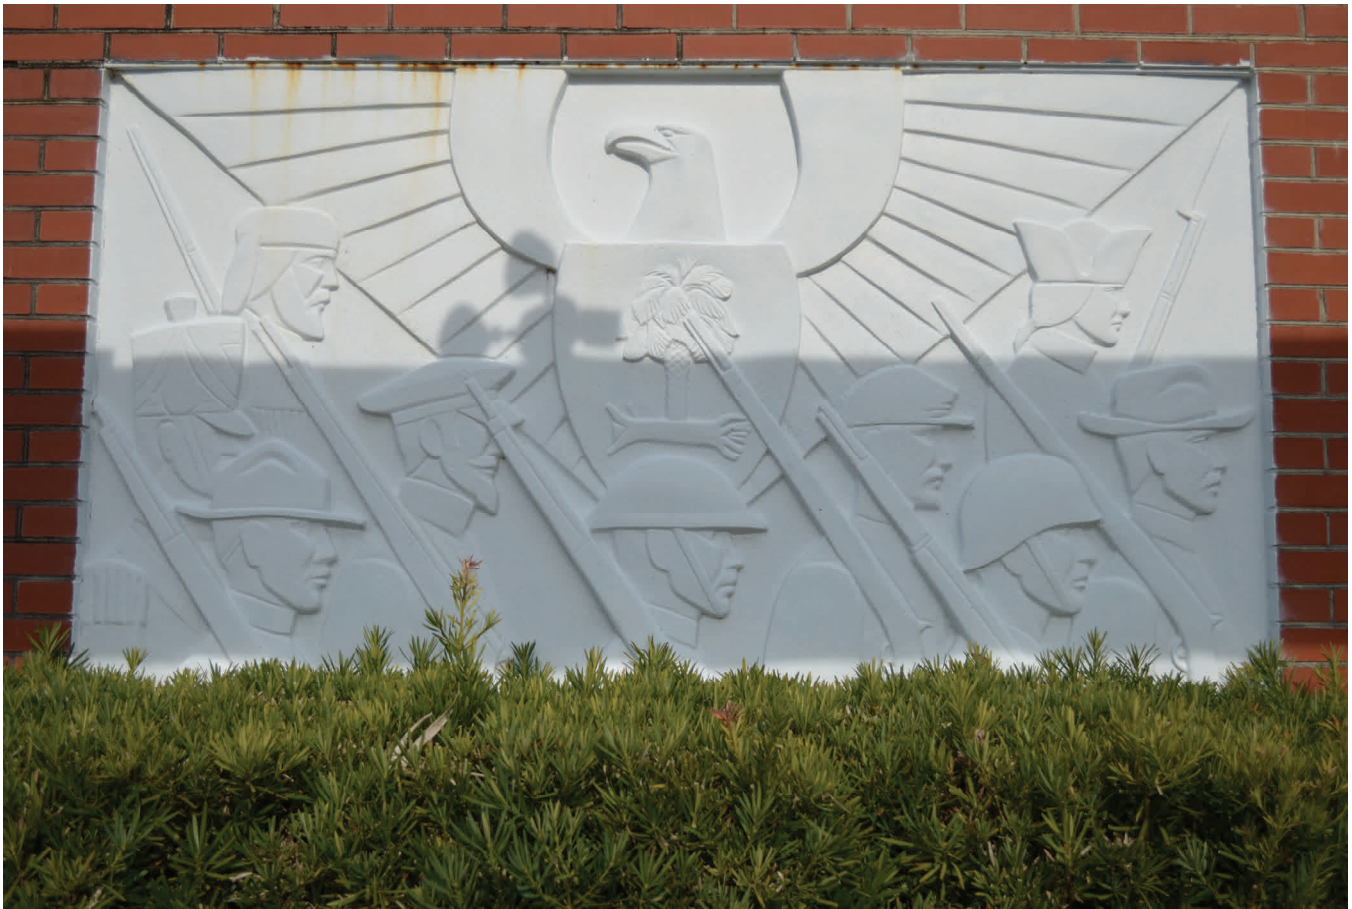
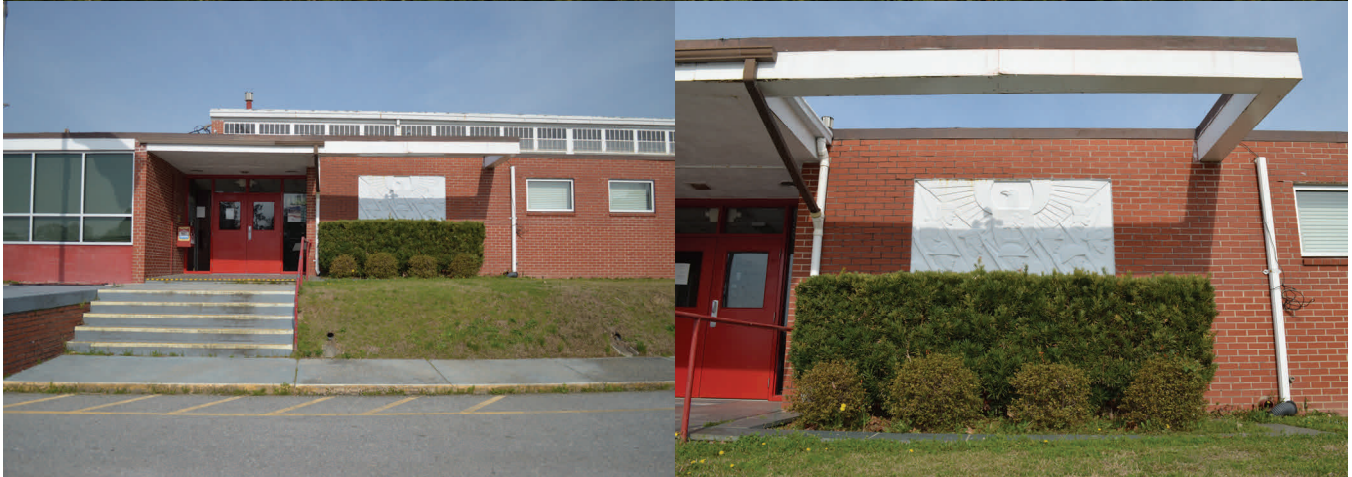
SALUDA ARMORY

The Saluda Armory Hirsch panel has been thinly covered in a white paint. Some peeling of the paint is present. This is one instance in which the shrubbery was too close and too tall to permit close photo documentation, but it did appear that some surface pitting was also present which would indicate a previous sandblasting episode. The Saluda Armory is one of the original fifteen **NRHP-eligible** complexes.

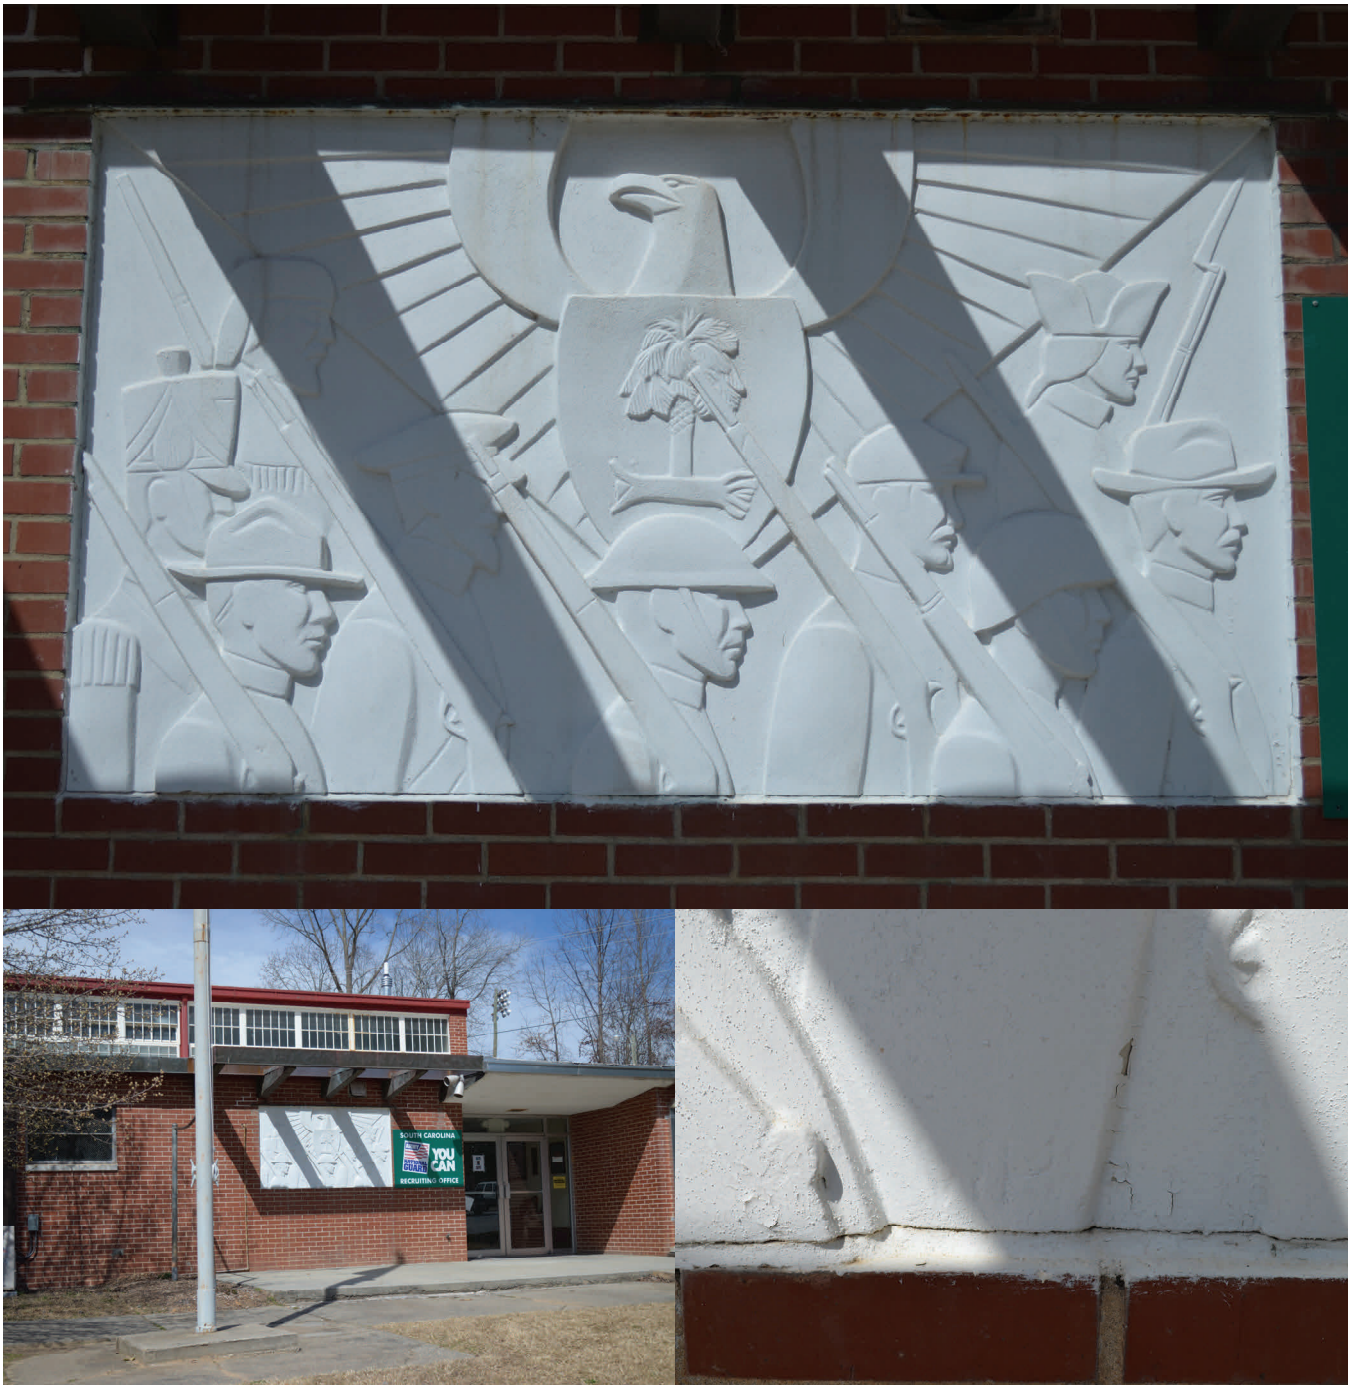
SENECA ARMORY

The Seneca Armory has a Hirsch panel which has been painted in white. Some peeling is present but otherwise the panel is in descent condition.

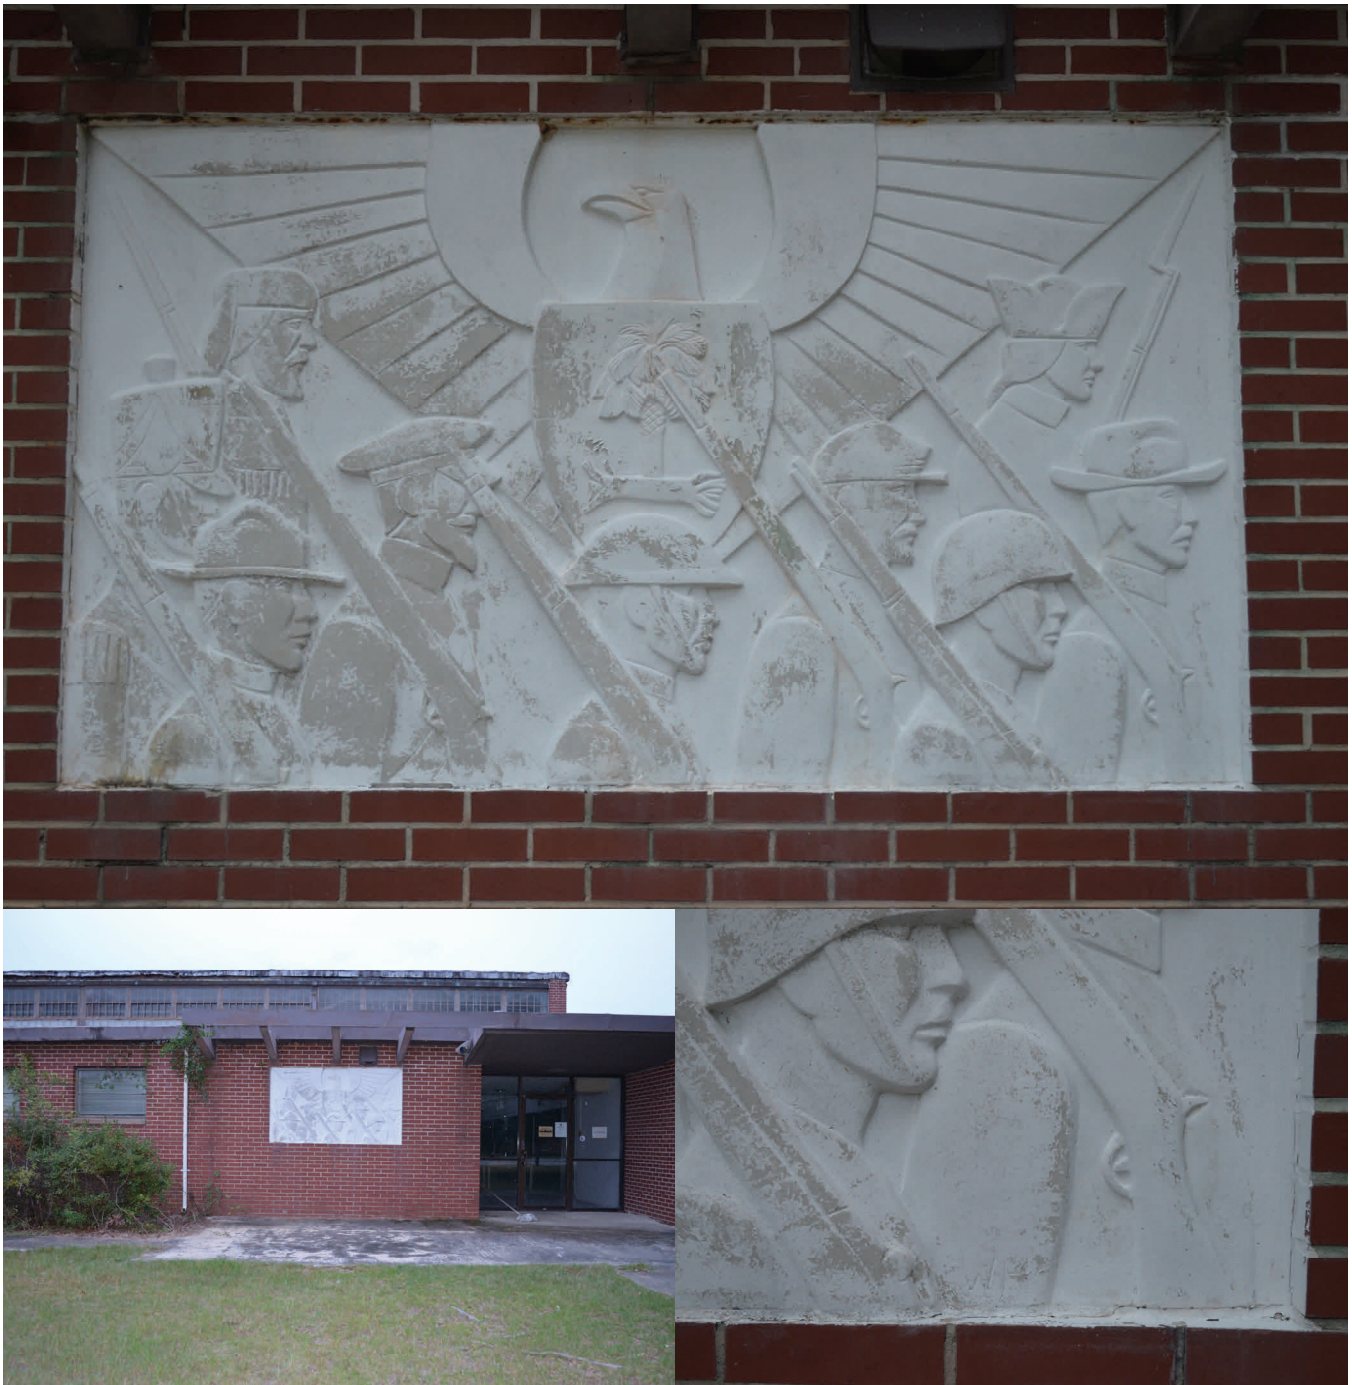
ST MATTHEWS ARMORY

Like many of the panels documented during the project, the Hirsch Panel at St. Matthews Armory has been thinly covered in a white paint or wash, which is wearing off some high-relief parts of the design. The armory complex is city owned and slated for a community center though lacking funds, according to a local passerby. The cold war-era structure is in one of the worst conditions seen, and yet the community is in great need of such a facility.
