Faces of the Guard

A Portrait of the Willard Hirsch Panel Then and Now

Report prepared for
the South Carolina Army National Guard
Columbia, South Carolina

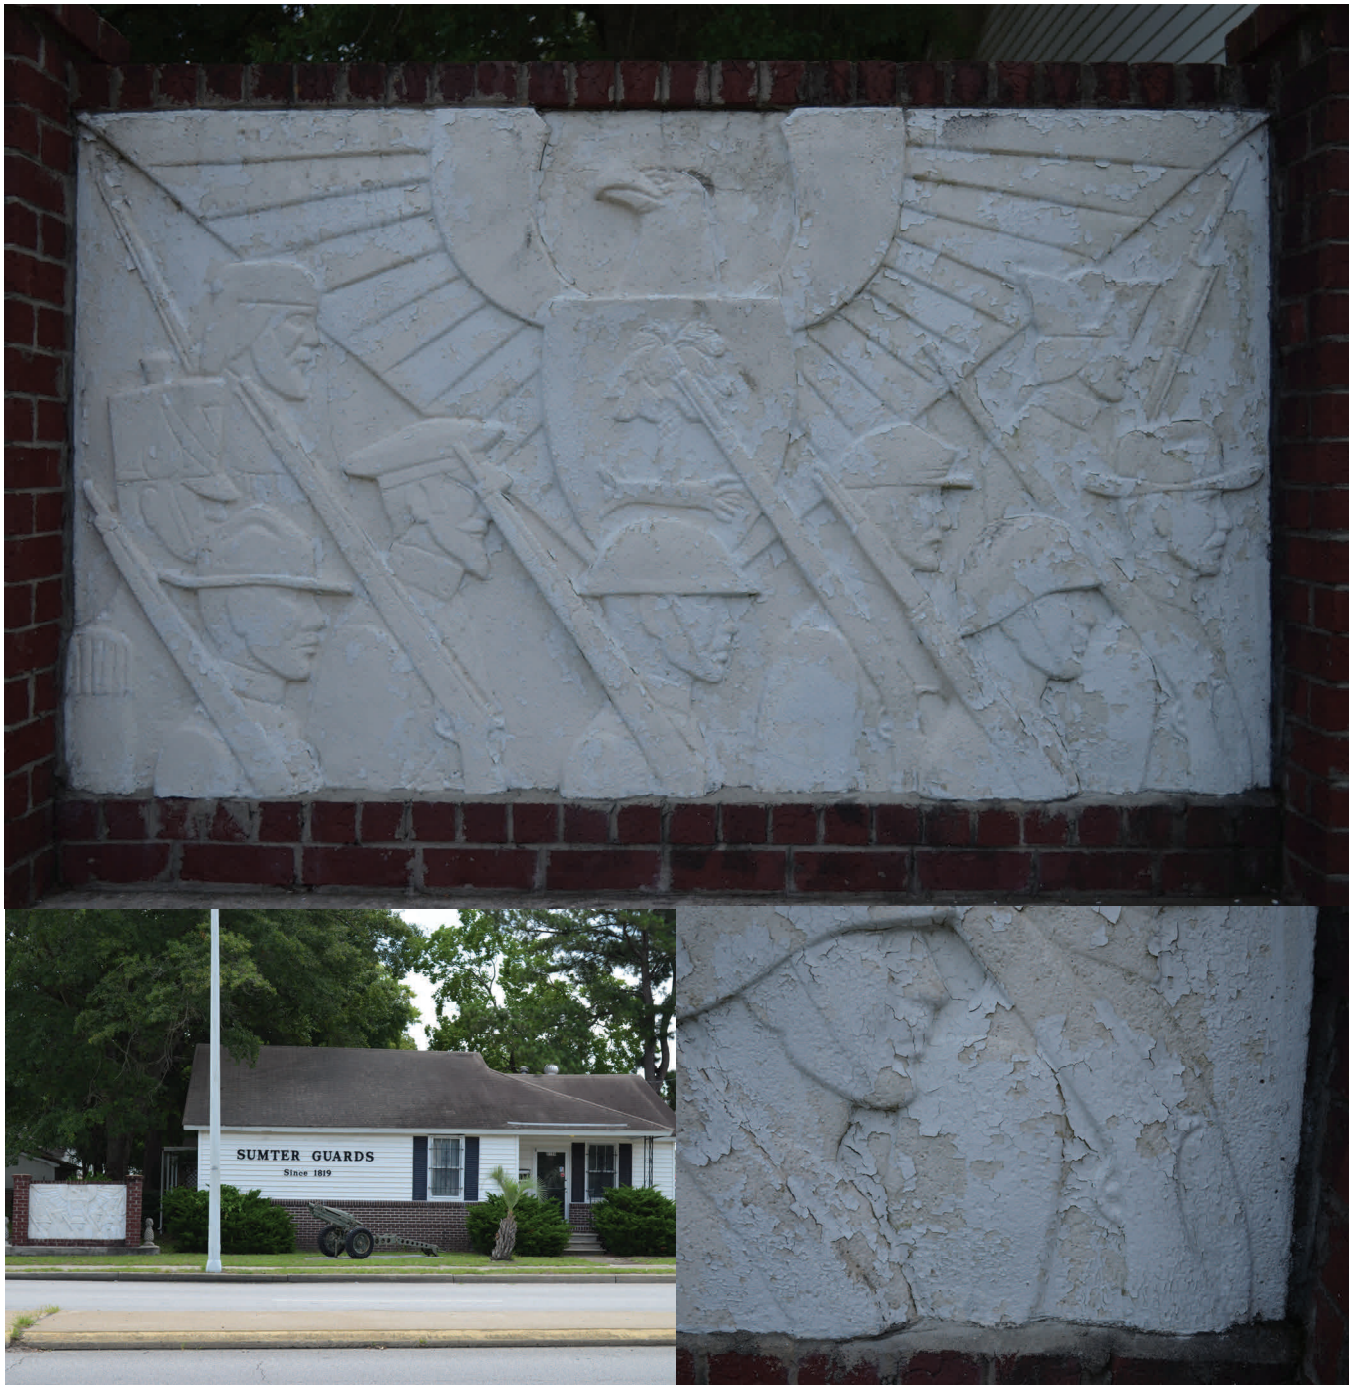
SUMTER GUARDS

The Sumter Guards panel, located on Cosgrove Ave. in North Charleston, is framed in brick but stands detached from whatever Armory for which it had originally been cast. The panel has been painted white and the surface coat is peeling away from the original composite stone. Pock marks in the panel that may indicate a sandblasting episode of the sort that upset Hirsch following a Guard decision to remove polychroming.

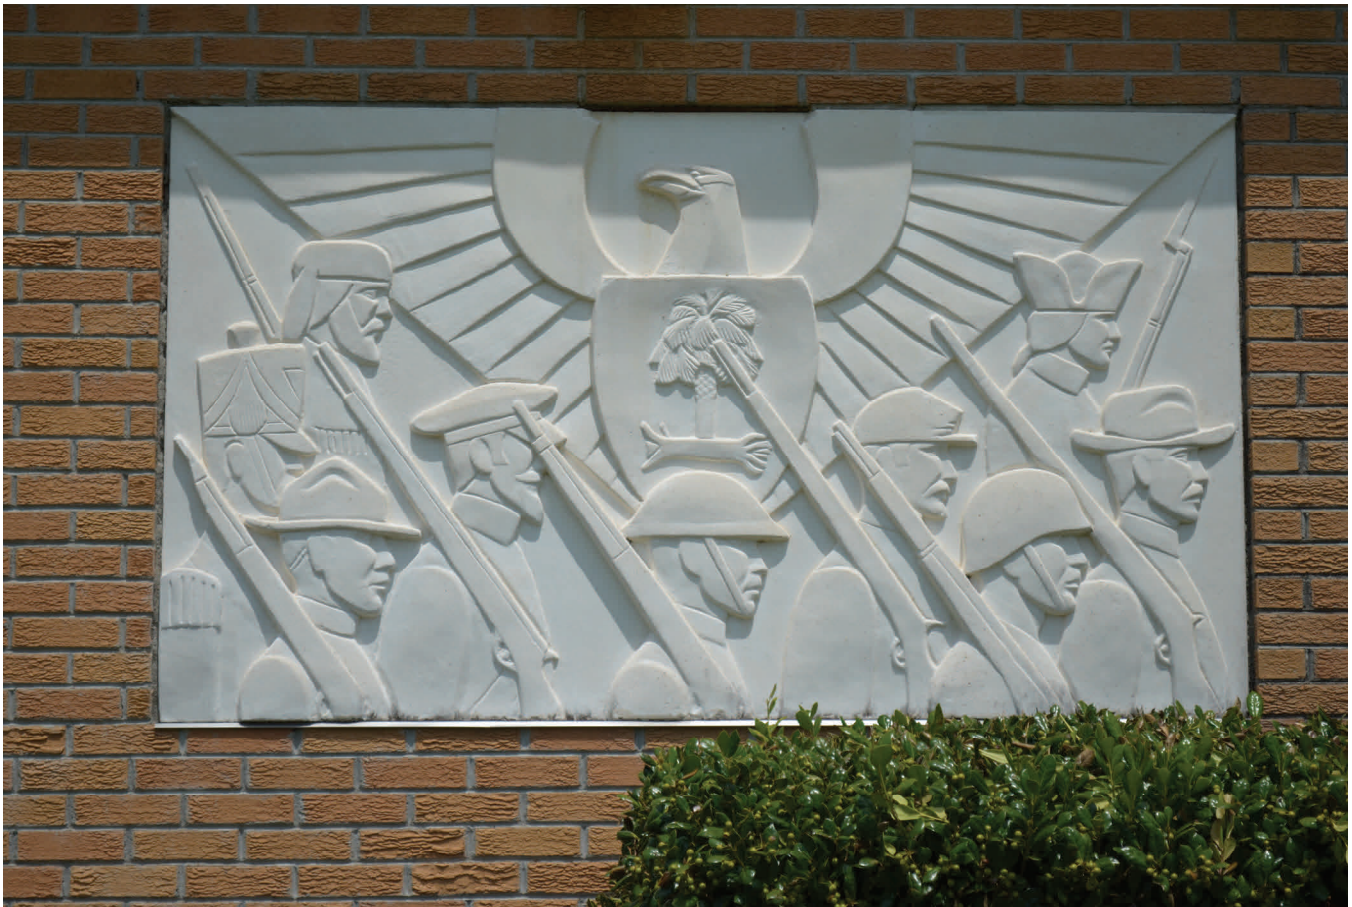
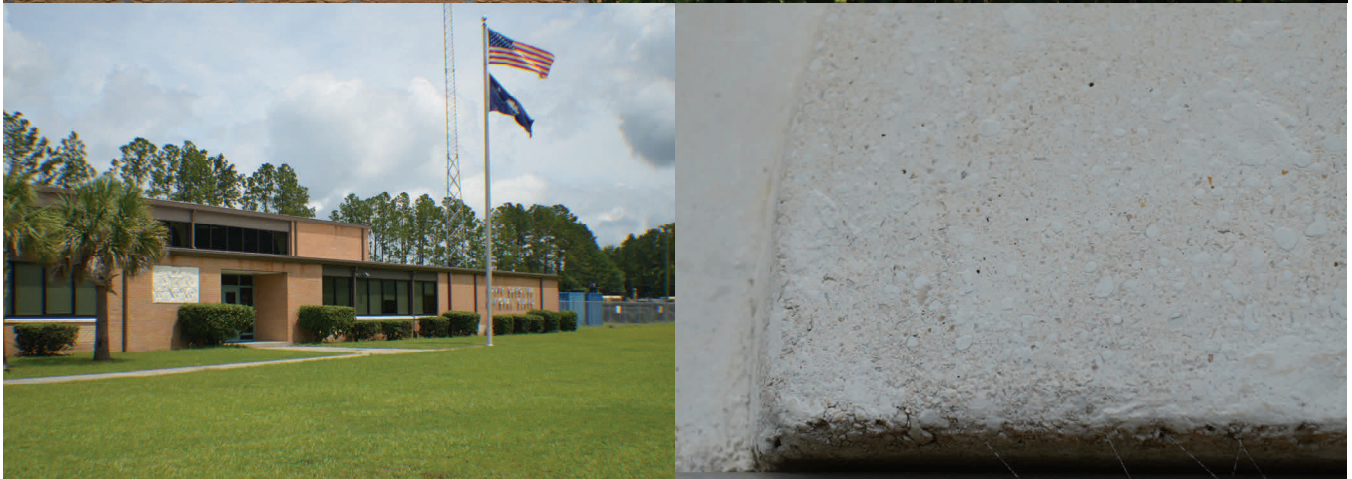
WALTERBORO ARMORY

The Walterboro panel is in good condition. Though no cleaning is needed, it is not clear whether the condition is the result of previous cleaning, long-term good care, or a slightly different material composition. The panel appears somewhat whiter and brighter than many of the others visited and the building itself appears to be a later Cold War era construction, leading one to suspect the composition is a little different.

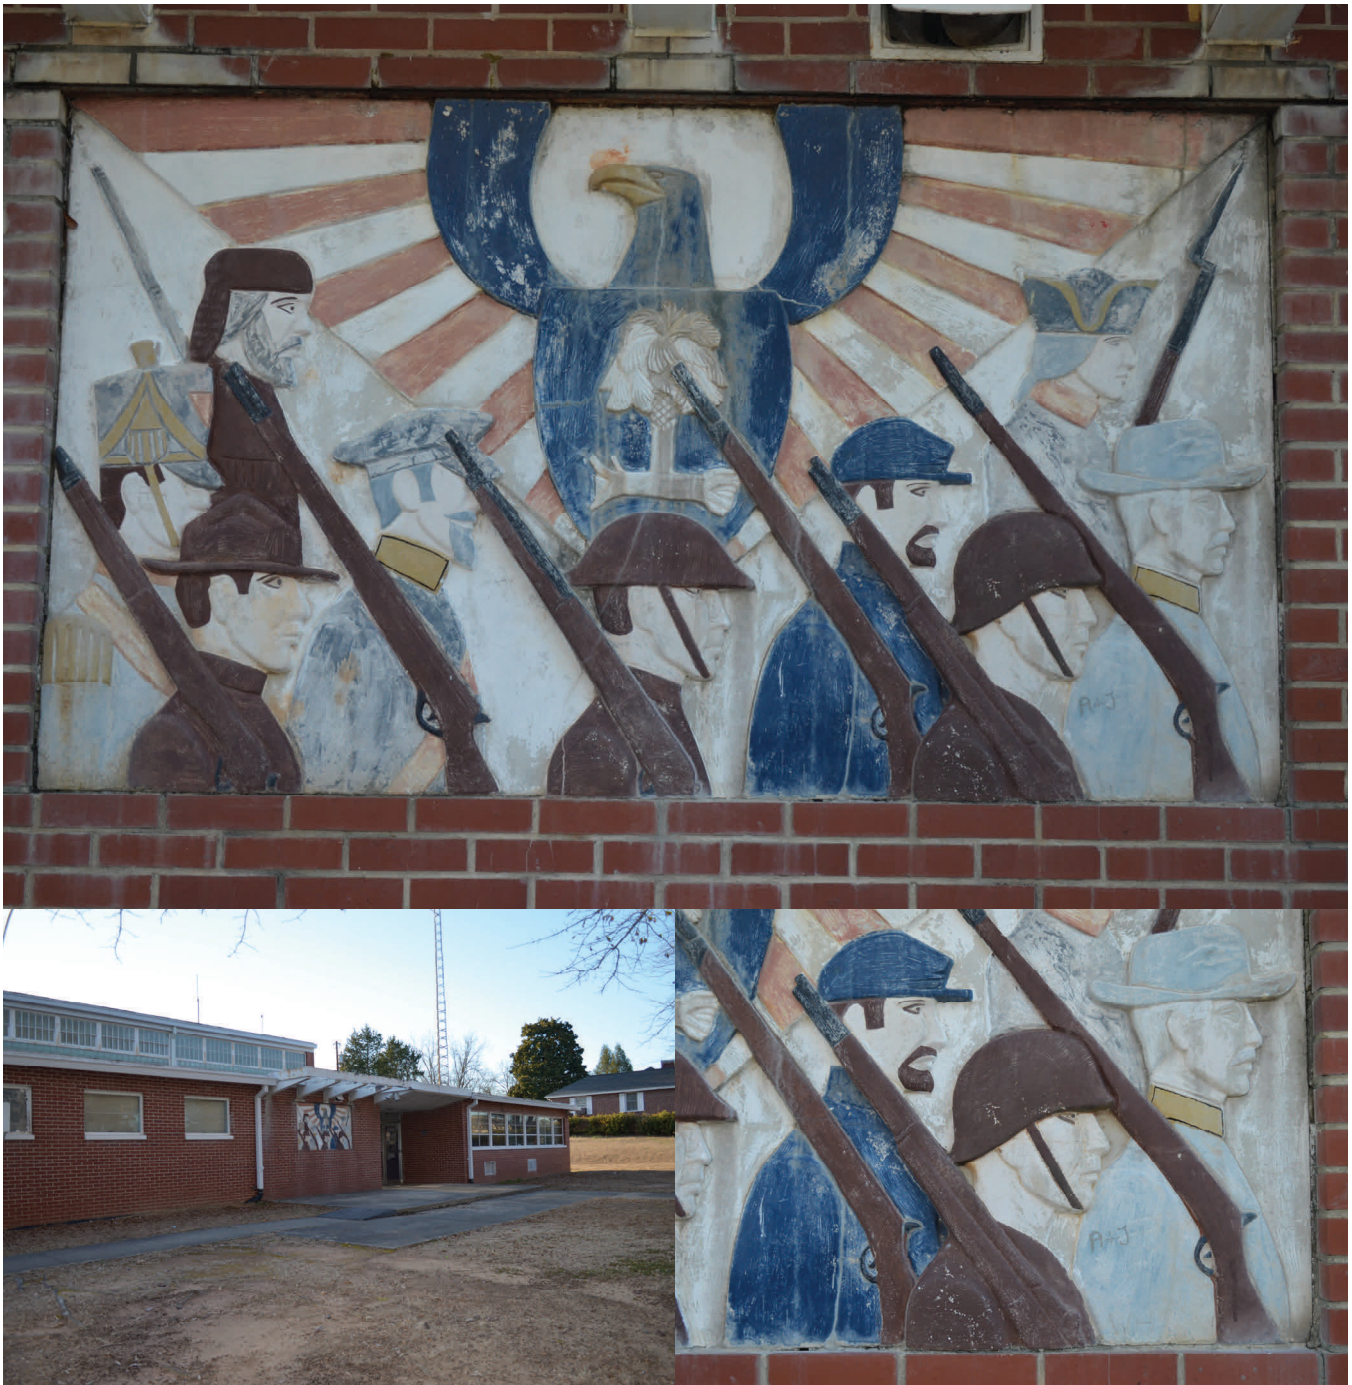
WARE SHOALS ARMORY

The Ware Shoals Armory, now part of Greenwood City Parks & Recreation, has a vividly colored, polychrome-painted Hirsch panel to the left side of the entrance. Some of the paint may represent a more recent attempt to brighten the look of the panel; whereas, other painted guardsmen appear to be faded. The background white paint is peeling or faded in spots and the original composite stone shows through. The panel also is cracked in places.

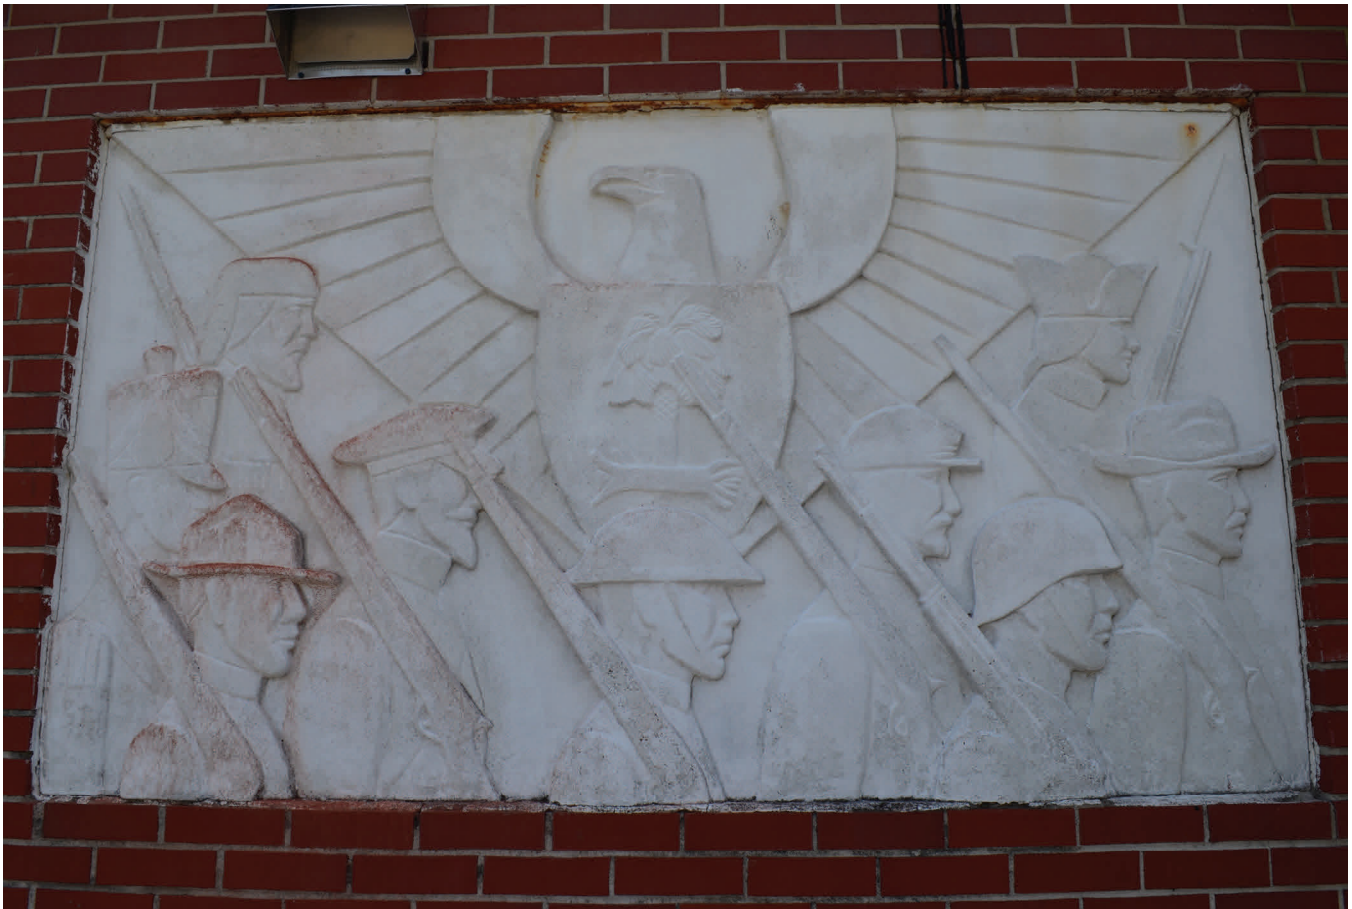
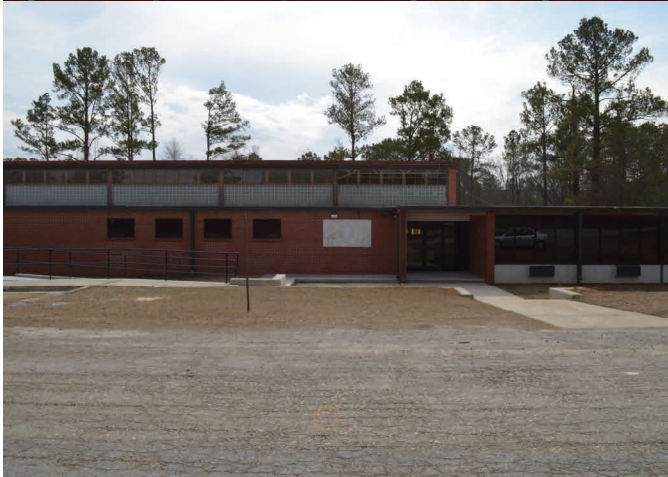
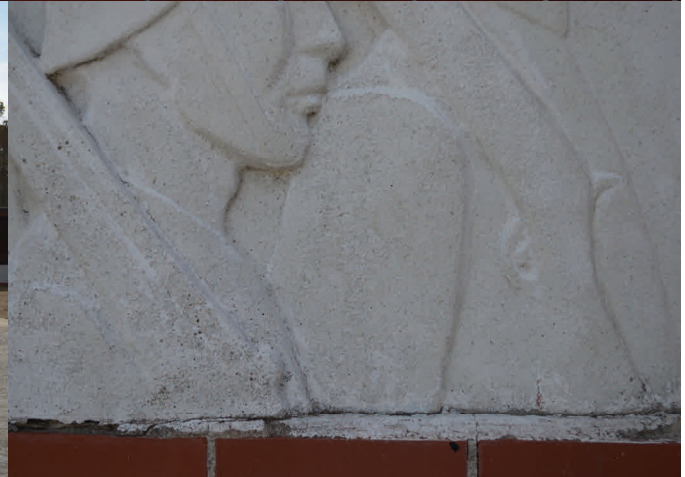
WHITMIRE ARMORY

The Whitmire Armory has not been owned by the SCARNG for some time but appeared to be in private hands. A Hirsch panel is present to the left of the main front entrance. The panel appears to have been painted white at one time. Most of this surface coat has worn off.

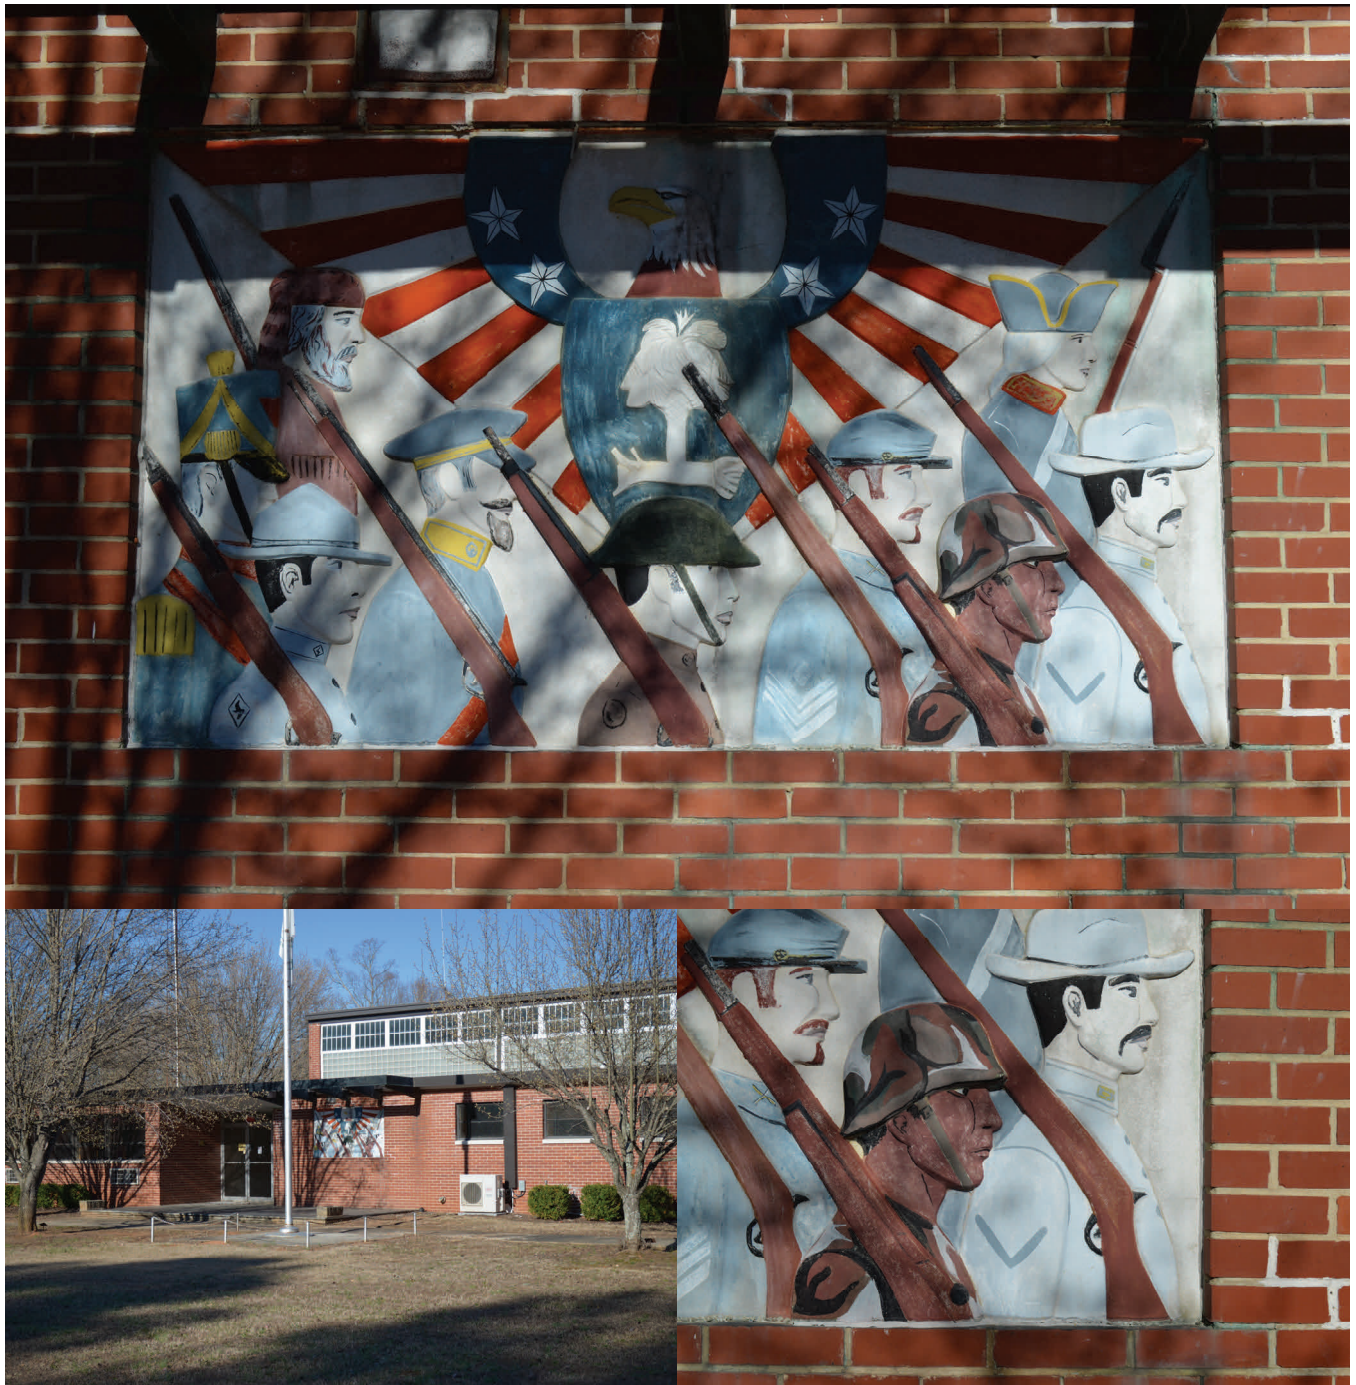
WILLIAMSTON ARMORY

The Williamston Armory has a polychrome painted Hirsch panel located to the right of the entranceway. Some cracks in the panel were observed, most noticeably around the eagle's head. The polychrome paint is bright and suggests a more recent paint episode compared to some of the other polychrome panels. The Williamston Armory is one of the original fifteen **NRHP-eligible** complexes.

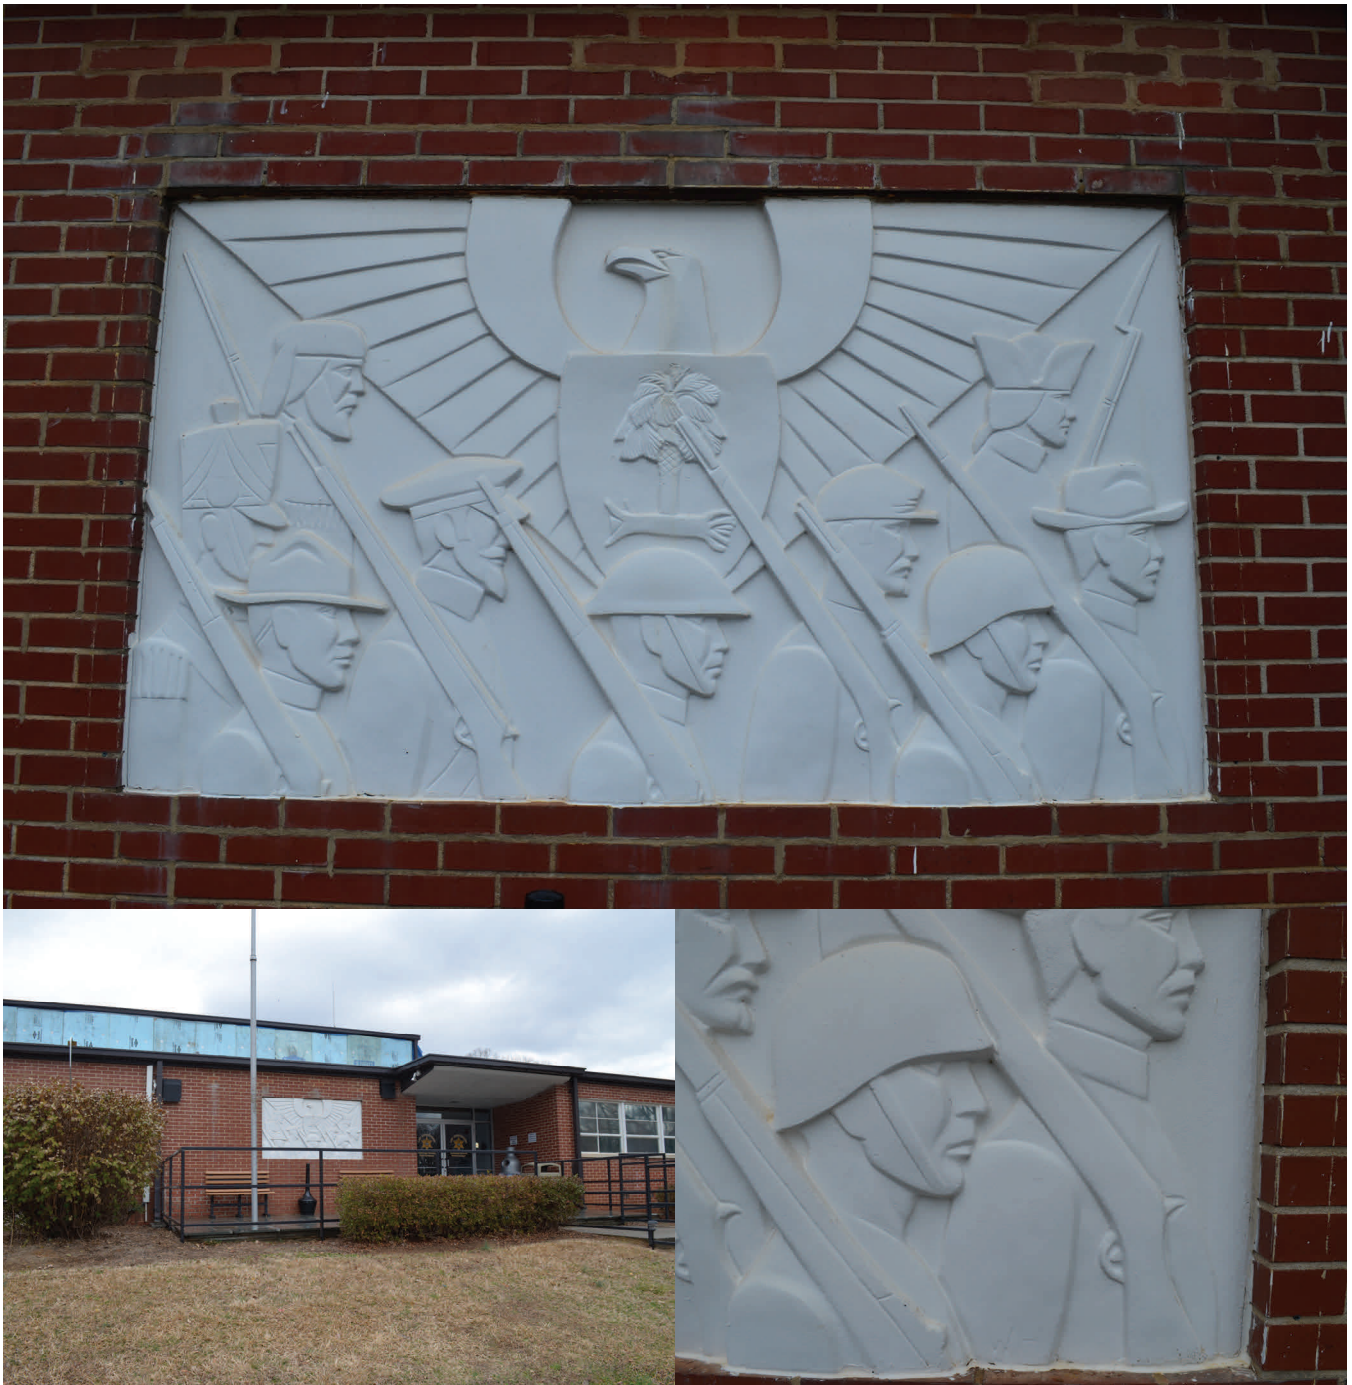
YORK ARMORY

The York Armory on Lincoln Rd. has been repurposed as the York County Law Enforcement Training Center. The Cold War-era building was undergoing renovations at the time of the visit, but the Hirsch panel remains intact and located to the left of the exterior front entryway. The panel has been painted or washed in white but is otherwise in good condition.
